Memo to the Programs, Projects and Operations Subcommittee

Subject: Elkhorn River IPA – Bank Stabilization Construction Project Change Orders

Date: July 9, 2012

Re: Elkhorn River IPA Bank Stabilization Change Order 3 Recommendation

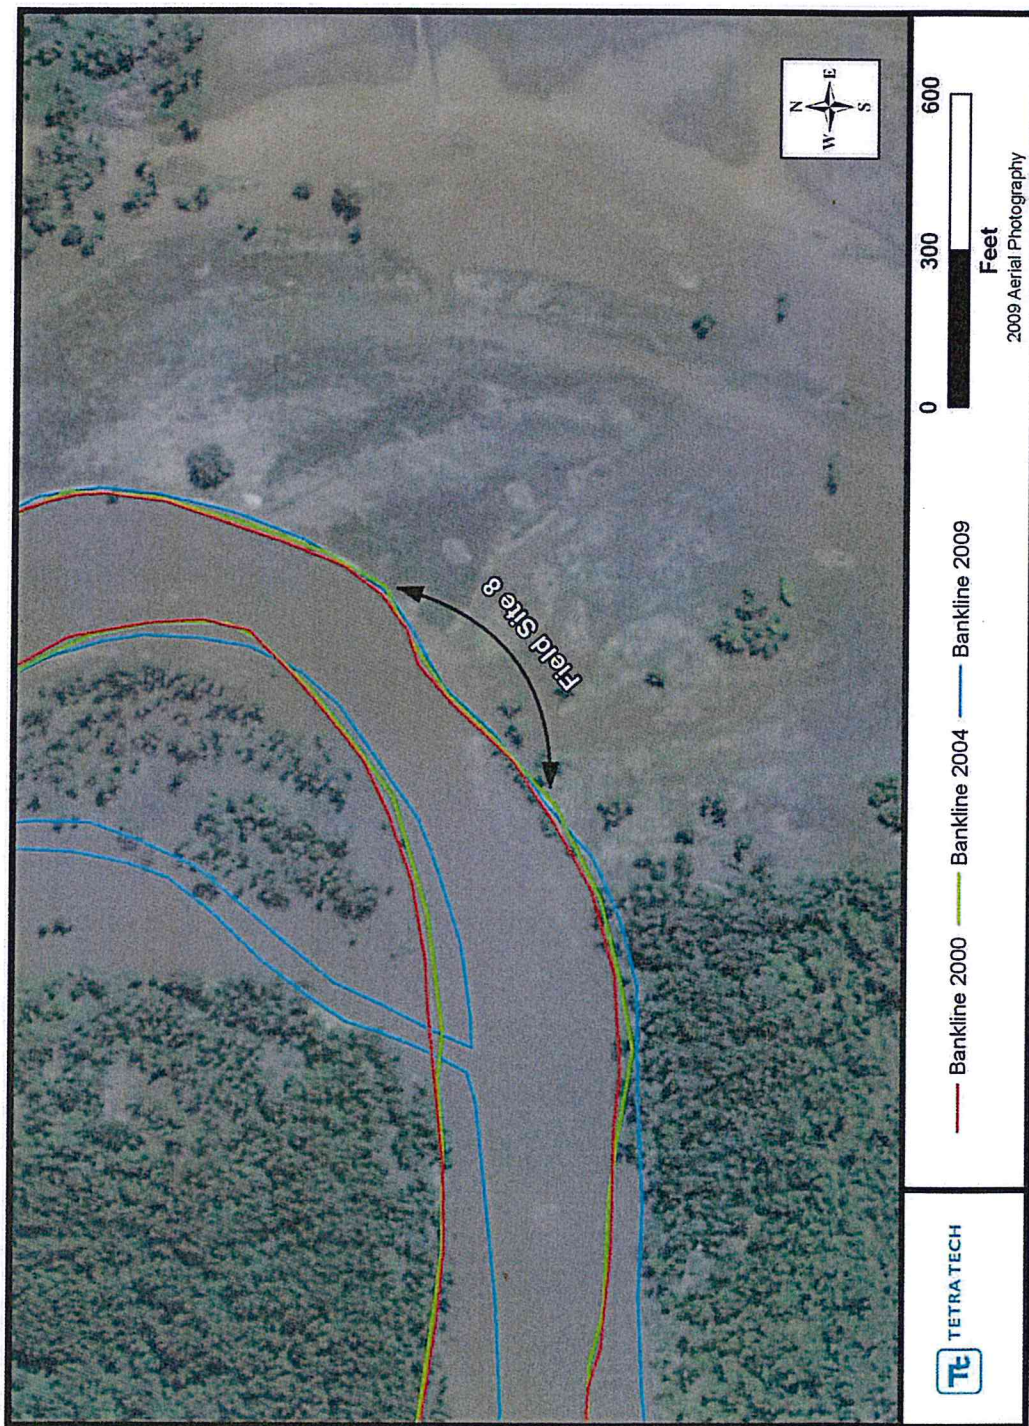
Field Site 8 is an approximately 300-foot long scallop that has developed in the left bank just downstream from a pre-existing rock spur located at the downstream end of the windrow revetment for Site 13B (**Figures 34 and 35**). The bankline at this location retreated into the overbank by nearly 80 feet downstream from the rock spur. The IPA construction plans called for cabled-tree revetment for approximately 1,000 feet downstream from the rock spur. The cabled-trees were not installed during the original construction, but windrow revetment was placed in this area in the late 1990s (**Figure 36**; Table 1, Note 16). With the exception of the scalloped area, the remainder of the bankline appears to be relatively stable at the present time.

Figure 34. Aerial photograph taken on June 16, 2010 (discharge ~37,250 cfs) of Field Site 8. Also shown are the banklines from the October 2000, October 2004 and September 2009 aerial photographs.

Recommended repairs at Field Site 8 include realigning the bankline to eliminate the scallop, and placement of appropriately sized rock riprap on the realigned bankline (**Figure 37**). The length of the realigned bankline would be about 350 feet, and the area that would need to be filled between the existing and new bankline is about 17,000 ft². Assuming a bank height of 12

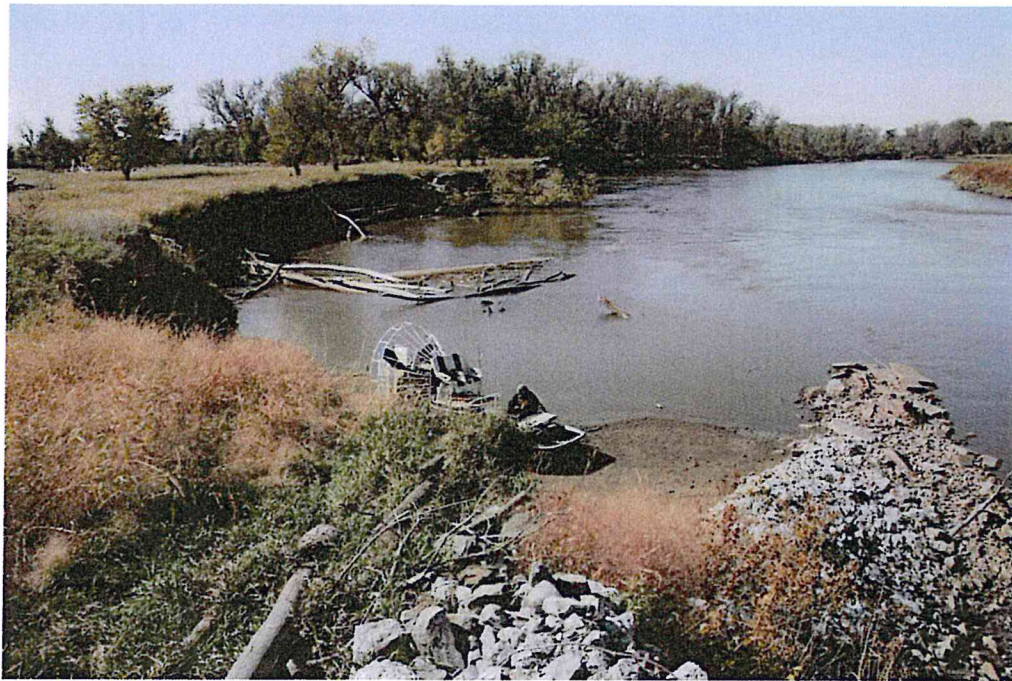
Figure 35. View looking downstream flows from the pre-existing rock spur at Field Site 8 across the scallop in the left bank that developed during the June 2010 high flow.

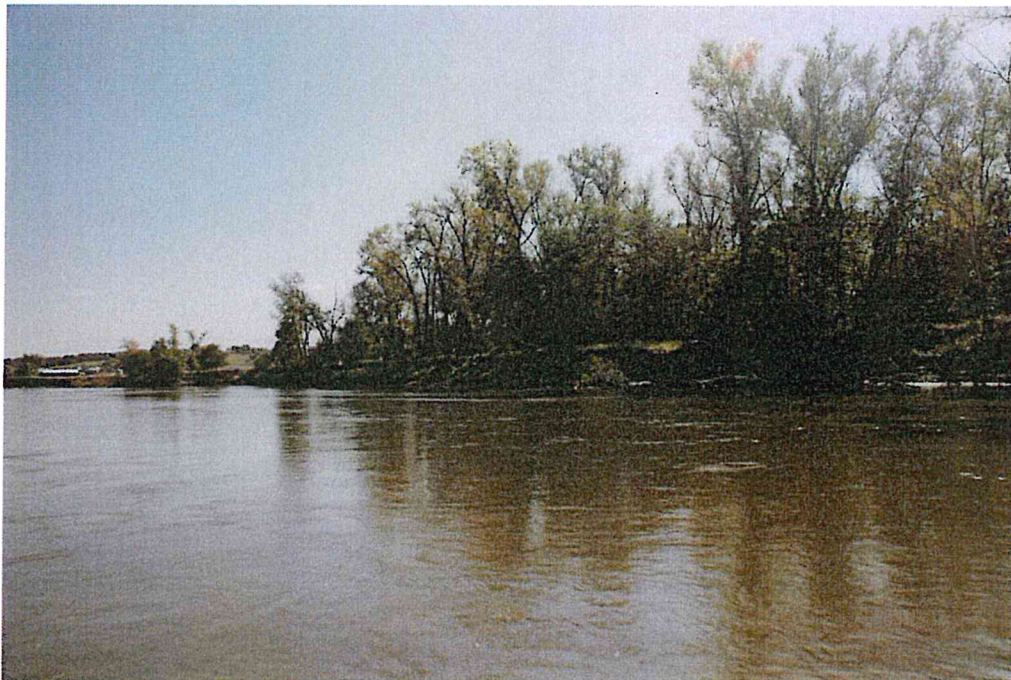
Figure 36. View looking upstream along the bankline in the downstream portion of IPA Site 13B where cabled-tree revetment was called for in the construction plans. Note the launching rock along the bank. A portion of Field Site 8 is visible on the far left side of the photo.

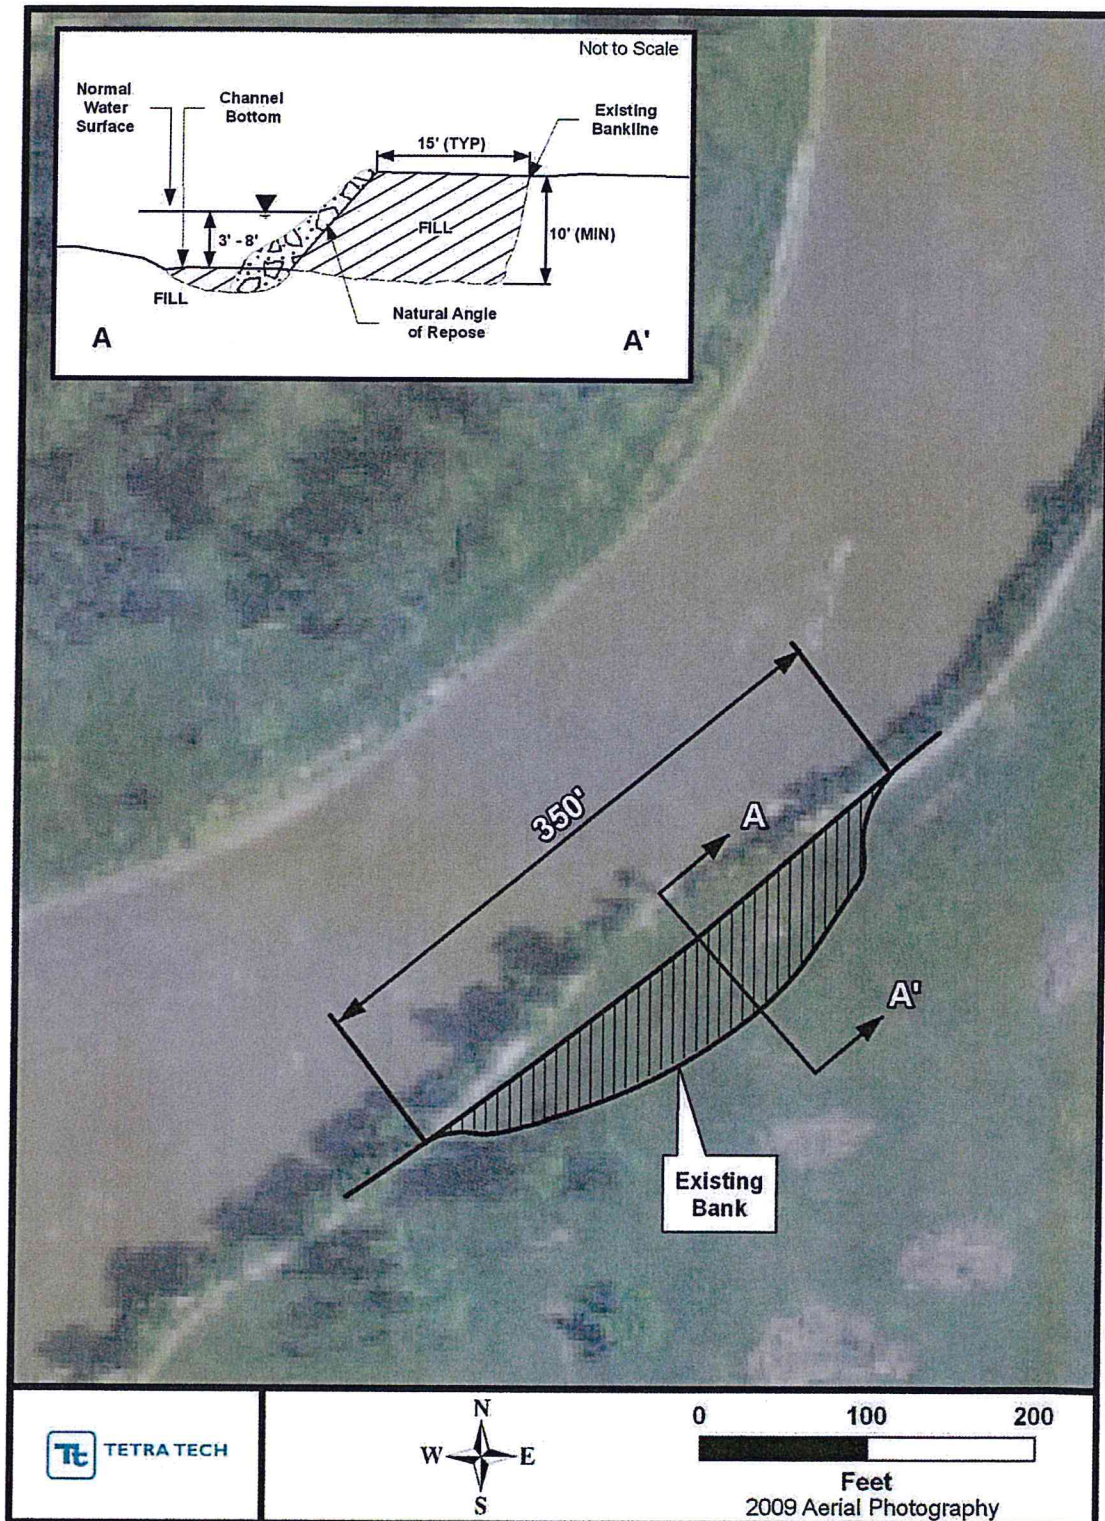
Figure 37. Recommended re-alignment of bankline at Field Site 8 and typical cross section of the rock riprap that should be placed along the realigned bank.

feet, based on the topography in the IPA plans, plus approximately 5 feet of local scour on the outside of the bend, a total fill volume of about 7,600 yd³ would be required.
