MEMORANDUM

SUBJECT: Little Papio Channel (Center Street to Grover Street) Stabilization Project
Professional Services Contract with HDR Engineering

DATE: May 5, 2015

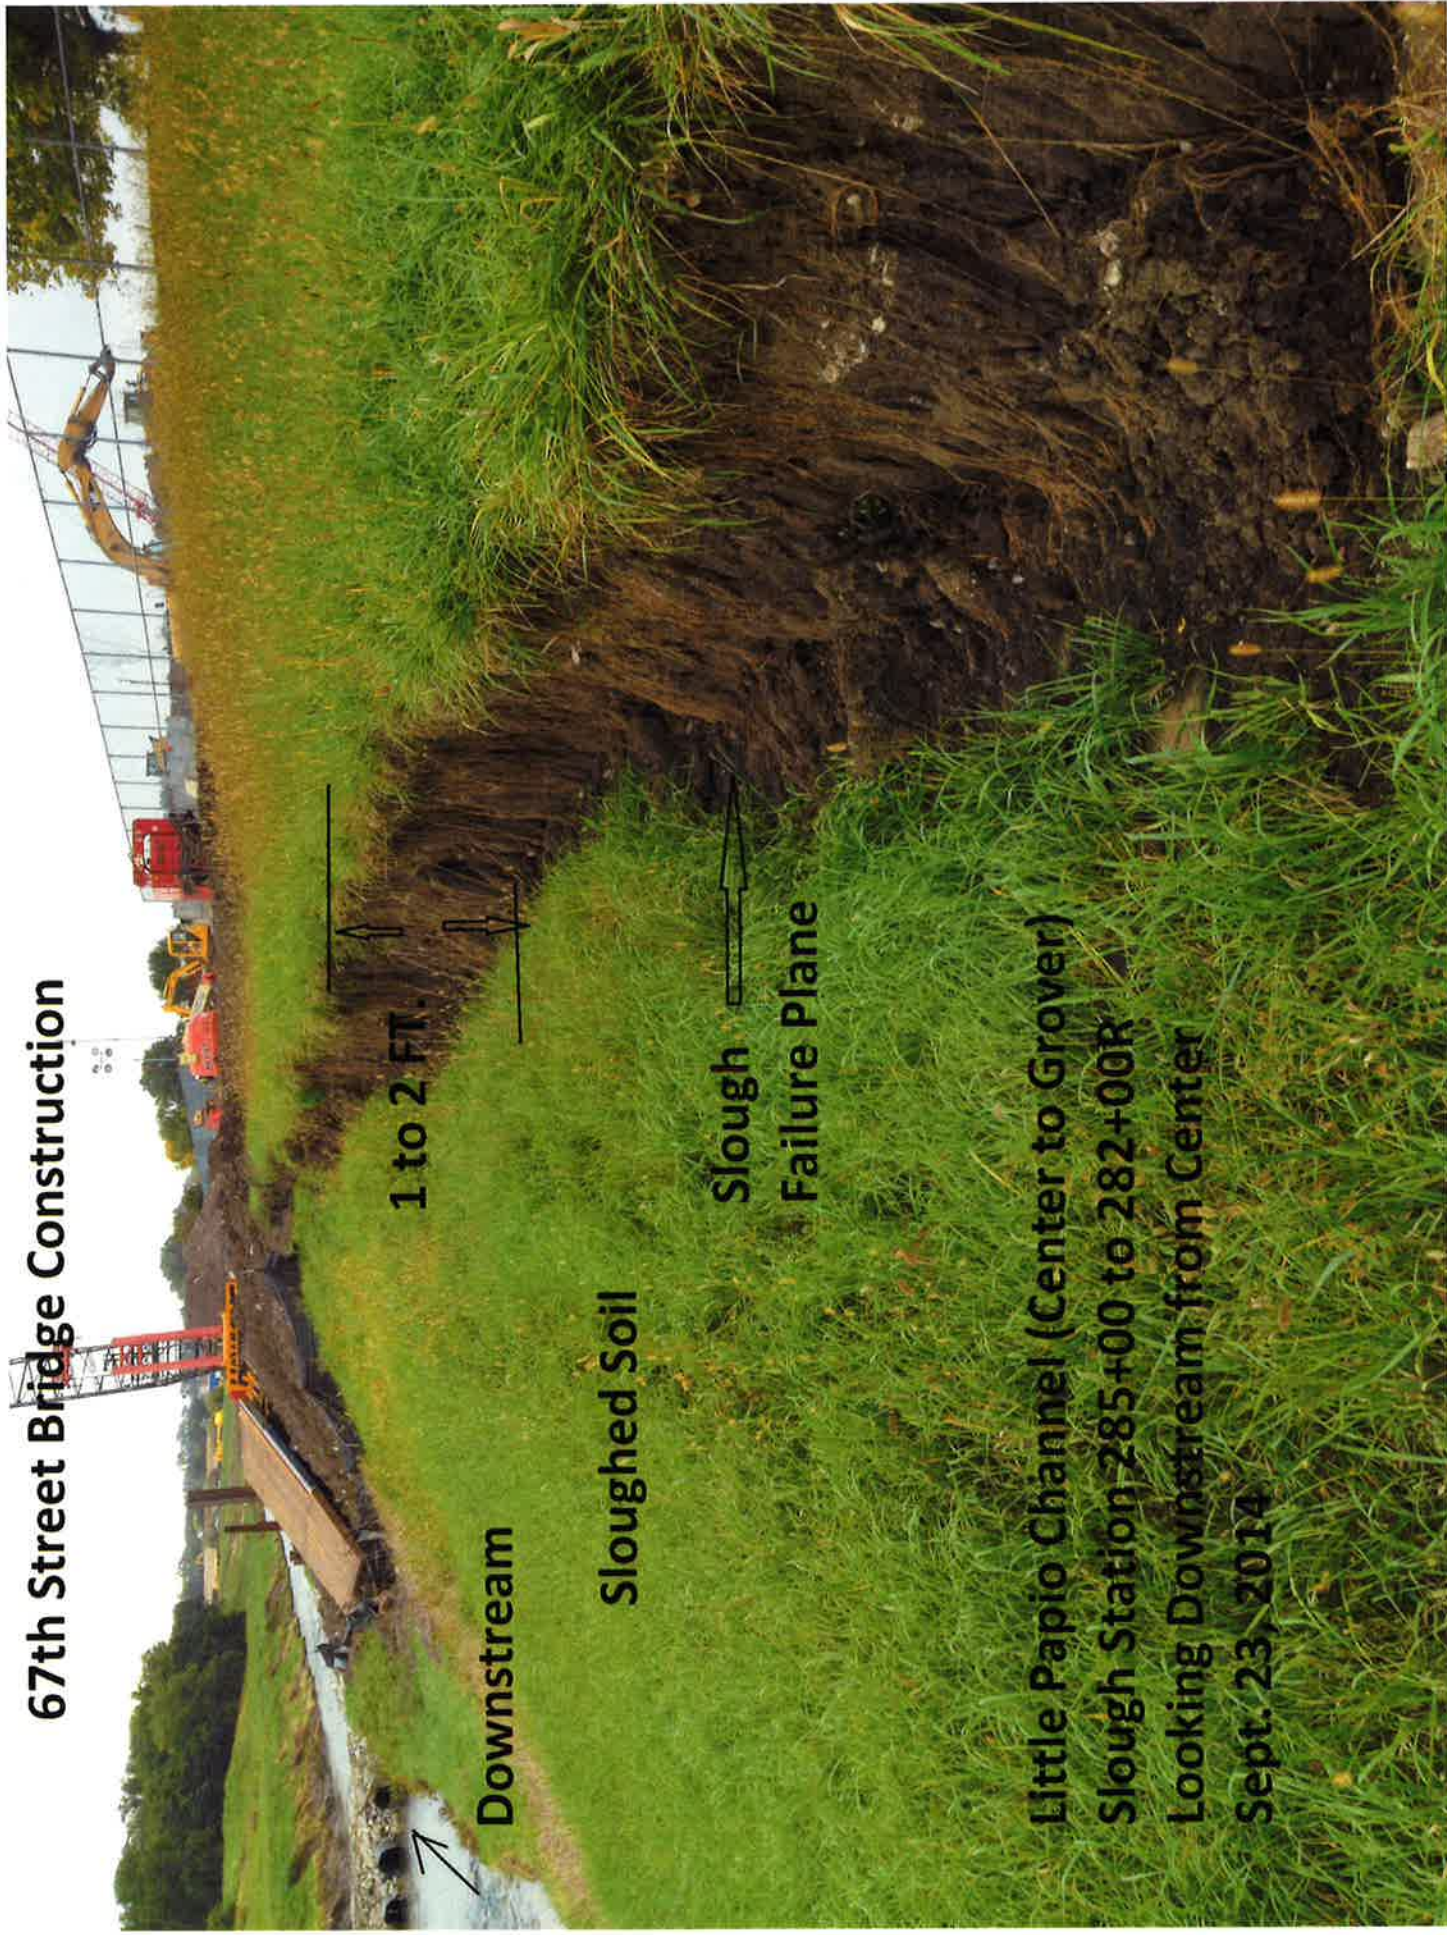
Little Papio Channel (Center to Grover)

In mid-September 2014, District staff noticed a major 500 ft. long bank slough, downstream of Center Street on the right bank of Little Papio Channel, looking downstream. Enclosed are location map and photos of the slough. This slough likely occurred due to multiple high water events in 2014, one of which occurred in early September 2014.

1 to 2 FT.

Failure Plane

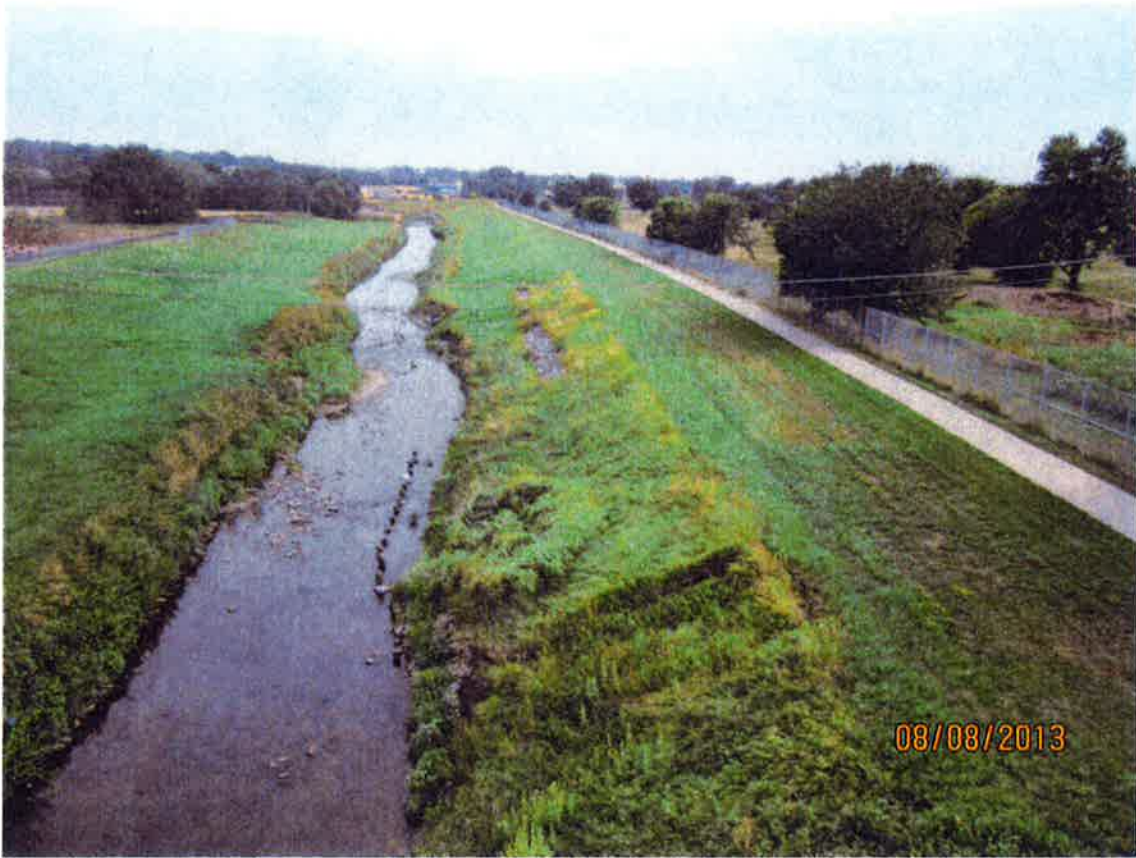
10. 8/8/2013 View of right (west) bank of channel from Center Street Bridge.

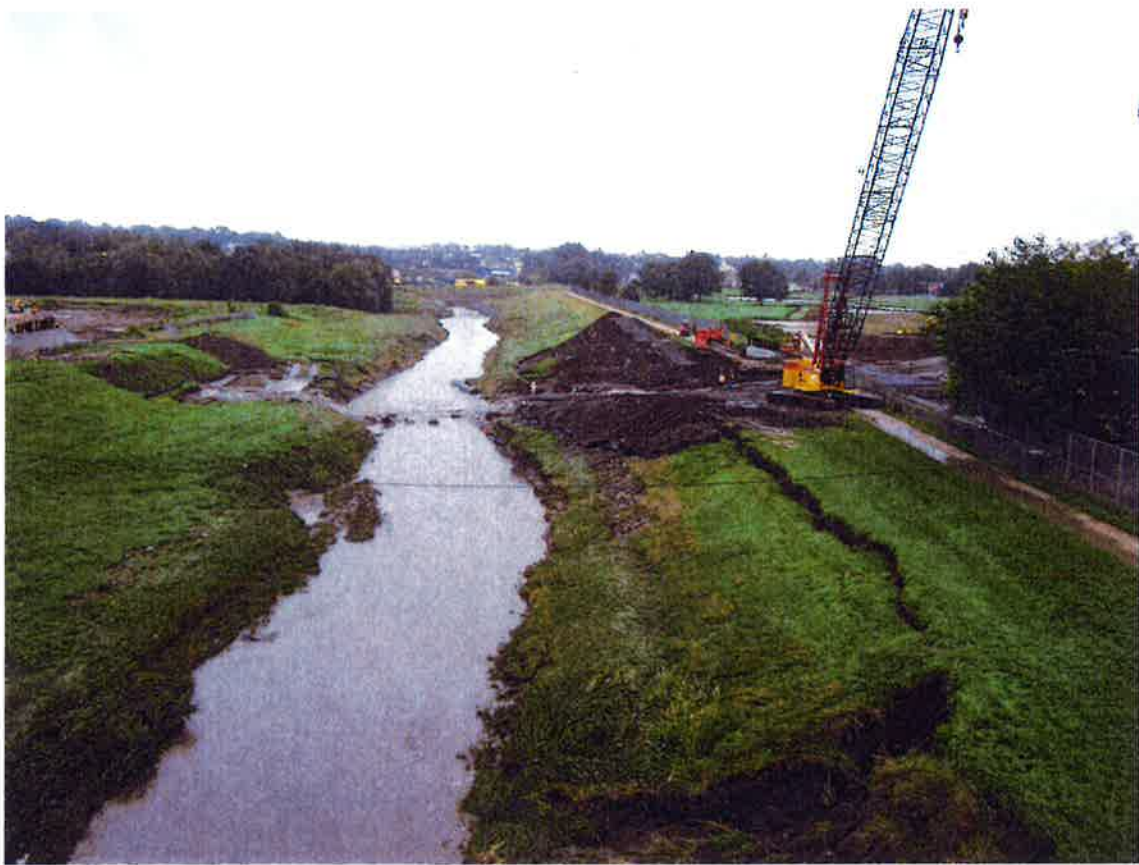
The channel instability at the project site was first noted by the 67th Street bridge construction observation representatives on September 10, 2014. As shown in Table 1 for Eppley Airfield, approximately 11.19 inches of rainfall occurred over the 20 days that preceded the first sign of channel instability, which included 3.43 inches on the previous day. Approximately 3.17 inches of rainfall occurred over the 21 days after the first sign of channel instability. Photo 13 shows no sign of scarping on August 28, 2014, while Photo 14 shows significant scarp development on September 10, 2014.

14. 9/10/2014 View of slope distress and 67th Street Bridge construction.

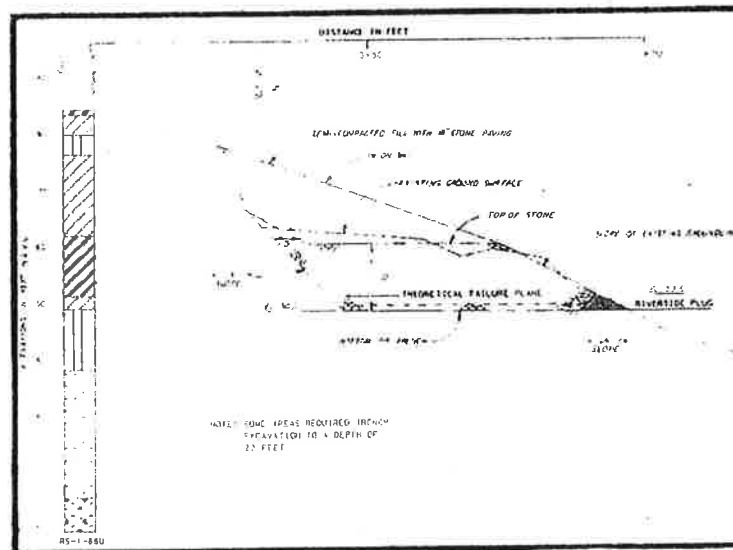
Figure 2. Typical Section of Slide Area

Conditions Contributing to Slide. The site investigations in 1983 and 1988, cross sections of the area taken on regular intervals and familiarity with the construction problems associated with the 1984-85 repair led to the conclusions that the initial triggering mechanism for the slide was the steepening of the river bank due to erosion of the silty sand substratum. This in turn caused sliding to occur in the backswamp clays. The initial attempt to stabilize the slide using the stone dike and sand berm was to
