To: Gerry Bowen
Papio-Missouri River Natural Resources District (PMRNRD)

Date: January 10, 2011

Subject: Preliminary Observations and Recommendations for Repairs to Elkhorn River IPA

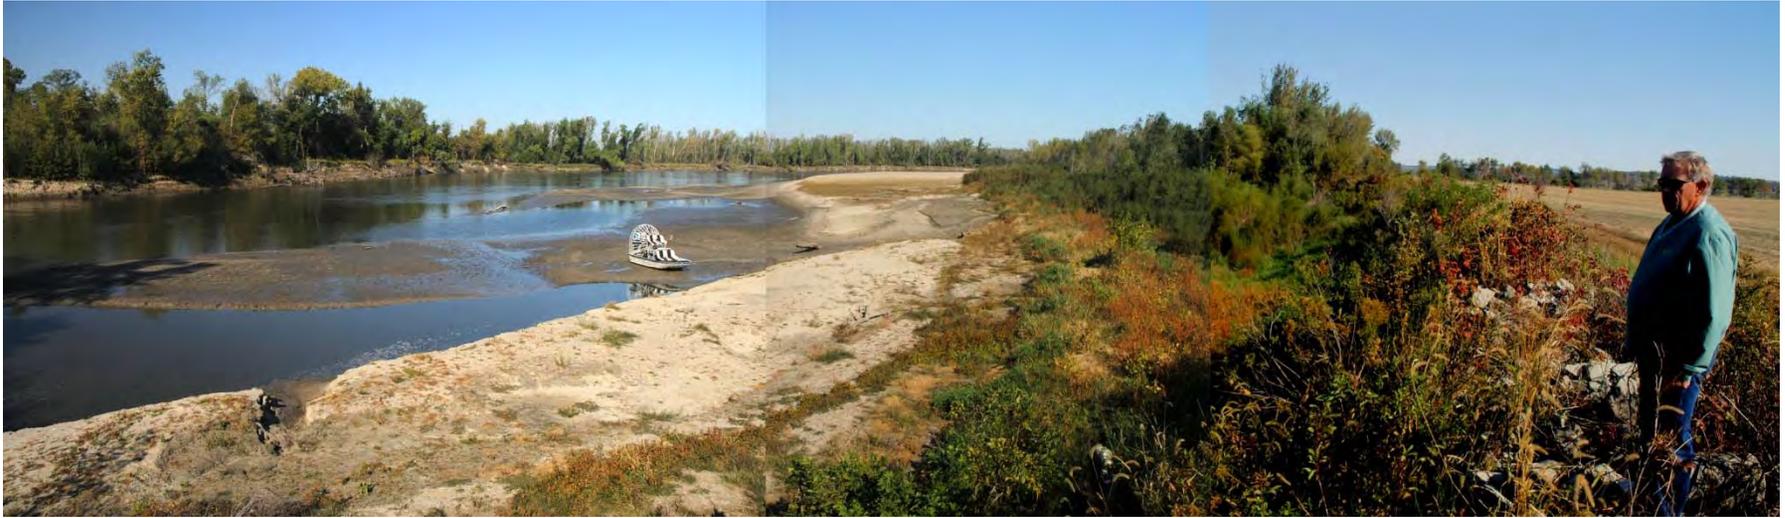
Field Site 1 is located on the left bank just downstream from the original IPA Site 10B, and consists of an approximately 500-foot long extension of the windrow revetment that was installed as part of the original project (**Figures 8a and 8b**). According to Mr. Bowen, the extension was constructed in the early 1990s after completion of the original project to stop erosion of the unprotected bank downstream from Site 10B. As the channel through the meander cutoff that was constructed as part of IPA Site 10A has continued to develop since construction, the river along the original Site 10B and most of the extension site has shifted toward the west through lateral erosion into the right bank, forming a vegetated bankline along the toe of the left bank and abandoning the protection. Based on the 2009 aerial photograph, the river was in direct contact with the bankline along the extension prior to the 2010 high flow, but a large sand bar is now present along the site (**Figure 9**). The rock riprap on the point in the left bank at the downstream end of the windrow extension appears to be intact and functioning as intended, although the rock appears to be relatively thin. The right bank upstream from Field Site 1 will continue to erode to the west and south, approximately as shown by the dashed red lines and arrow in **Figure 10**, expanding the size of the left-bank sandbar. The overbank area into which the river is eroding is the remnant of the former meander bend that was cutoff as part of the original IPA and a small wooded area directly to the south. Whether continued erosion into this area is a potential problem is uncertain, but it is recommended that the area, including the rock point on the left bank (**Figure 11**), be monitored and corrective actions taken if required. These actions could include windrow revetment along the right bank and maintenance of the rock points.

Figure 9. Panoramic view of Site 10B and the downstream end of Site 10A taken on October 6, 2010. Note the vegetated bankline along the windrow extension, large sand bar along the base of the bank, and erosion of the right bank (left side in photo).

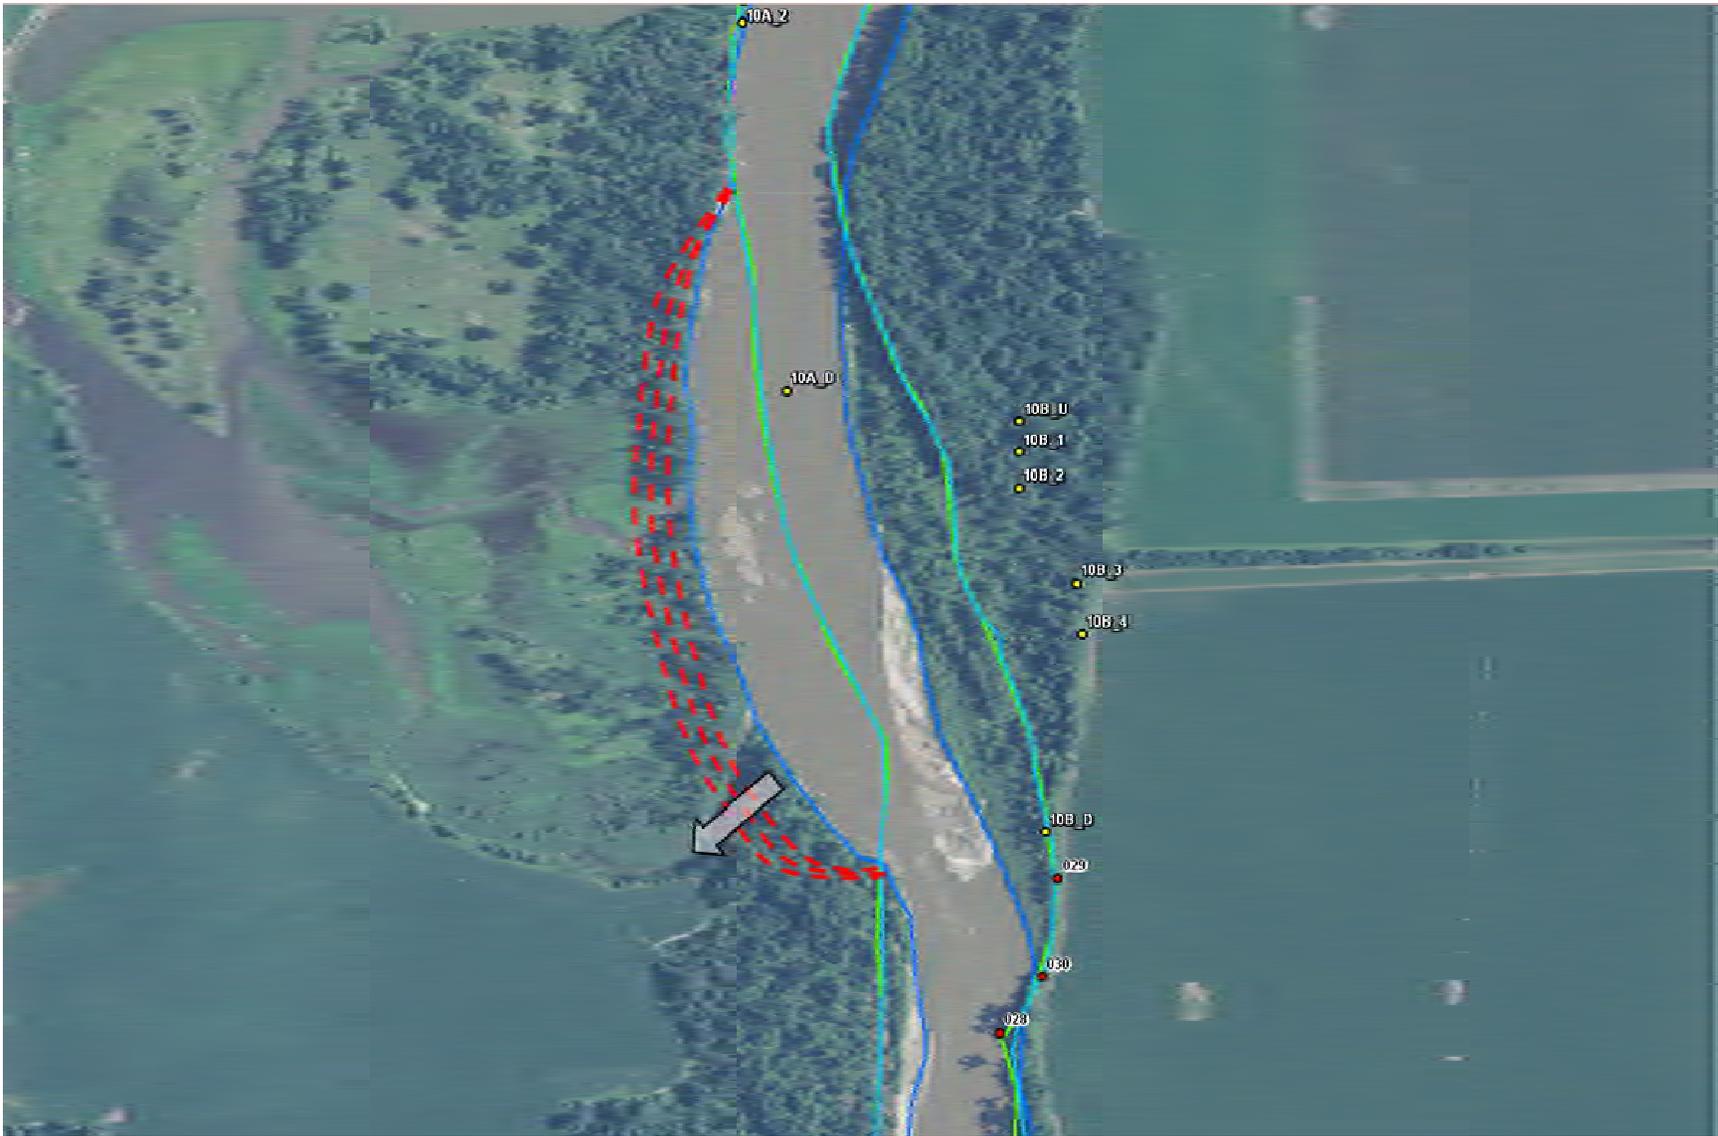
Figure 10. Expected trajectory of future bank erosion on the left bank at Field Site 1 (IPA Site 10A).

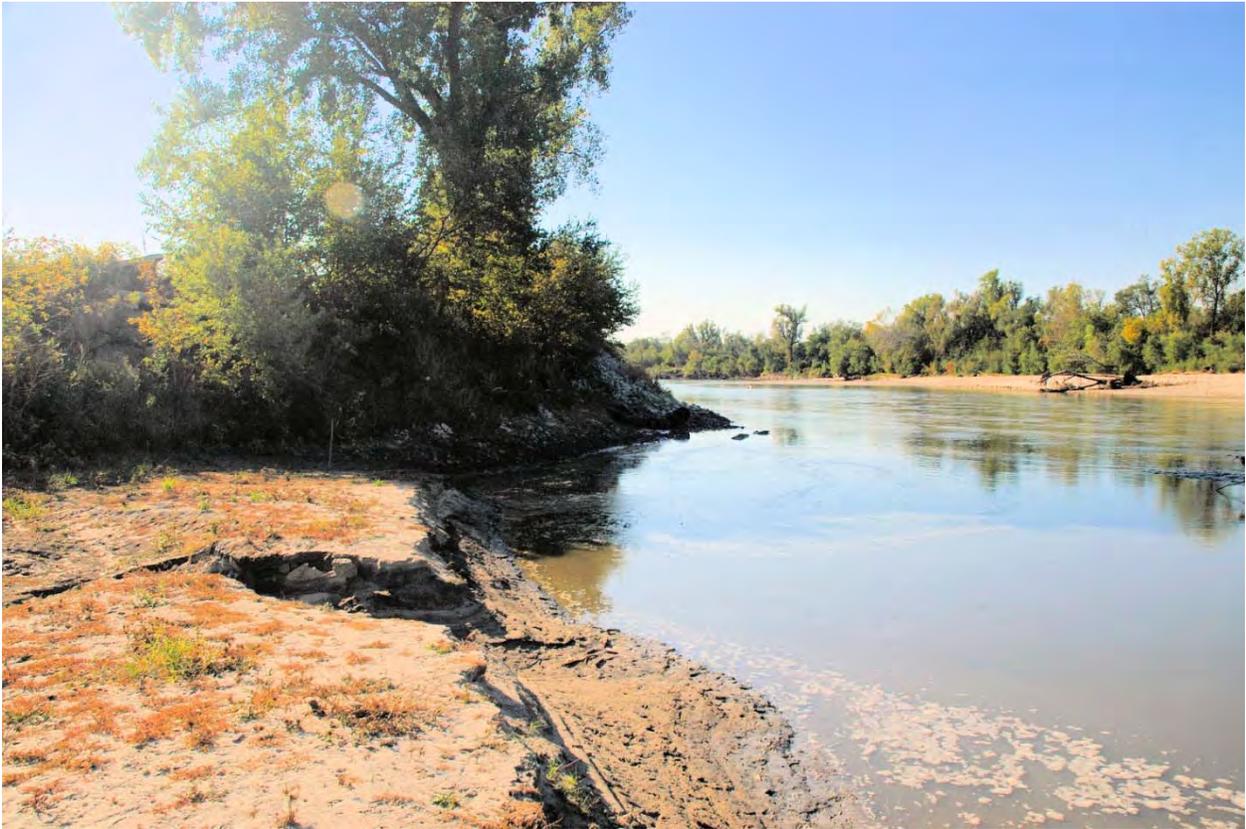
Figure 11. View looking downstream of rock-protected point at the downstream end of the windrow extension at Site 10B.

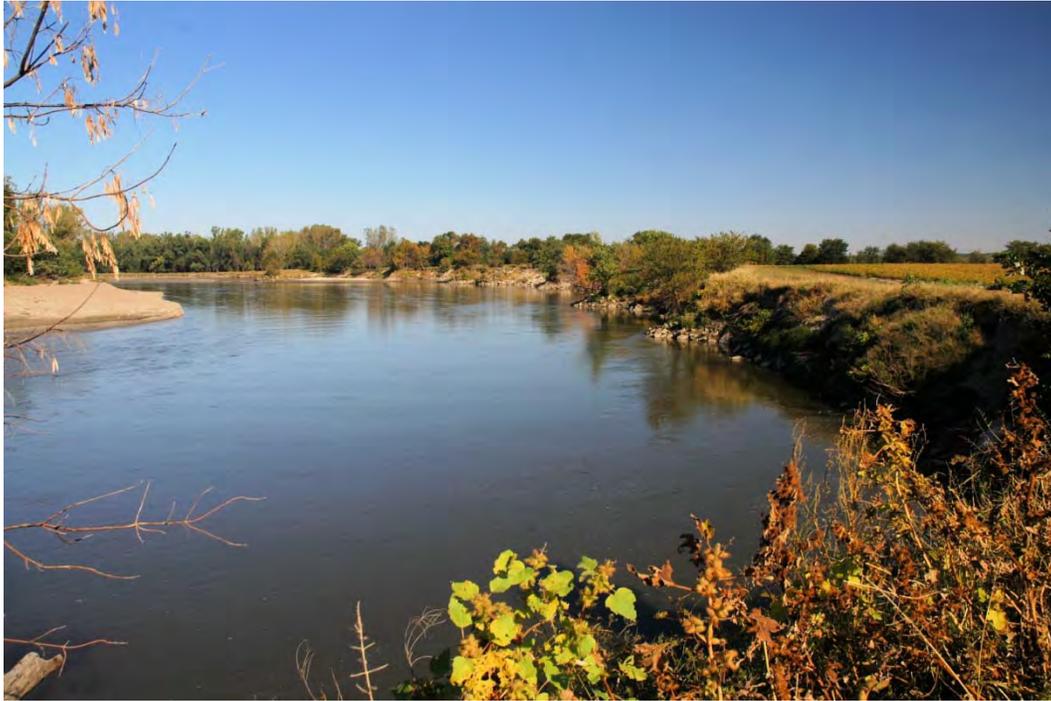
Field Site 2 is located near the middle of a left-bank jetty field that was constructed prior to the IPA project (**Figure 12**). The jetty field appears to be very stable and is functioning as intended (**Figure 13**). The problem area occurs just downstream from a large jetty near the middle of the jetty field where surface runoff has created a headcut and gully that is eroding back into the adjacent field (**Figures 14 and 15**). Sufficient information is not available to be certain about the source of the runoff that has caused the gulying, but it appears to have developed during the 2010 high-flow event, most likely due to overbank flows returning to the channel. Since it has developed in the low area/minor swale in the overbank area, both future overbank flows and local runoff from the adjacent field will continue to erode and expand the gully. Although expansion of the gully will damage the field, it is unlikely to endanger the stability of the overall dike field and bankline in this area; thus, this problem is not likely to affect the overall stability of the IPA reach.

Figure 13. View looking upstream along the upstream portion of the jetty field from Field Site 2.

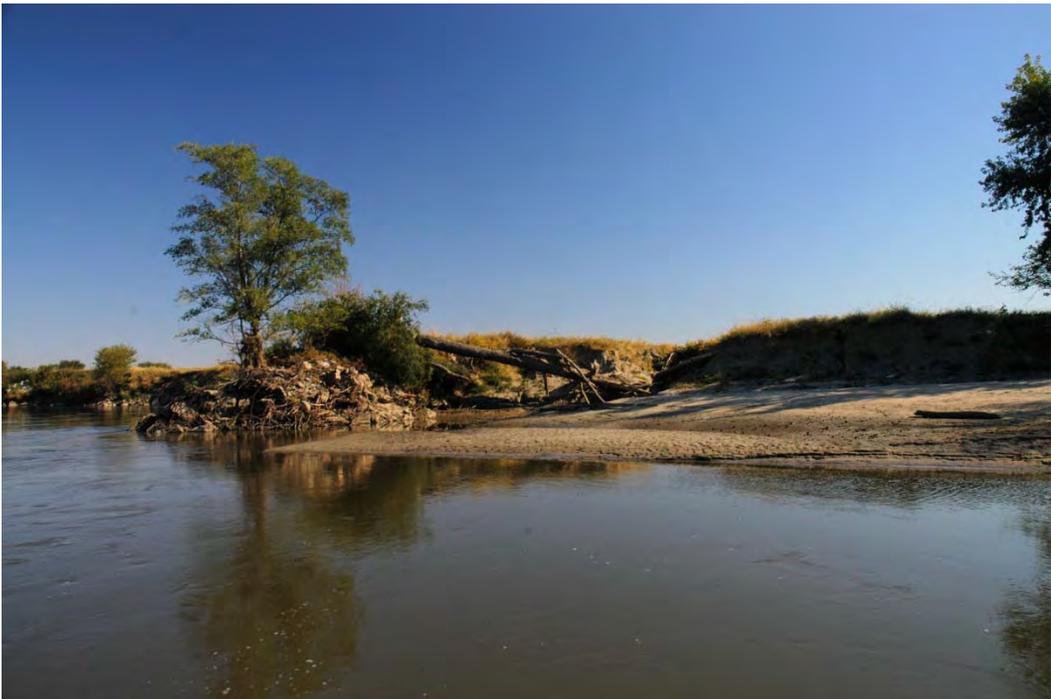
Figure 14. Rock jetty and mouth of headcut just downstream from the jetty at Field Site 2.

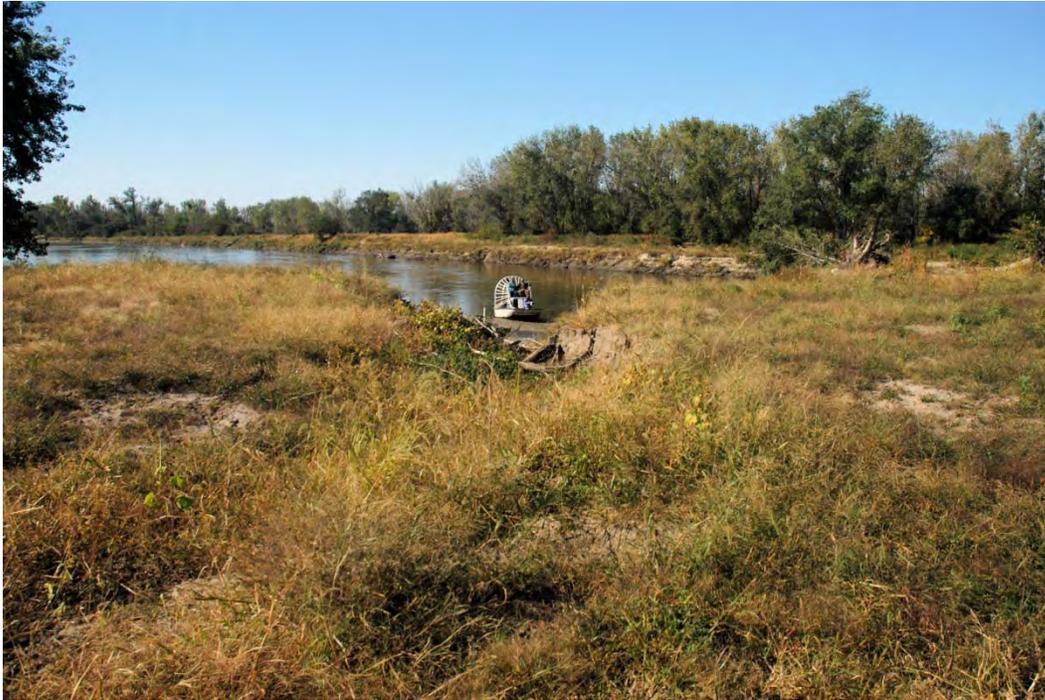
Figure 15. View looking downstream in the headcut at Field Site 2.

2. Construct rock grade-controls or a rock chute in the head cut from the top to the base of the bank, and formalize a drainage swale that would connect to the upstream end of the protection to insure that future flows do not flank the installation.

Given the available topography, the second solution is recommended. For this solution, the existing bank would be graded to develop a more defined drainage swale and then protected by the placement of rock riprap of an appropriate size along the surface (**Figure 16**). It is also recommended that a granular filter be placed under the rock rather than filter fabric, which has caused rock to launch in nearby locations. Care will need to be taken to tie the upstream and downstream ends of the revetment into the existing spur dike rock and channel bank, respectively, as well as to continue the placement of rock down to an appropriate toe-down depth below the channel to protect against local scour. The layer of riprap should extend up to the top of bank, where it should be thickened and keyed into the bank to prevent overtopping flows from undercutting the revetment.

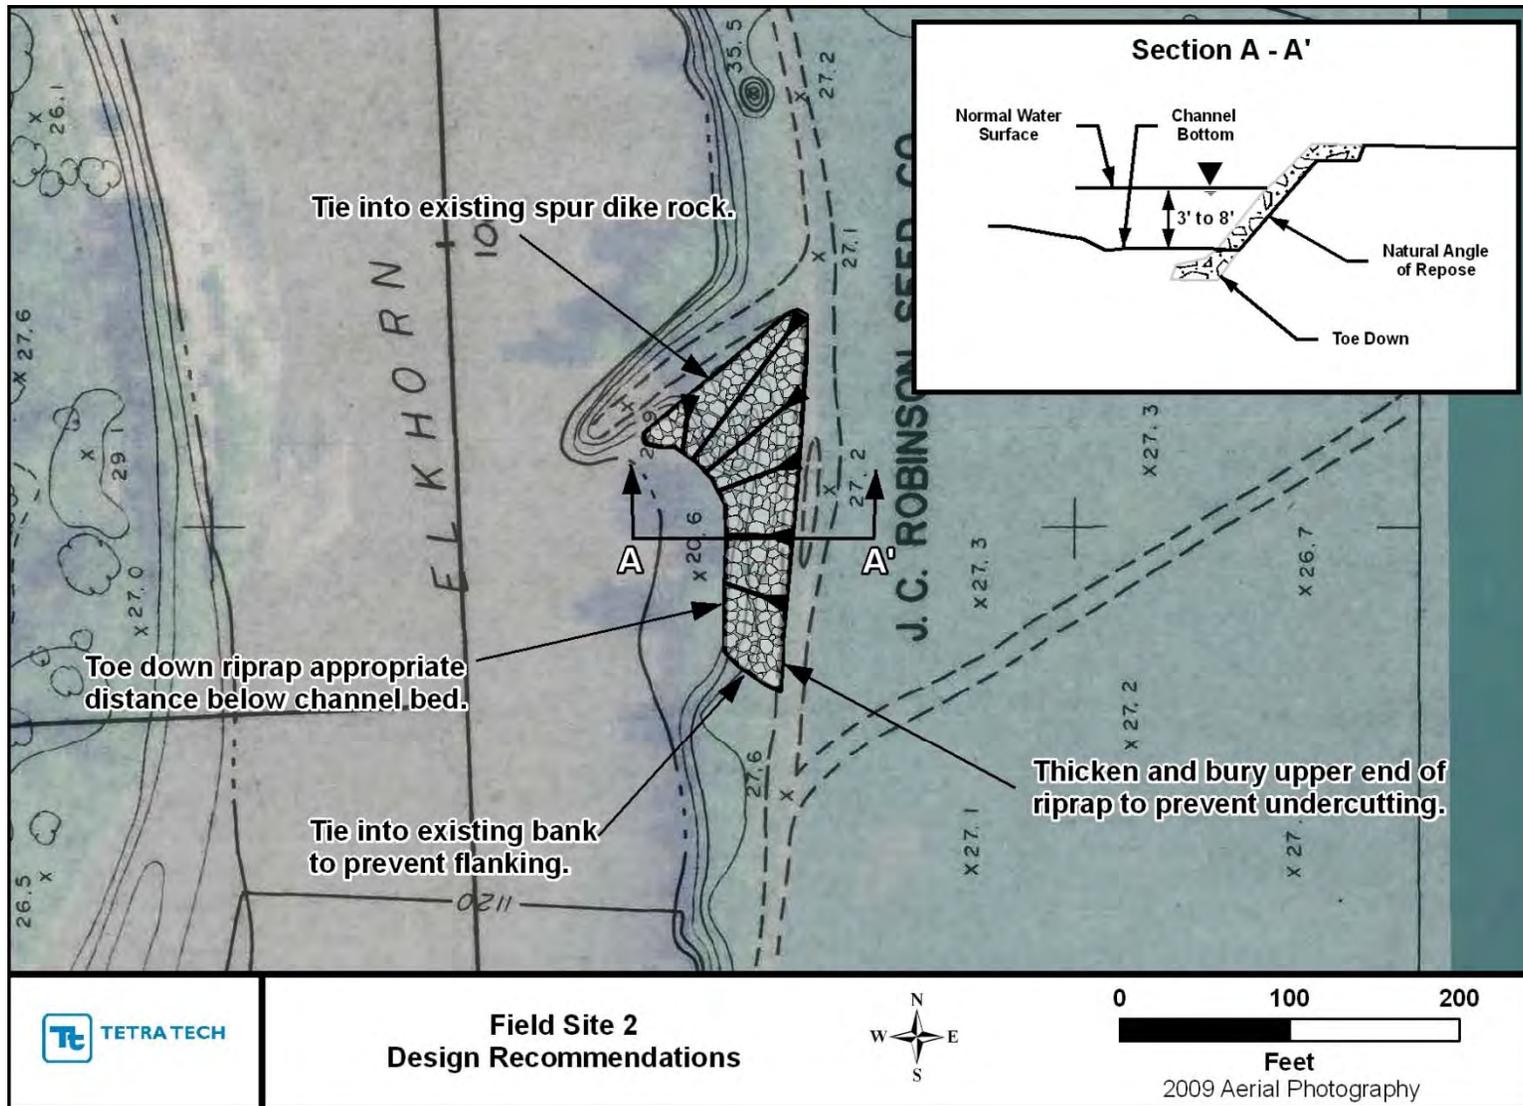
Figure 16. Recommended stabilization measures for Field Site 2.

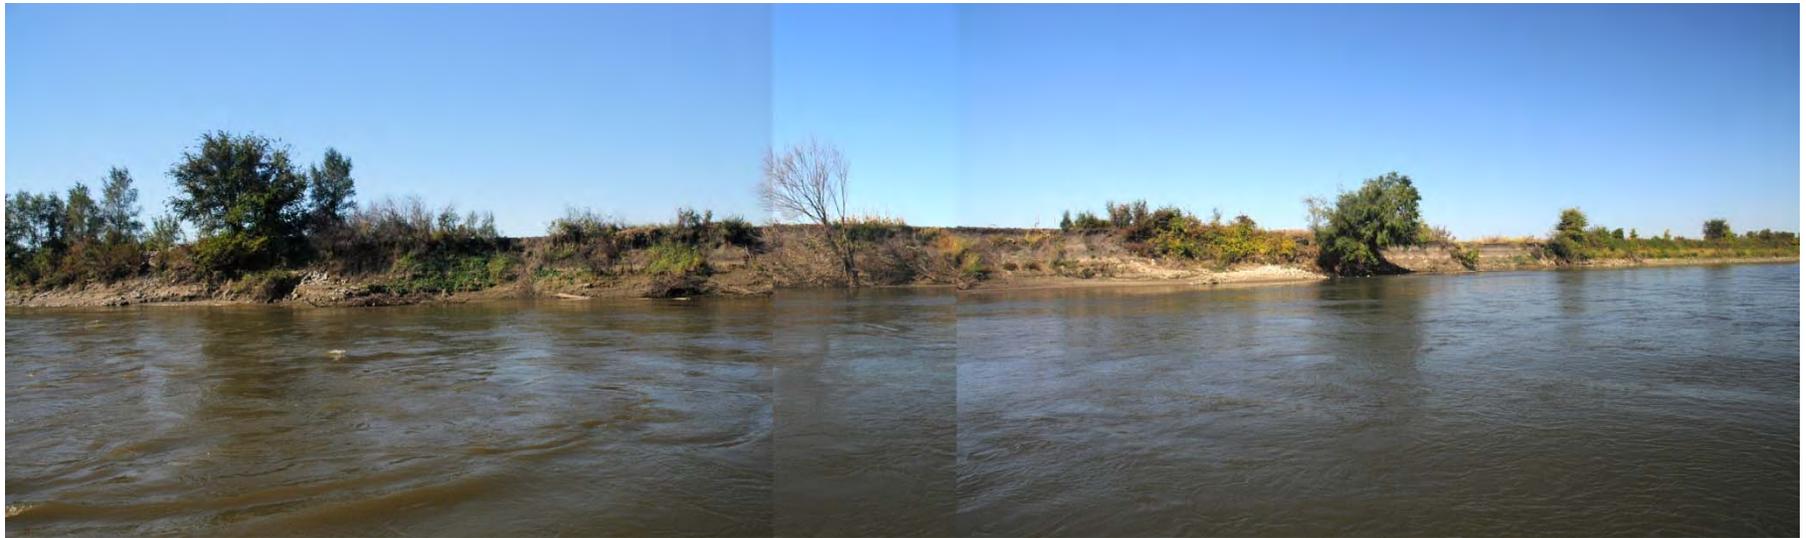
Field Site 3 is located along an approximately 900-foot reach in the middle of IPA Site 11 where the windrow revetment that was applied at a rate of 3.0 tons/foot has been fully launched (**Figure 17**) and there are now gaps in the rock that could allow undesirable bank erosion during future high flows (**Figure 18**). At the upstream end of the site, the rock is in place at the toe of the bank, but the part of the bank above the ~1,500 cfs water-surface is retreating behind the rock (**Figure 19**). With additional upper-bank retreat at this location, the channel will expand on the back side of the ridge formed by the rock, and the existing bank protection will no longer be effective. The bankline along the entire length of IPA Site 11 has shifted very little since the project was constructed (**Figure 20**). Approximately one-fourth of the rock in the windrow revetment in the portion of IPA Site 11 downstream from Field Site 3 remains to be launched, and this portion of the site appears to be stable and functioning as intended (**Figure 21**). Most of the rock has launched in the portion of IPA Site 11 between Field Site 3 and the mouth of Rawhide Creek and this bankline also appears to be stable (**Figure 22**). It is recommended that additional rock be added to the bank at Field Site 3 at a rate of 2.5 to 3 tons/foot over a total length of about 900 feet to prevent additional erosion of this bank that could impact the adjacent overbank area, and potentially allow flanking of the downstream portion of IPA Site 11.

Figure 18. Panoramic view of Field Site 3 showing the launched windrow rock and eroding banks.

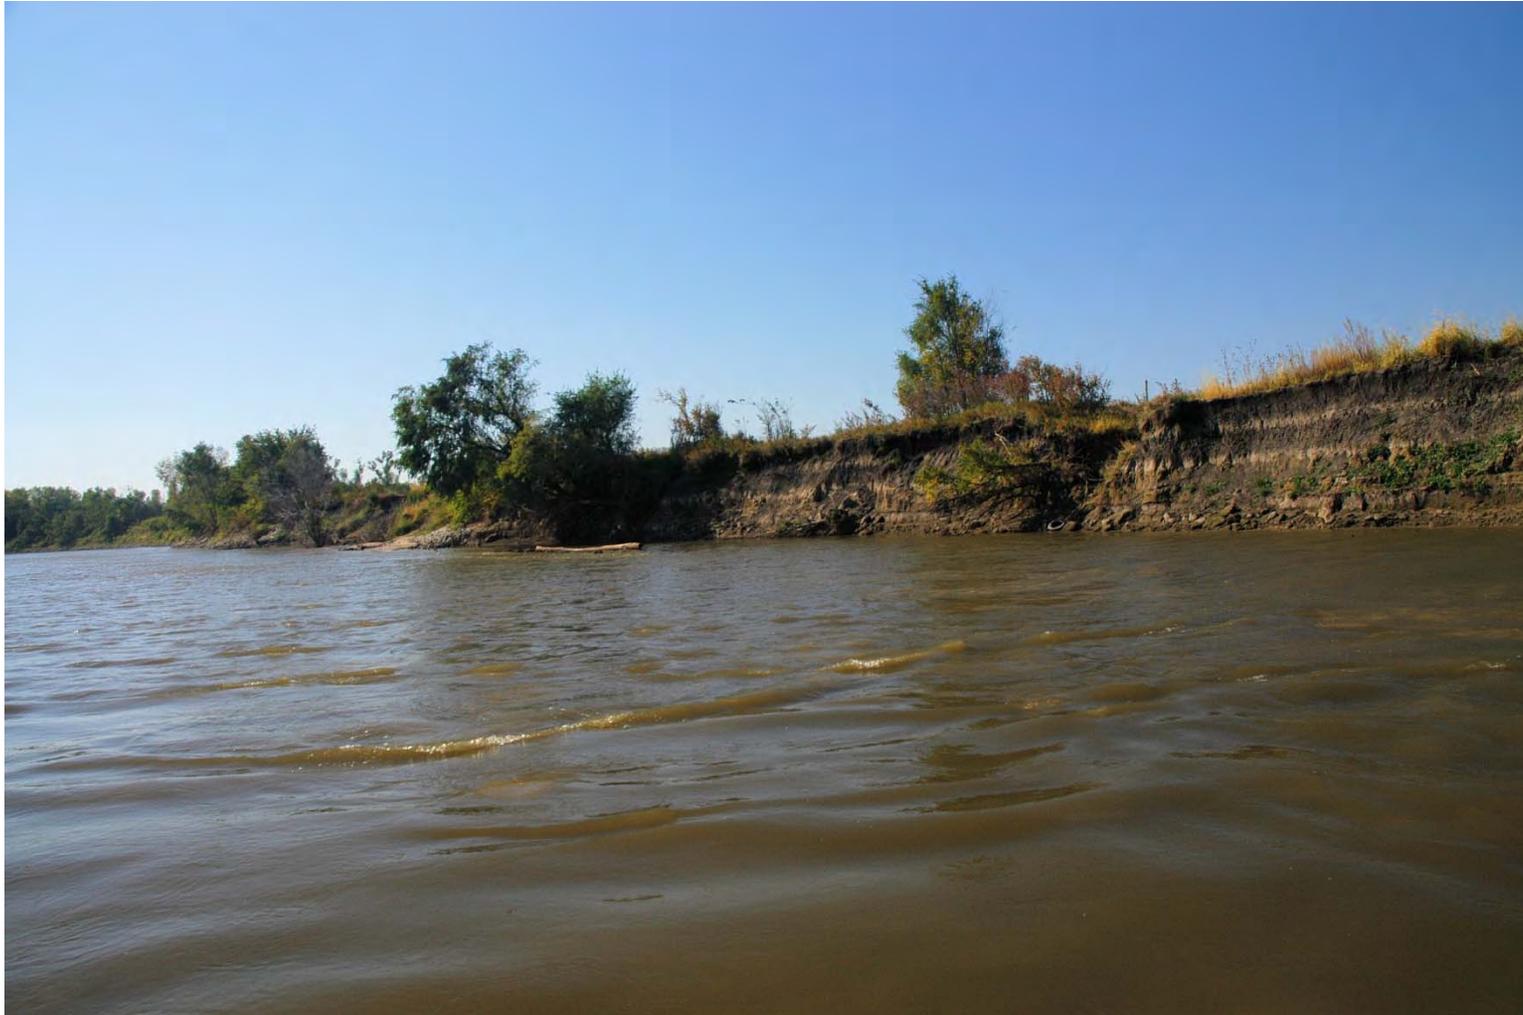
Figure 19. View looking downstream at the upstream end of Field Site 3 where the windrow revetment has fully launched and the rock is now forming a low-elevation bench above which the bank is retreating.

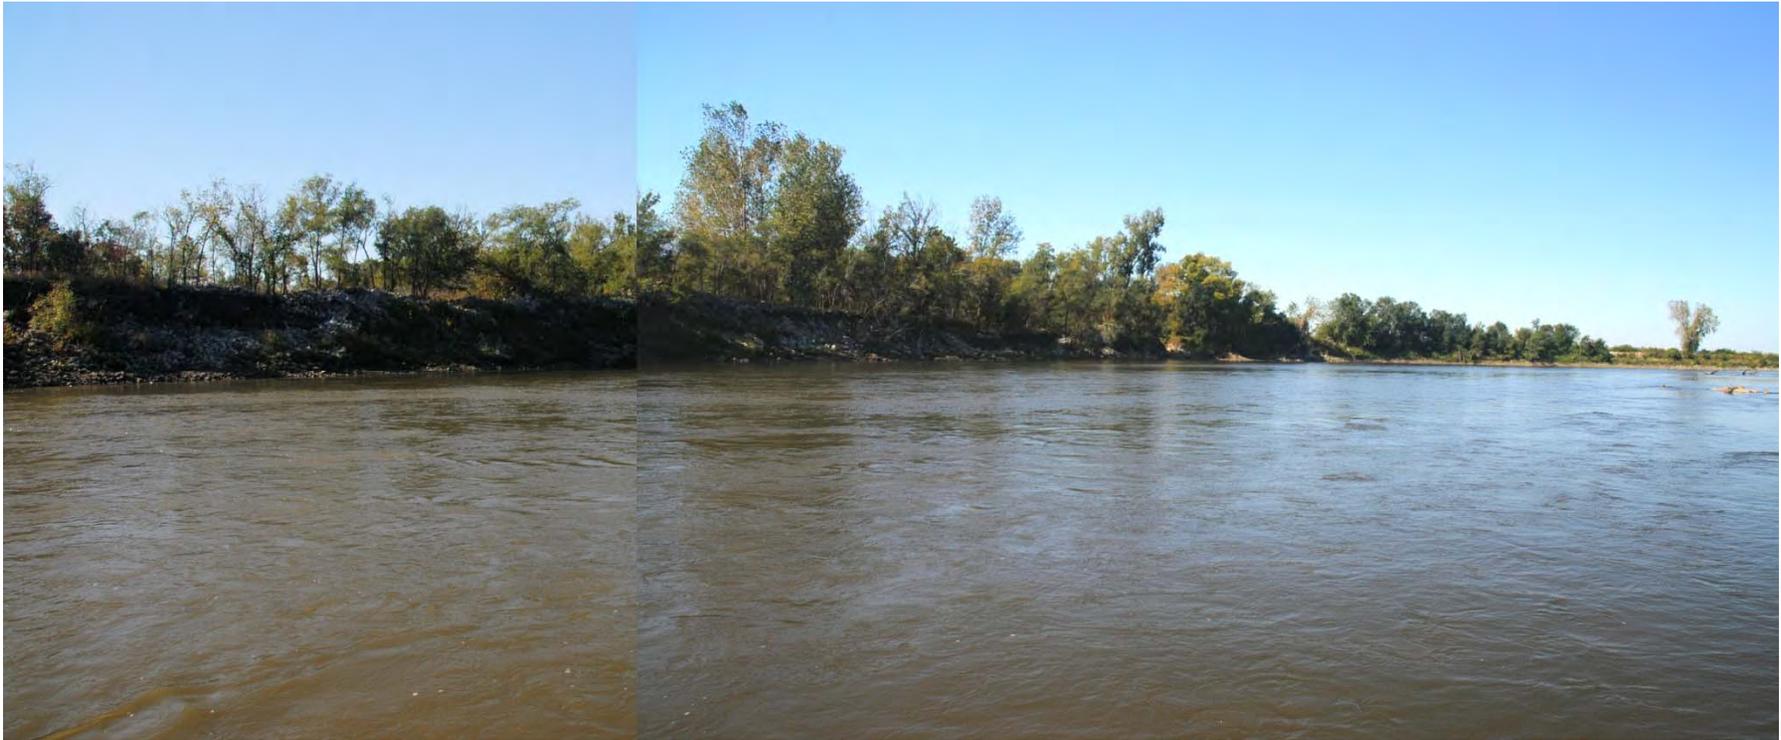
Figure 21. Downstream portion of IPA Site 11 where the about one-fourth of the original windrow revetment remains to be launched.

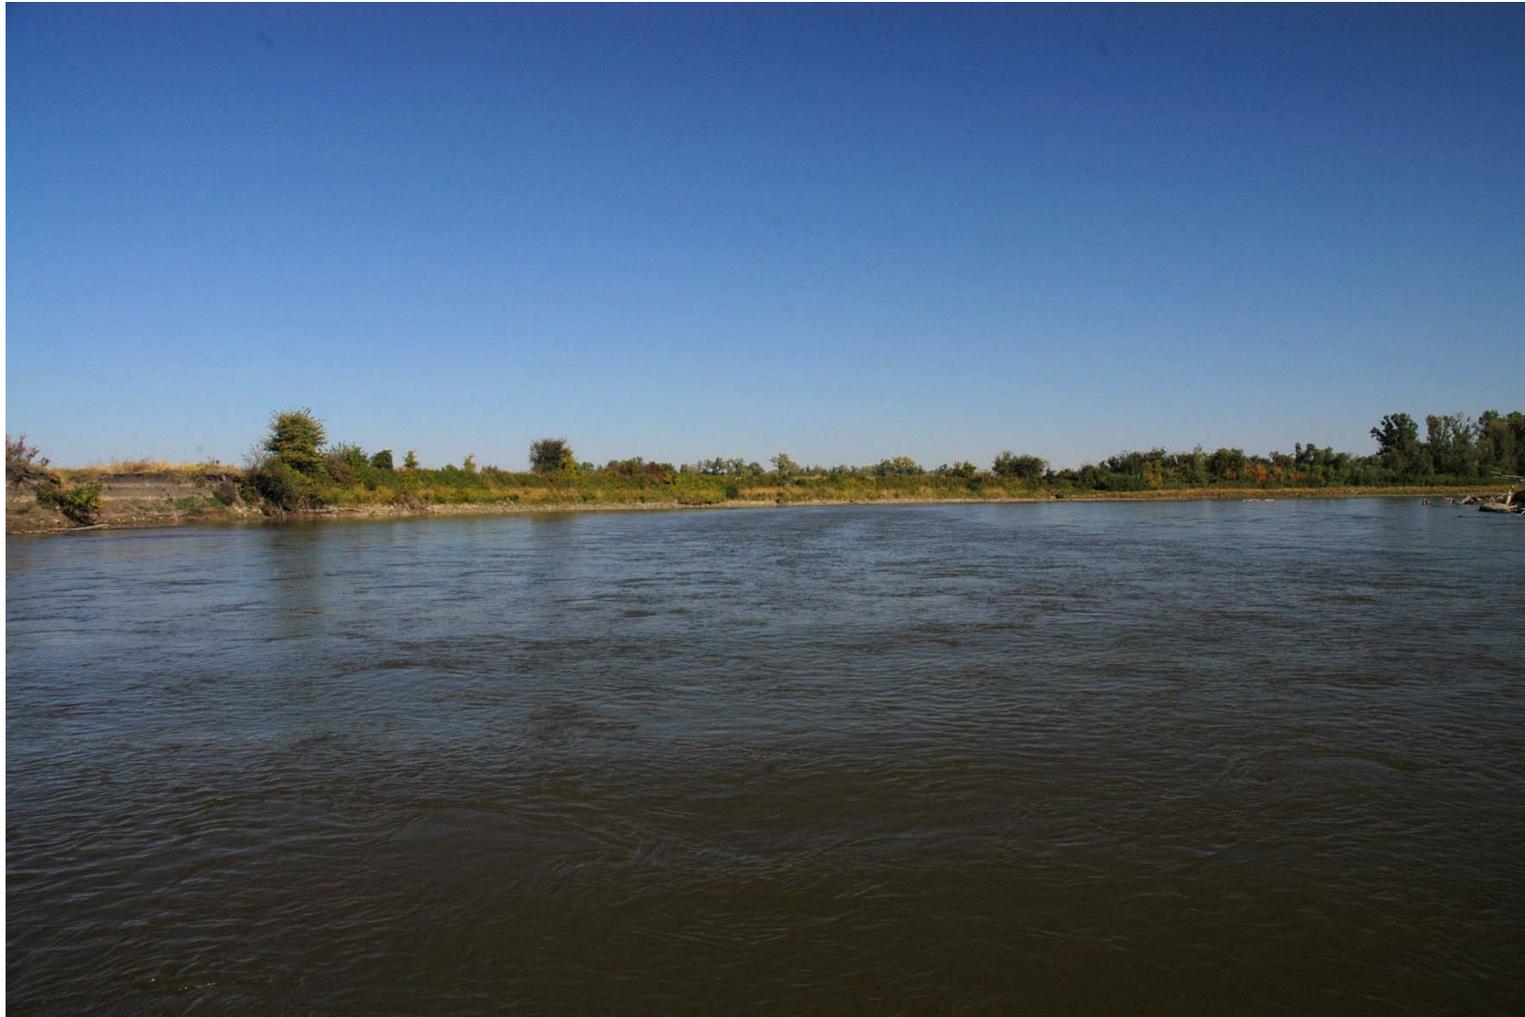
Figure 22. View looking upstream at the upstream portion of IPA Site 11 where most of the windrow revetment has launched, and the bankline appears to be intact and stable. The upstream end of Field Site 3 is visible on the left side of the photo.

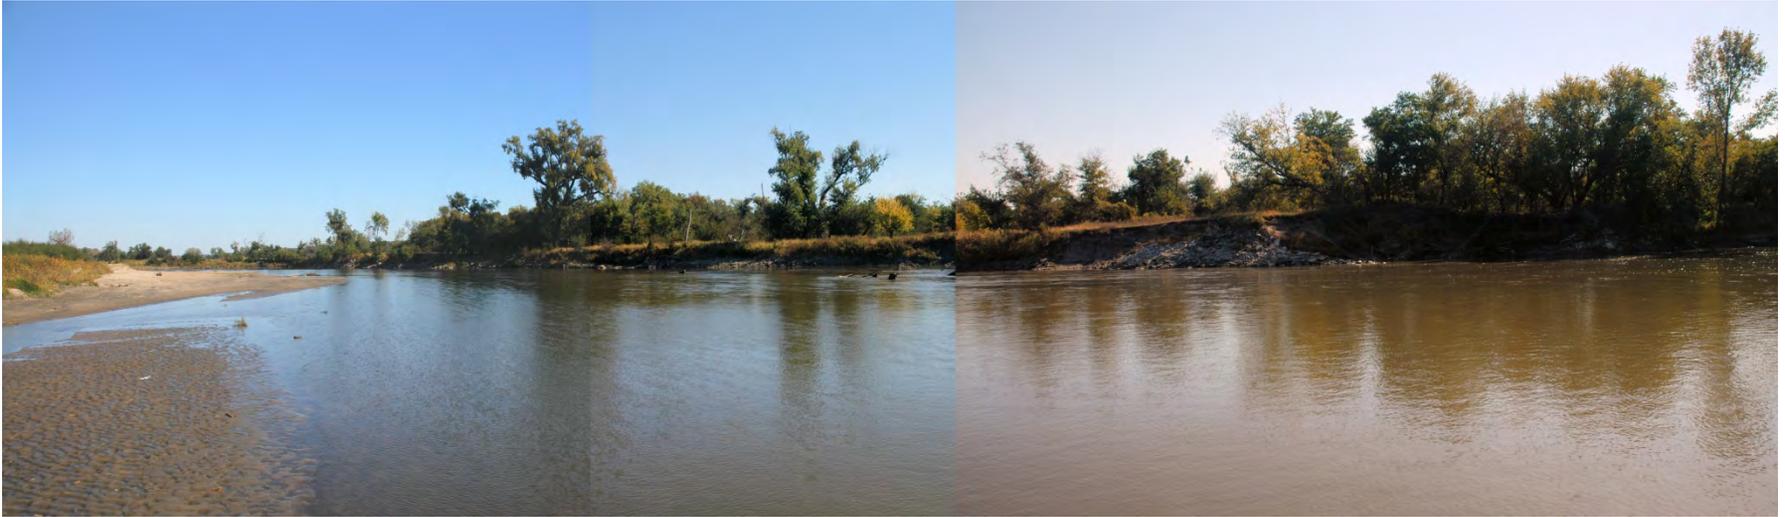
Figure 27. Panoramic view of Field Site 5 taken on October 6, 2010.

downstream from Field Site 5 appear to be in good condition, but Field Site 5 is unstable and eroding, with significant gaps in the existing rock/concrete rubble protection. The overbank area along this site consists of moderately thick woods. If continued lateral erosion into the wooded area is considered to be a problem, it may be possible to check the erosion with additional windrow revetment, applied at a rate of 2.5 to 3.0 tons/foot. Before such additional rock is installed, however, it would probably be prudent to study this area in more detail, including evaluation of the construction notes, to gain a better understanding of why the indicated bank erosion has occurred to insure that the recommended fix is, in fact, appropriate.

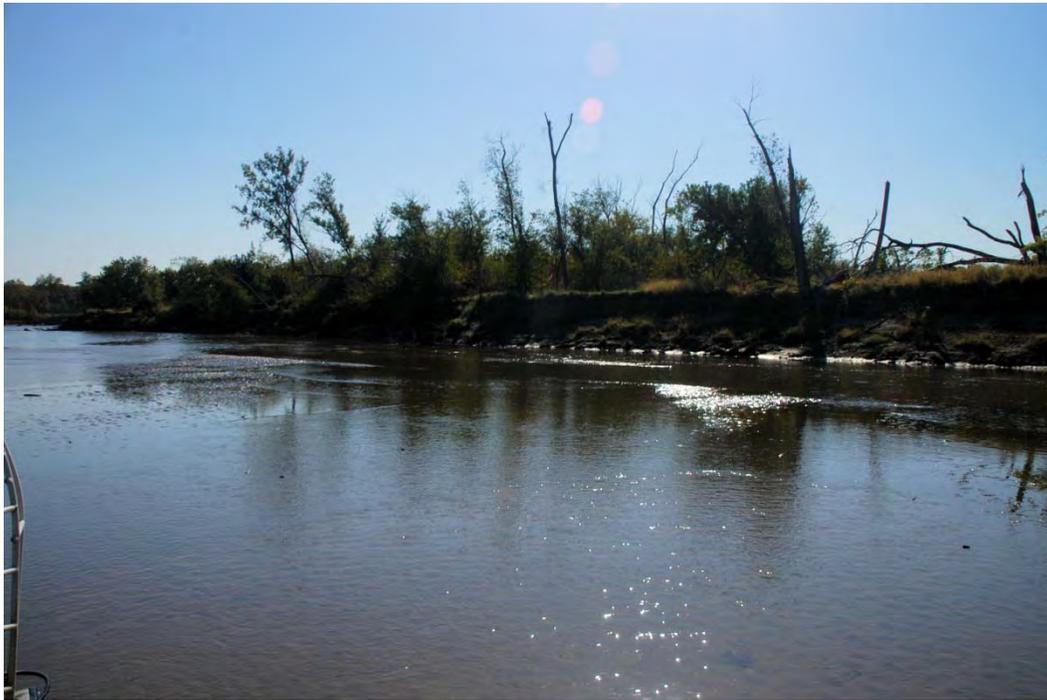
Figure 29. View looking downstream of the eroding bankline at Field Site 6.

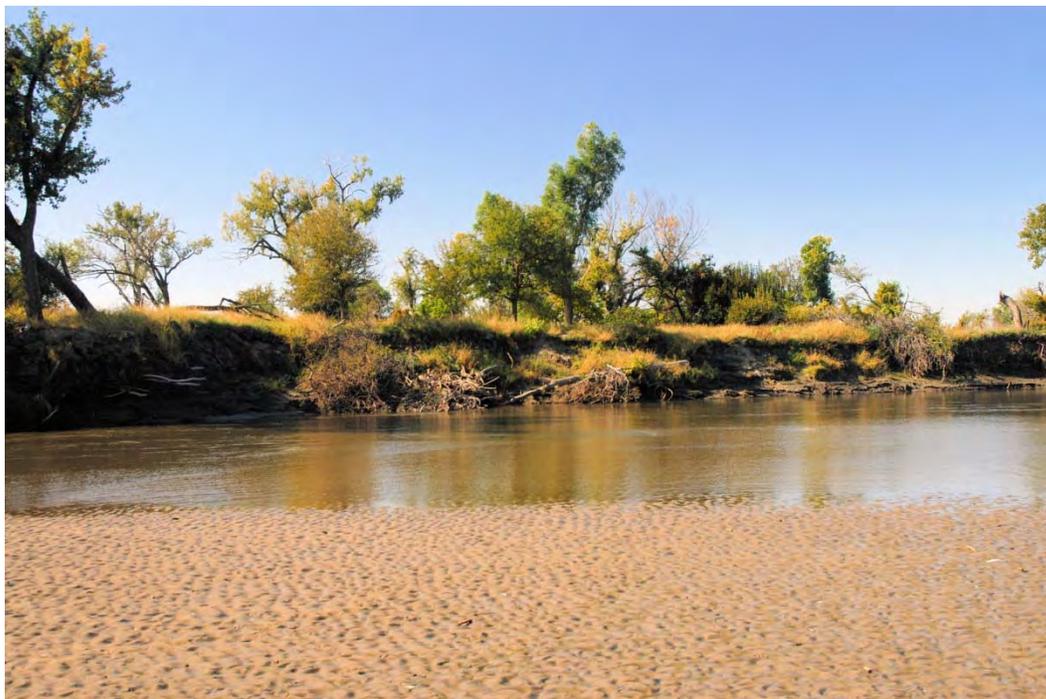
Figure 30. View looking near middle of the eroding bankline at Field Site 6.

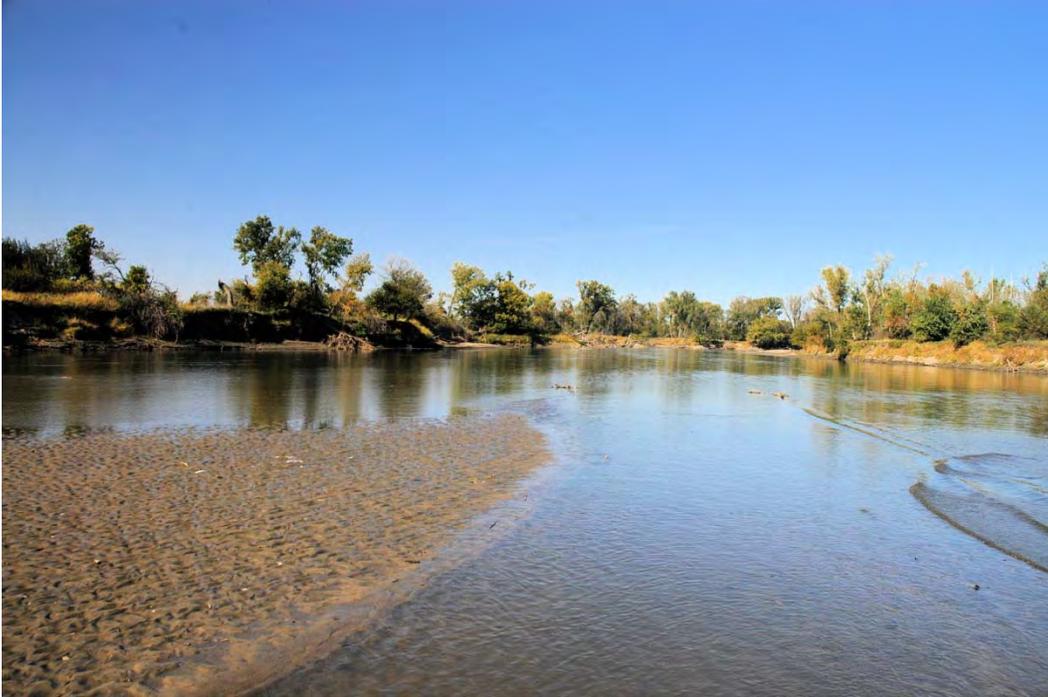
Figure 31. View looking upstream of the eroding bankline at Field Site 6.

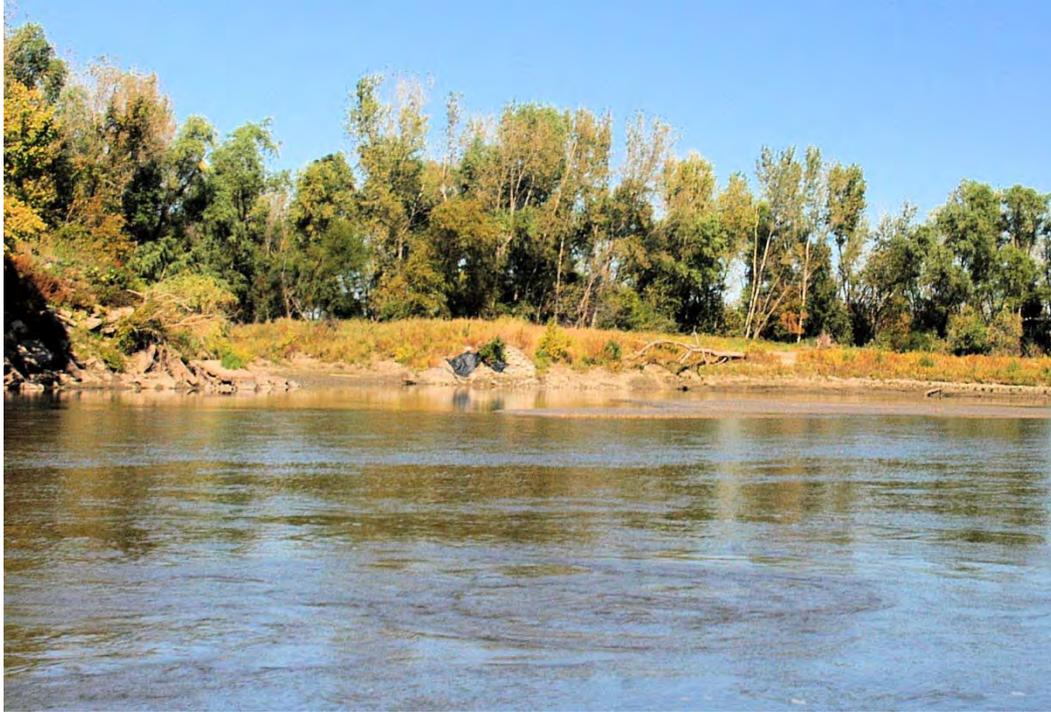
Field Site 7 is a riprap point at the downstream end of the levee that was constructed in the late 1990s where the rock has been stripped off the underlying filter fabric (**Figures 32a, 32b and 33**). Although the erosion hazard does not appear to be severe at this location, the site can be repaired by replacing the rock with riprap of an appropriate size. It is recommended that a granular filter be placed under the rock rather than the filter fabric that was previously used to limit the likelihood that the rock will simply slide off the underlying filter.

Figure 33. View looking upstream at the damaged rock point at Field Site 7. Note exposed filter fabric that was placed under the rock.

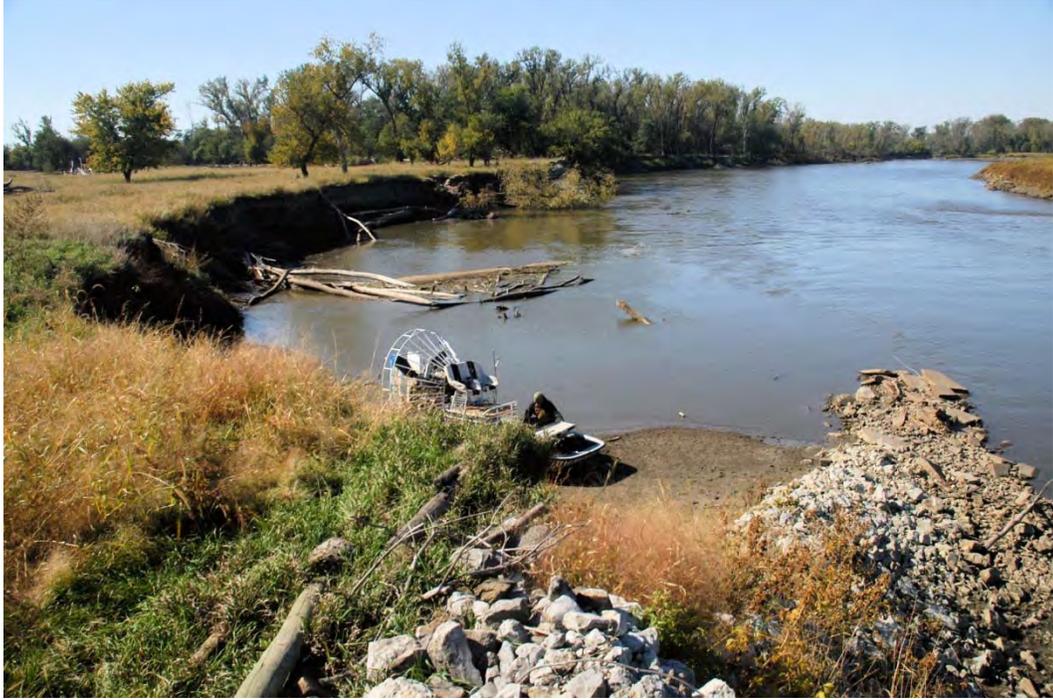
Figure 35. View looking downstream flows from the pre-existing rock spur at Field Site 8 across the scallop in the left bank that developed during the June 2010 high flow.

Recommended repairs at Field Site 8 include realigning the bankline to eliminate the scallop, and placement of appropriately sized rock riprap on the realigned bankline (**Figure 37**). The length of the realigned bankline would be about 350 feet, and the area that would need to be filled between the existing and new bankline is about 17,000 ft². Assuming a bank height of 12

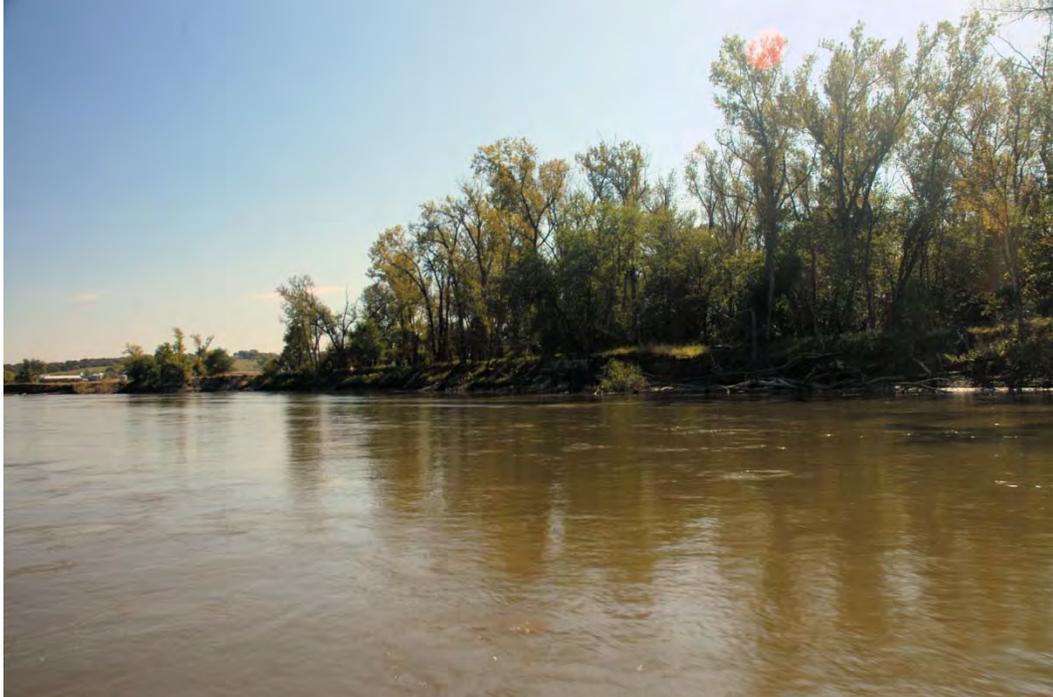
Figure 36. View looking upstream along the bankline in the downstream portion of IPA Site 13B where cabled-tree revetment was called for in the construction plans. Note the launching rock along the bank. A portion of Field Site 8 is visible on the far left side of the photo.
