To: Gerry Bowen
Papio-Missouri River Natural Resources District (PMRNRD)

Date: January 10, 2011

Subject: Preliminary Observations and Recommendations for Repairs to Elkhorn River IPA

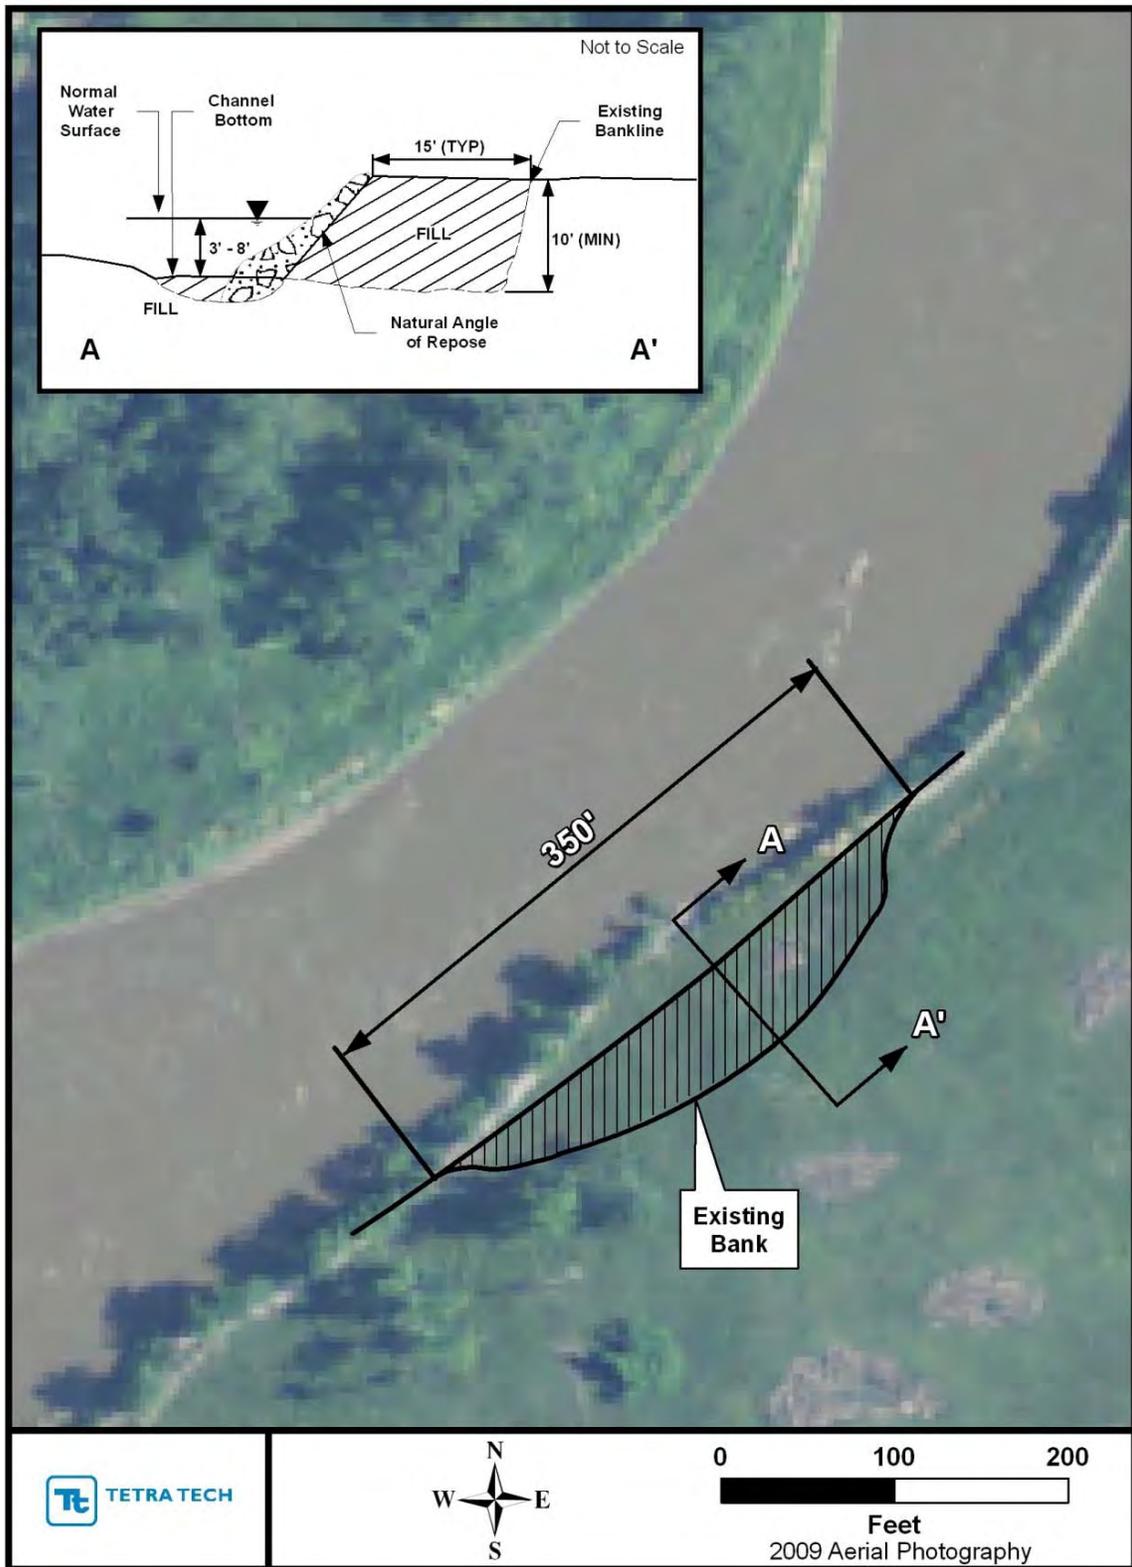
Figure 37. Recommended re-alignment of bankline at Field Site 8 and typical cross section of the rock riprap that should be placed along the realigned bank.

Recommended repairs at Field Site 8 include realigning the bankline to eliminate the scallop, and placement of appropriately sized rock riprap on the realigned bankline (**Figure 37**). The length of the realigned bankline would be about 350 feet, and the area that would need to be filled between the existing and new bankline is about 17,000 ft². Assuming a bank height of 12

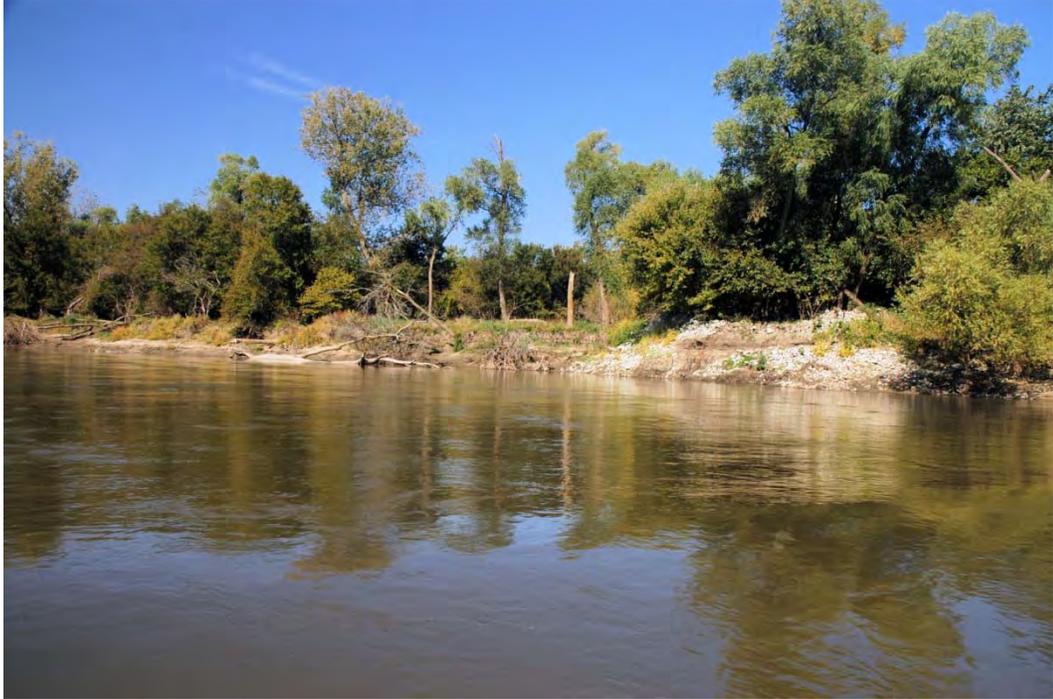
Figure 41. View looking upstream end of the existing windrow revetment at IPA Site 13B, and the moderately eroding bank at Field Site 9, just upstream from the windrow revetment.

While Field Site 9 is not in a critically unstable condition at the moment, it should be monitored after future high flows, and the windrow revetment extended upstream at an application rate of 3.0 tons/foot, if necessary. Although the debris jam likely provides habitat value, removal of at least the part that projects into the main current would also relieve some of the erosional pressure on the left bank.

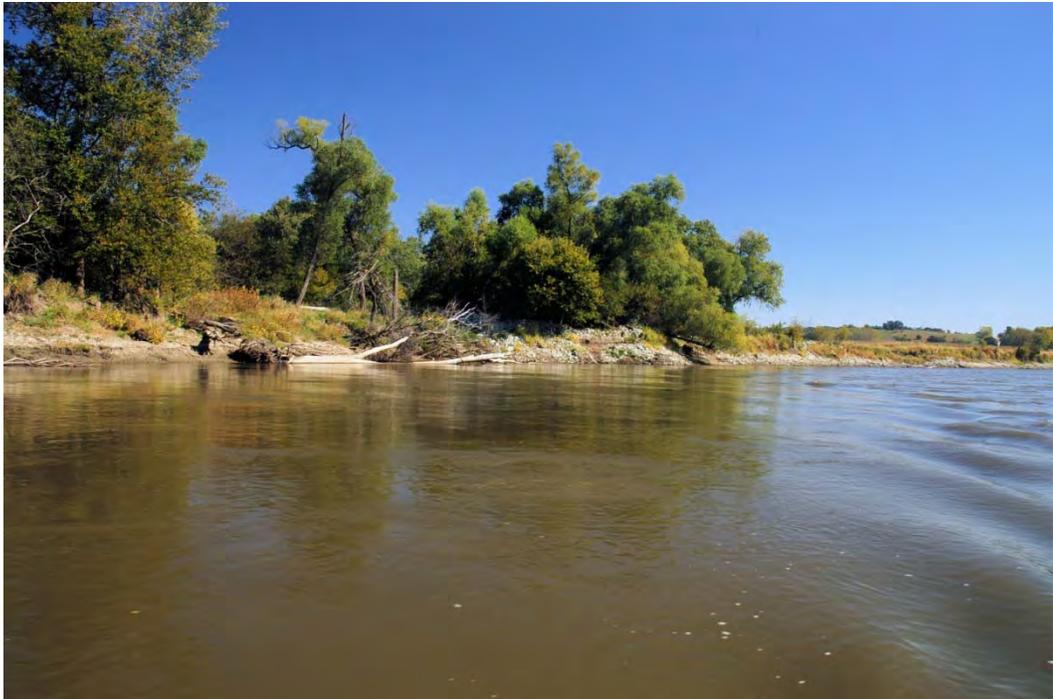
Figure 42. View looking downstream at the upstream end of the existing windrow revetment at IPA Site 13B, and the moderately eroding bank at Field Site 9.

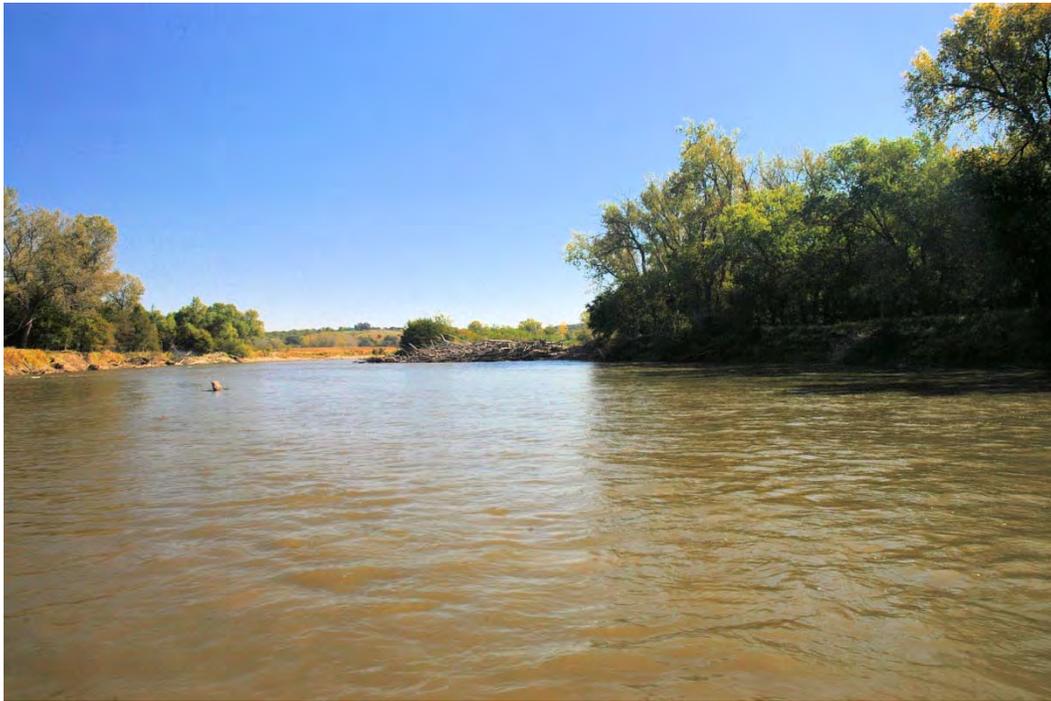
Figure 44. View looking downstream of the existing debris jam. Field Site 9 is visible near the right side of the large trees along the left bank in the background.

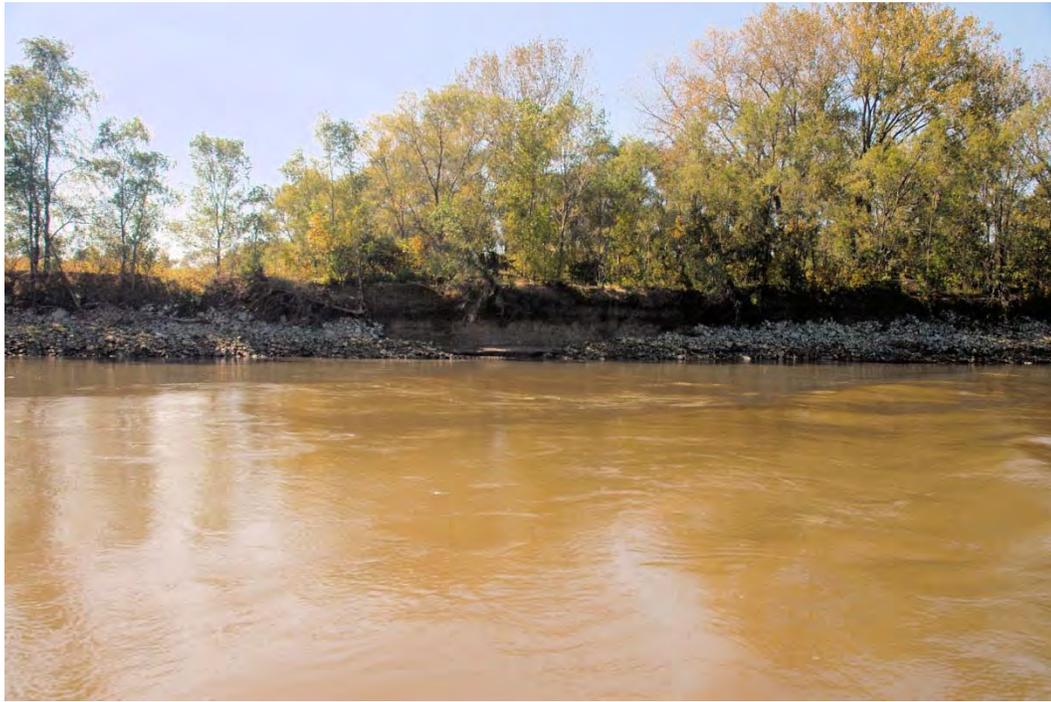
Figure 49. Right bank at the edge of the downstream edge of the wooded area at the Elkhorn Crossing Recreation Area (IPA Site 13A and Field Site 10).

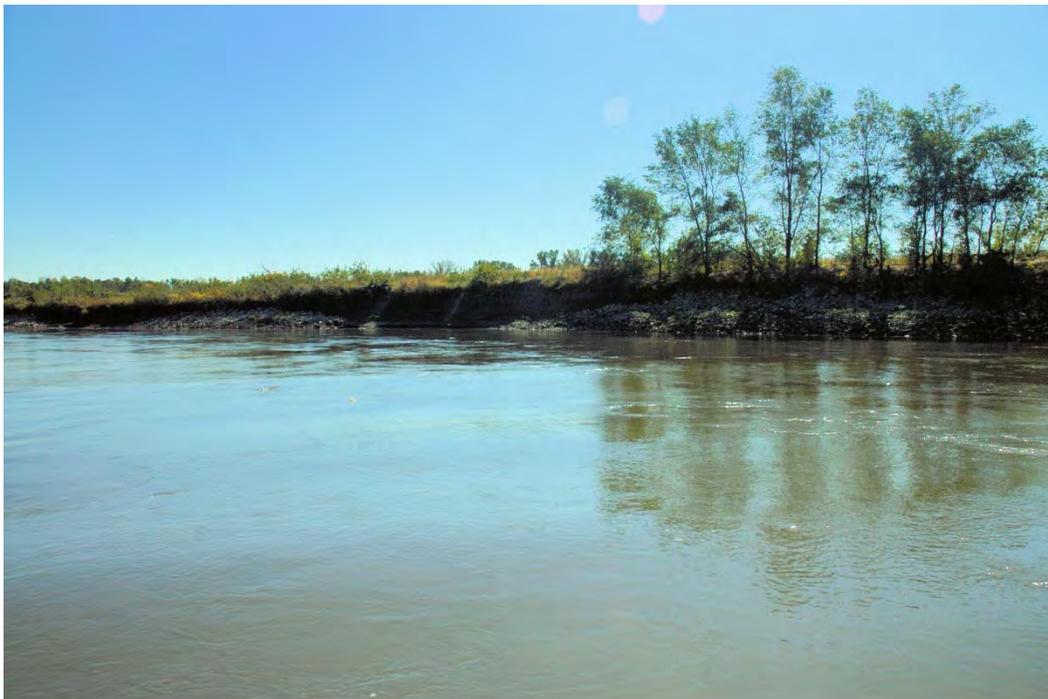
Figure 50. View looking downstream of the right bank downstream from the wooded area at the Elkhorn Crossing Recreation Area (IPA Site 13A and Field Site 10).

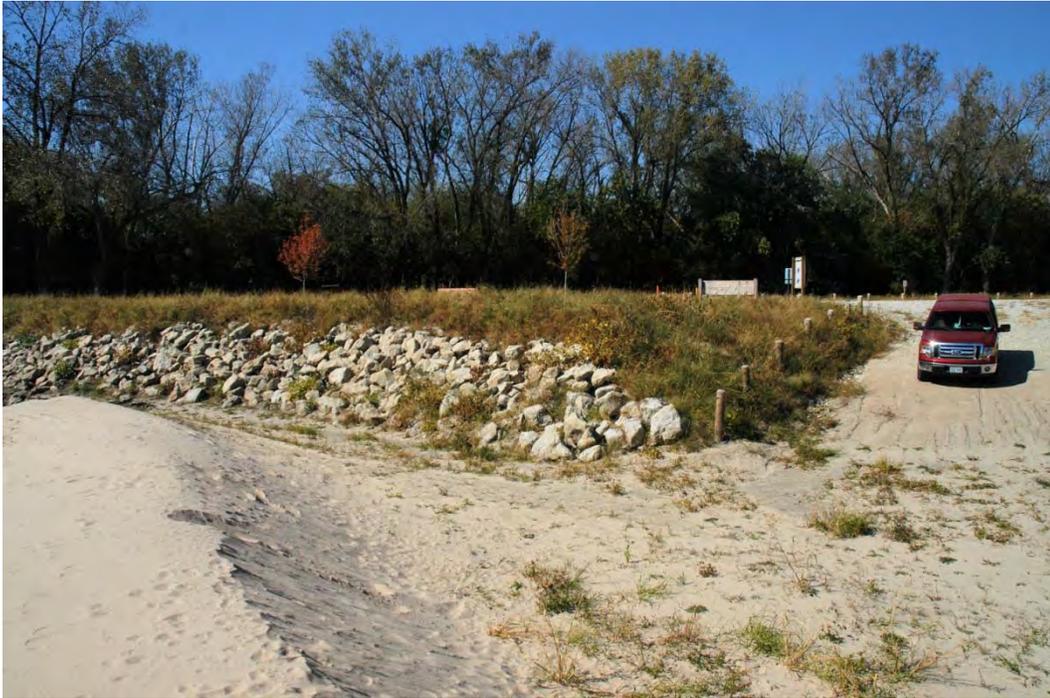
Figure 53. Blocked boat ramp and upstream end of riprap bank protection at the Elkhorn Crossing Recreation Area.

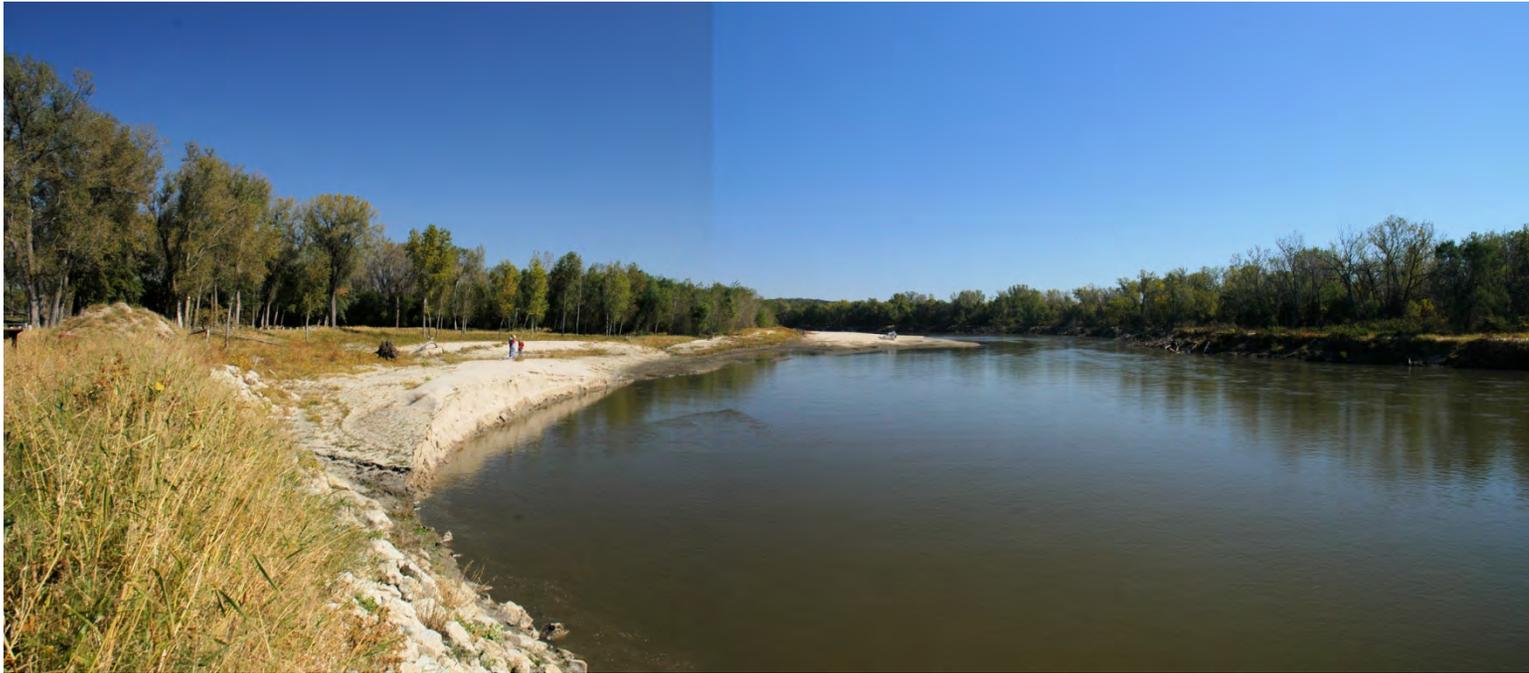
Figure 54. View looking upstream of the large sandbar that has formed along the right bank at the Elkhorn Crossing Recreation Area. The boat ramp shown in Figure 52 is just behind the mound on the left side of the photo.

The sandbar at the boat ramp obviously creates a problem for use of the ramp, and PMRNRD has expressed a desire to modify the site in a manner that will remove and prevent future formation of the sandbar. Since this sandbar is formed by accretion on the inside of the bend that is associated with migration of the opposite bank, the only effective way to cause the river to remove the sandbar and insure that it does not re-form is to shift the left bank opposite the site back to its approximate position prior to formation of the sandbar. This could be achieved by constructing a series of rock jetties or bendway weirs in the eroded area along the left bank, with the ends of the structures at approximately the 2004 bankline (**Figure 57**), but the cost would be very high (cumulative length of the spurs would be ~1,700 feet, not considering the necessary tie-back to prevent flanking). It is questionable whether the necessary environmental permits could be obtained for such a project. Two other alternatives could be considered for dealing with the sedimentation issues at the boat ramp, both of which would require stabilization of the existing bankline at IPA Site 14 to insure their continued viability:

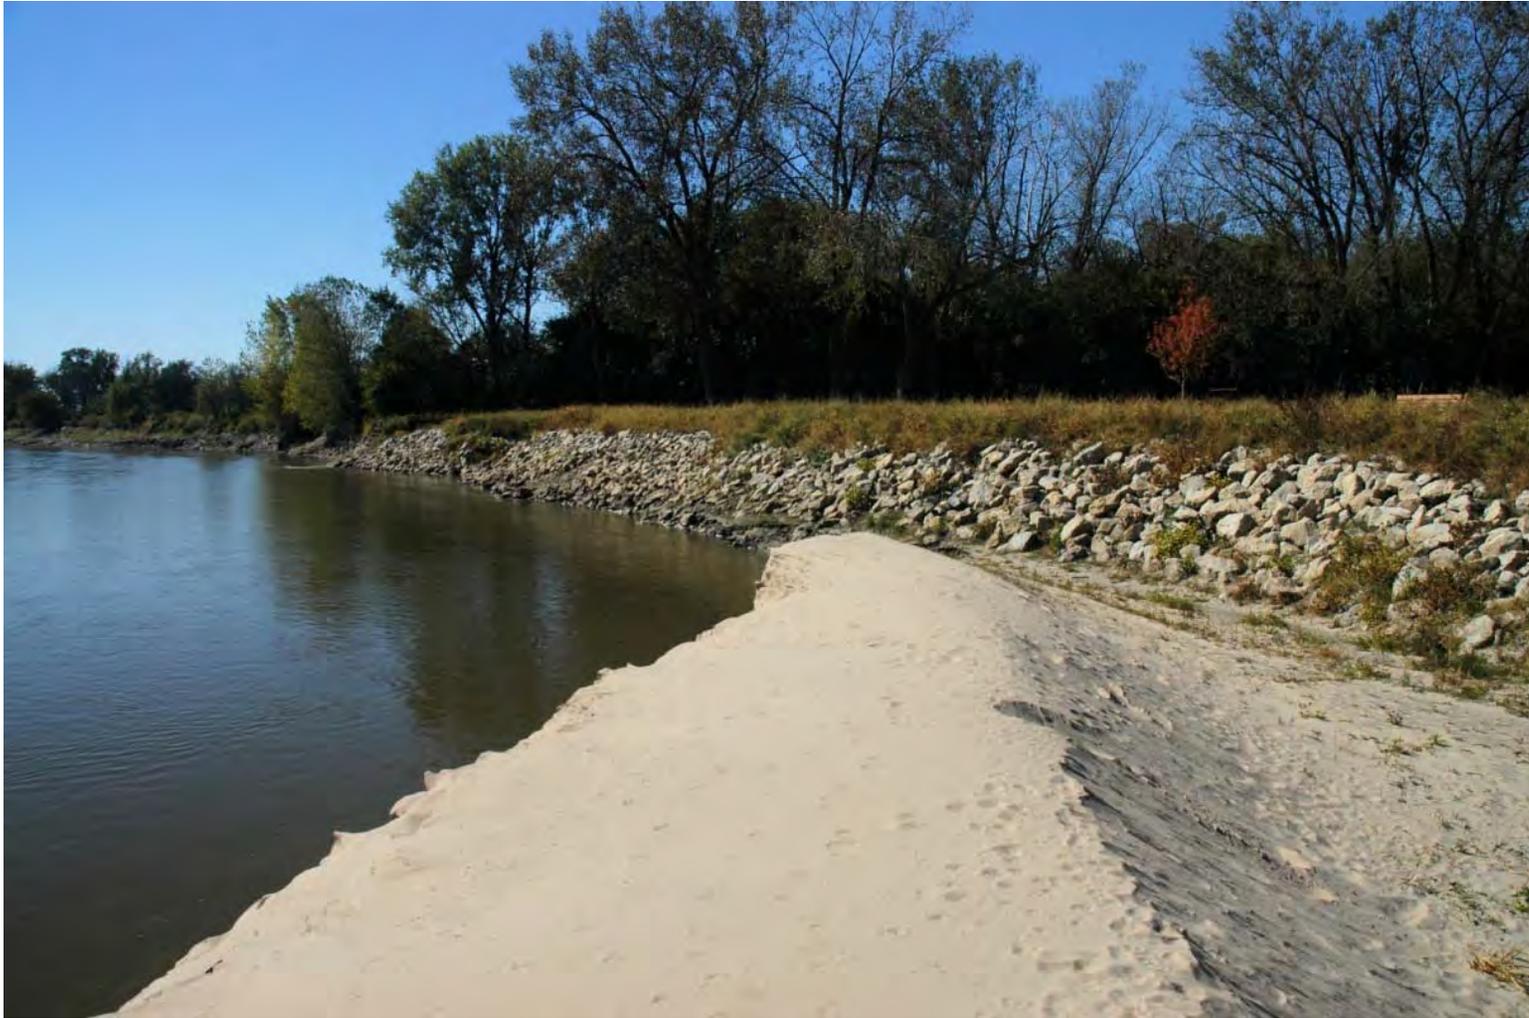
During the field visit, Director Tesar indicated that the rock that is visible in Figure 57 that was placed in 2009 has slumped 2 to 3 feet down into the channel, and he is concerned that the installation may eventually fail. Sufficient data are not available confirm this observation, but it appears to be reasonable based on the existing elevation at the top of the bank compared to the top of the rock. If the observation is correct, it may be necessary to repair the installation to insure continued stability, and these repairs could be done in conjunction with relocating the boat ramp.

Figure 58. Looking downstream at the end of the sandbar that blocks the Elkhorn Recreation Area boat ramp toward the riprap bank protection that was installed in 2009. It may be possible to relocate the boat ramp to the rock-protected area downstream from the sandbar.

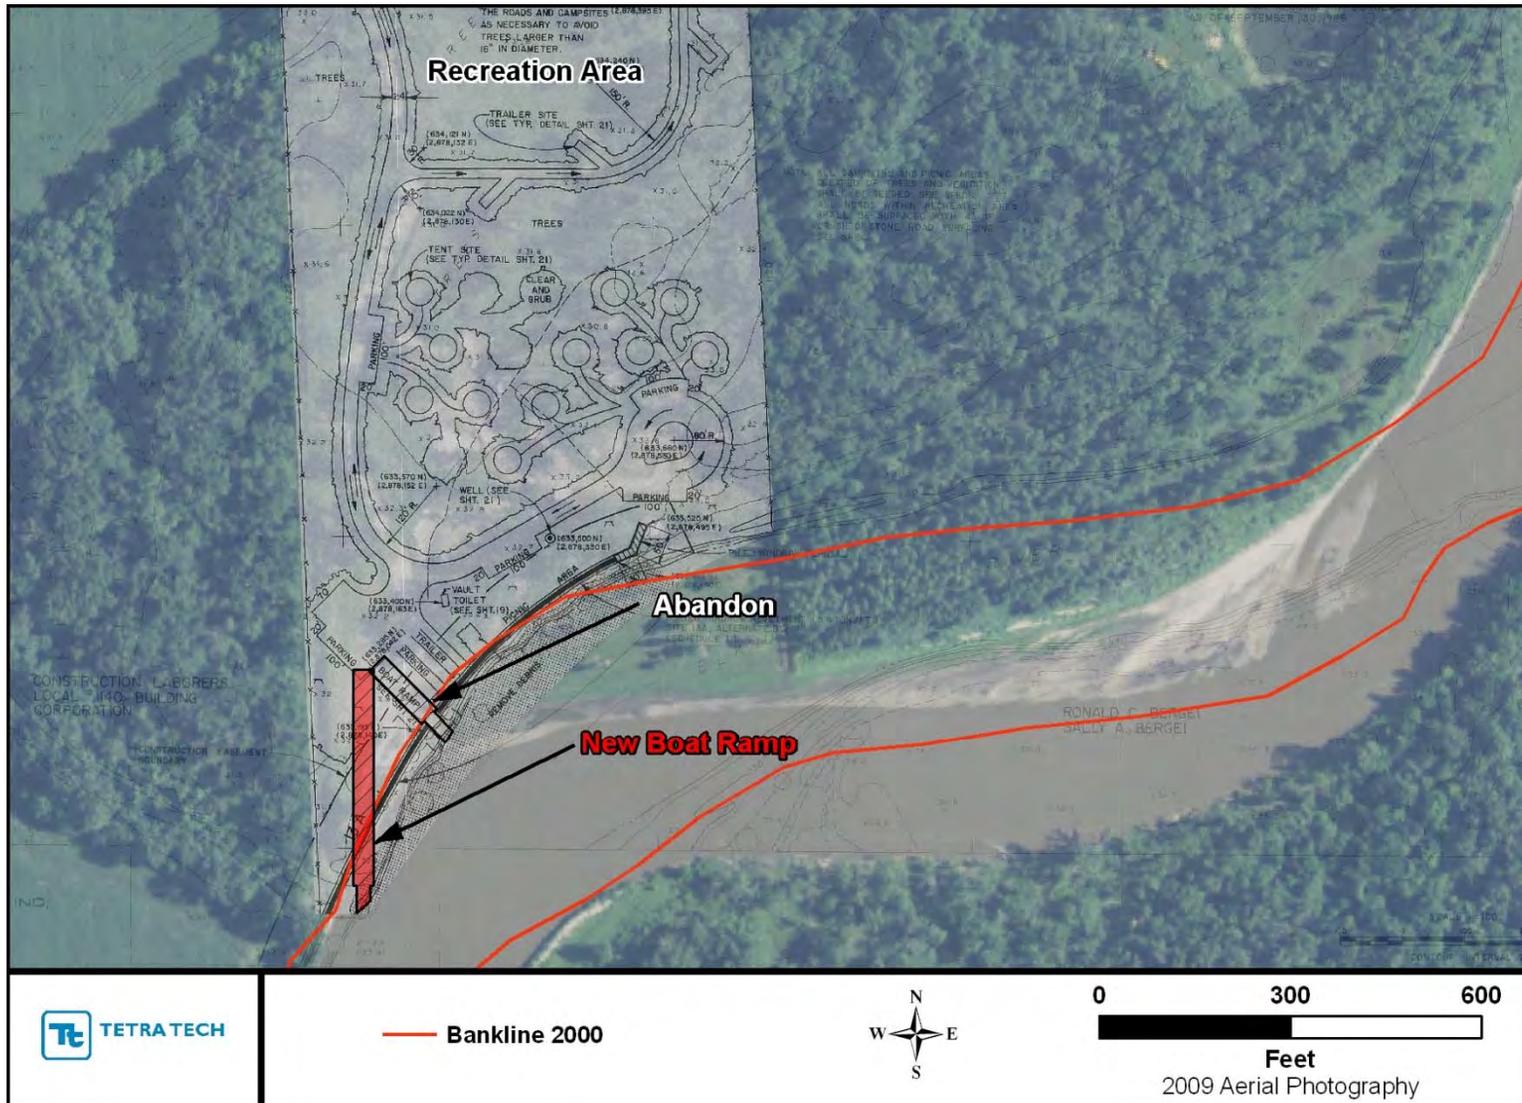
Figure 59. Suggested relocation of Elkhorn Crossing Recreation Area boat ramp.

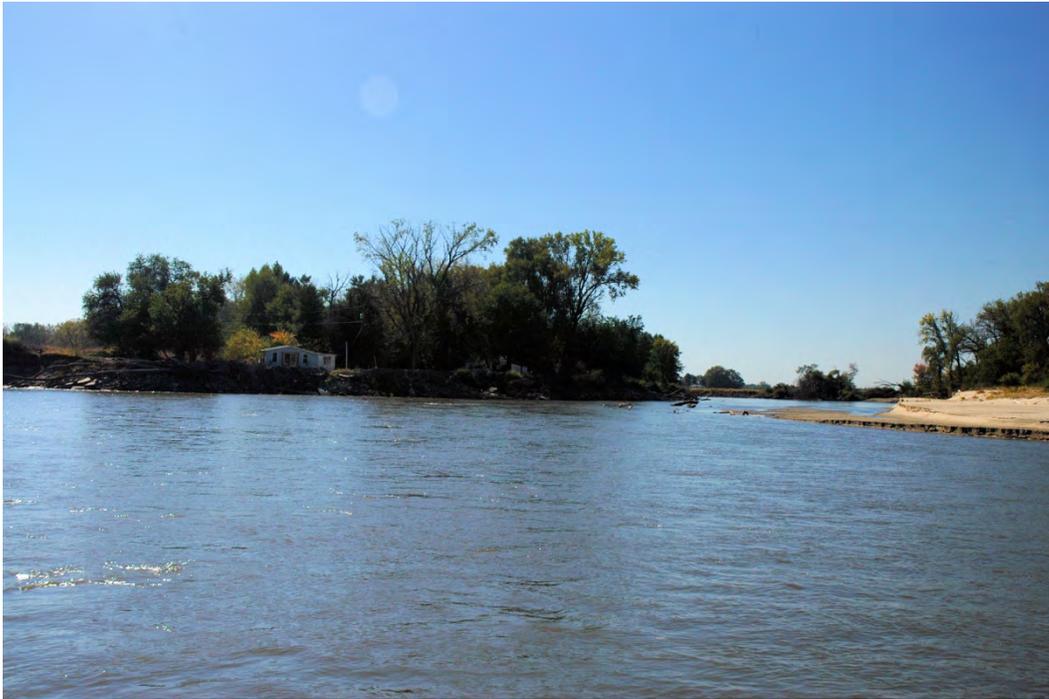
Figure 65. Looking downstream at the protected bank at the downstream end of Field Site 13.

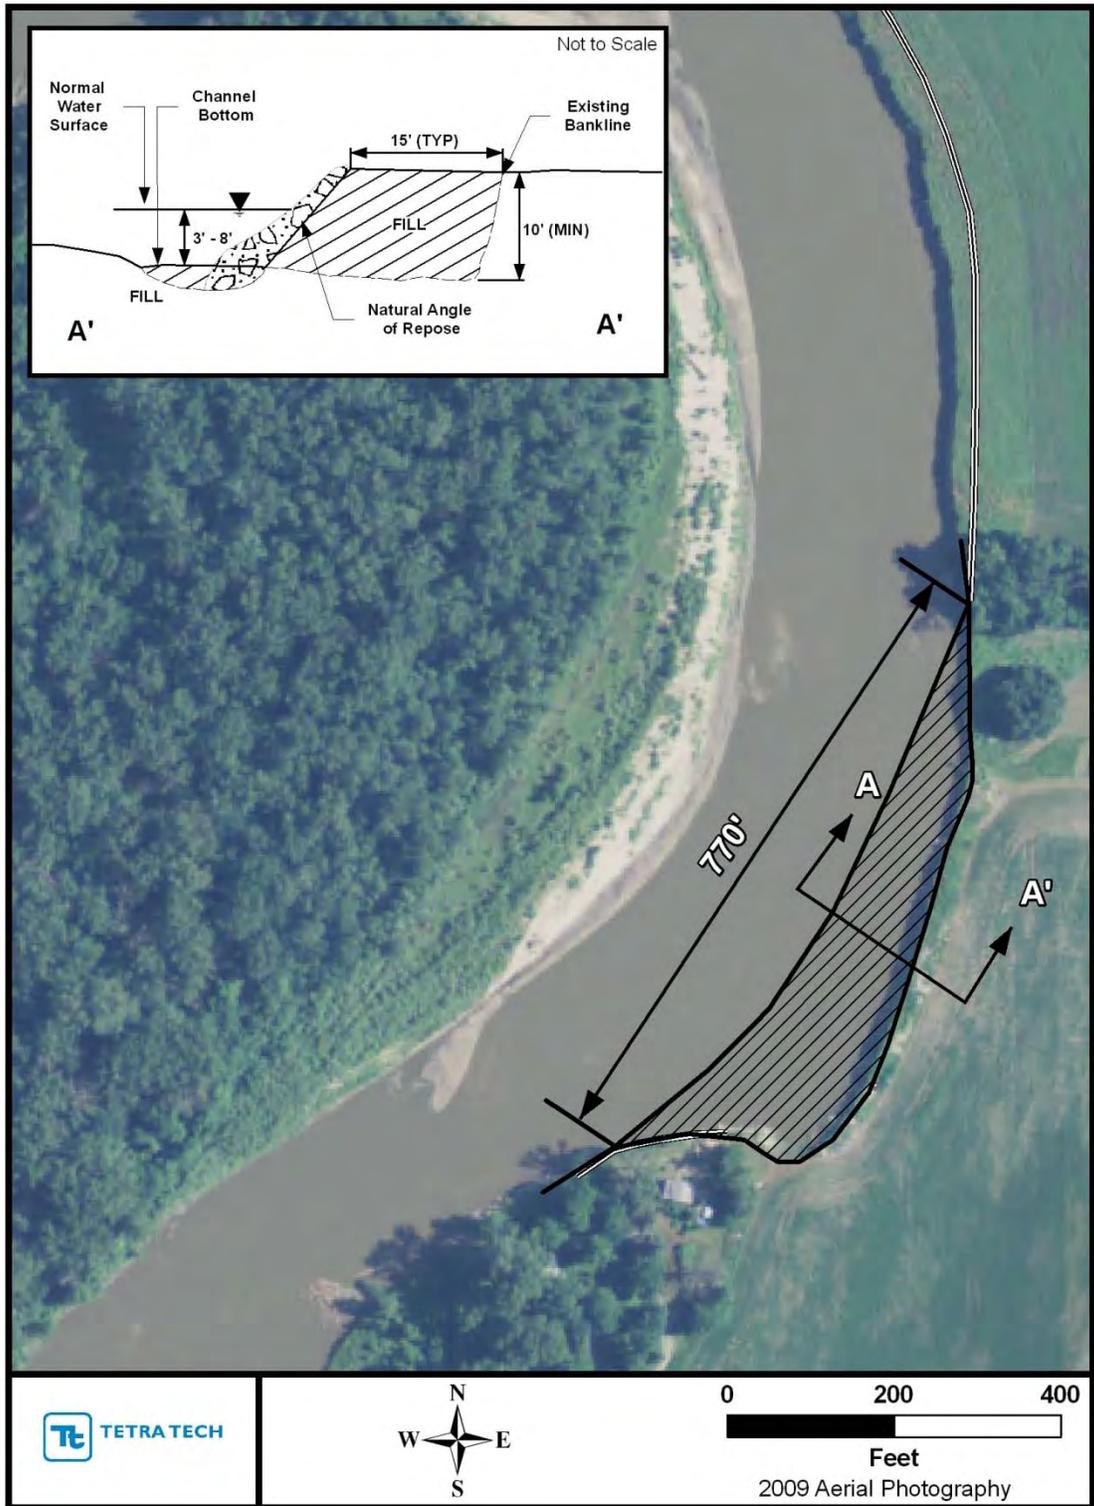
Figure 66. Preliminary recommended for bank protection at Field Site 13.
