MEMORANDUM

SUBJECT: California Bend Environmental Restoration Project – Access Road

Geotechnical Exploration Report

California Bend Slope Failure

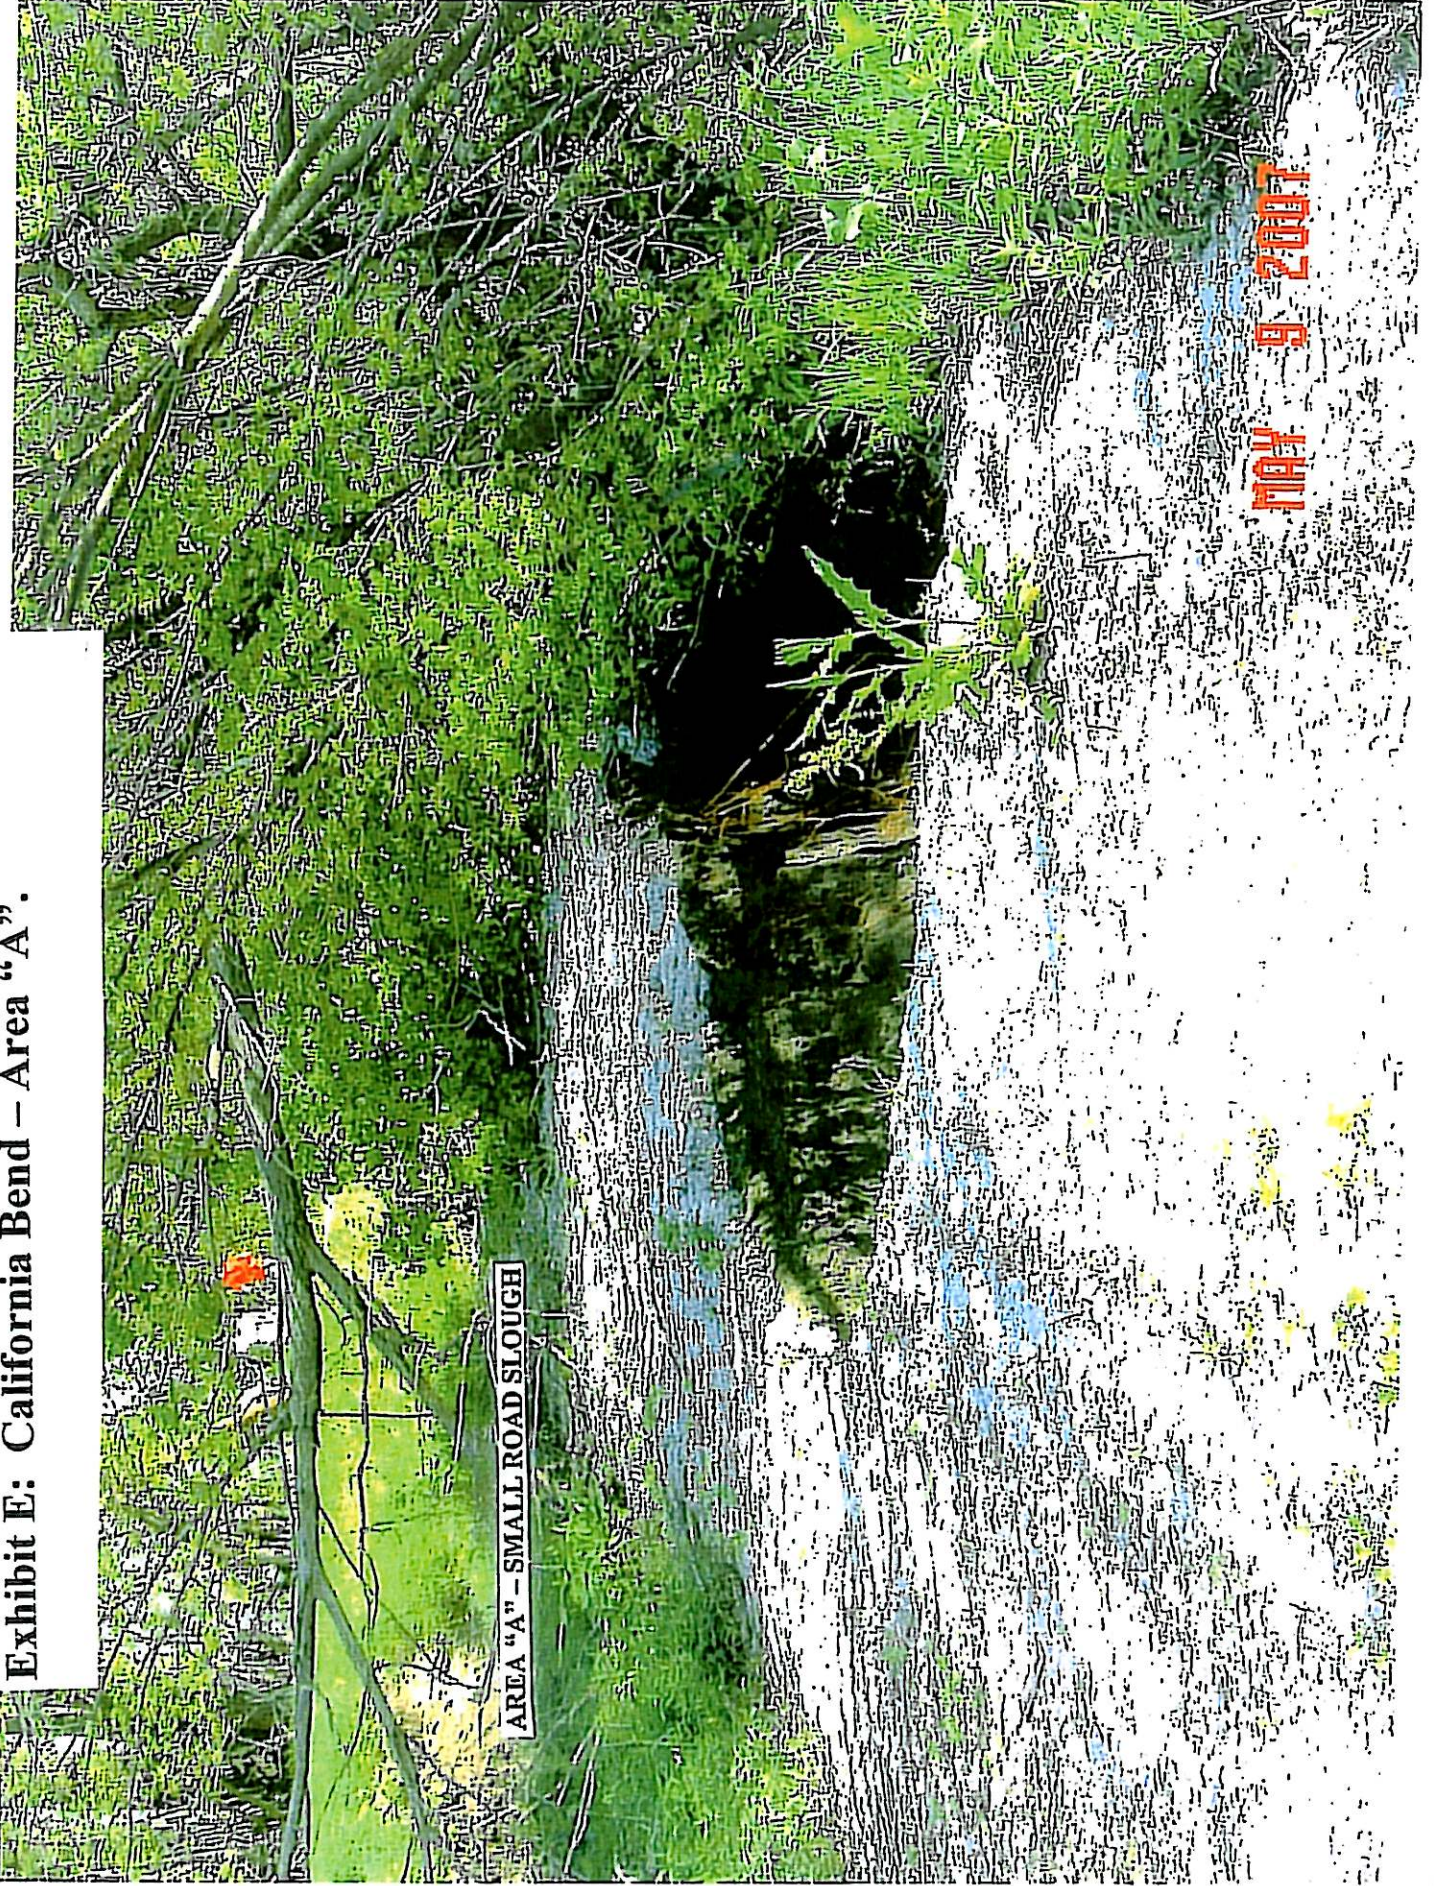
Exhibit E: California Bend – Area “A”.

AREA "A" - SMALL ROAD SLOUGH

MAY 9 2007

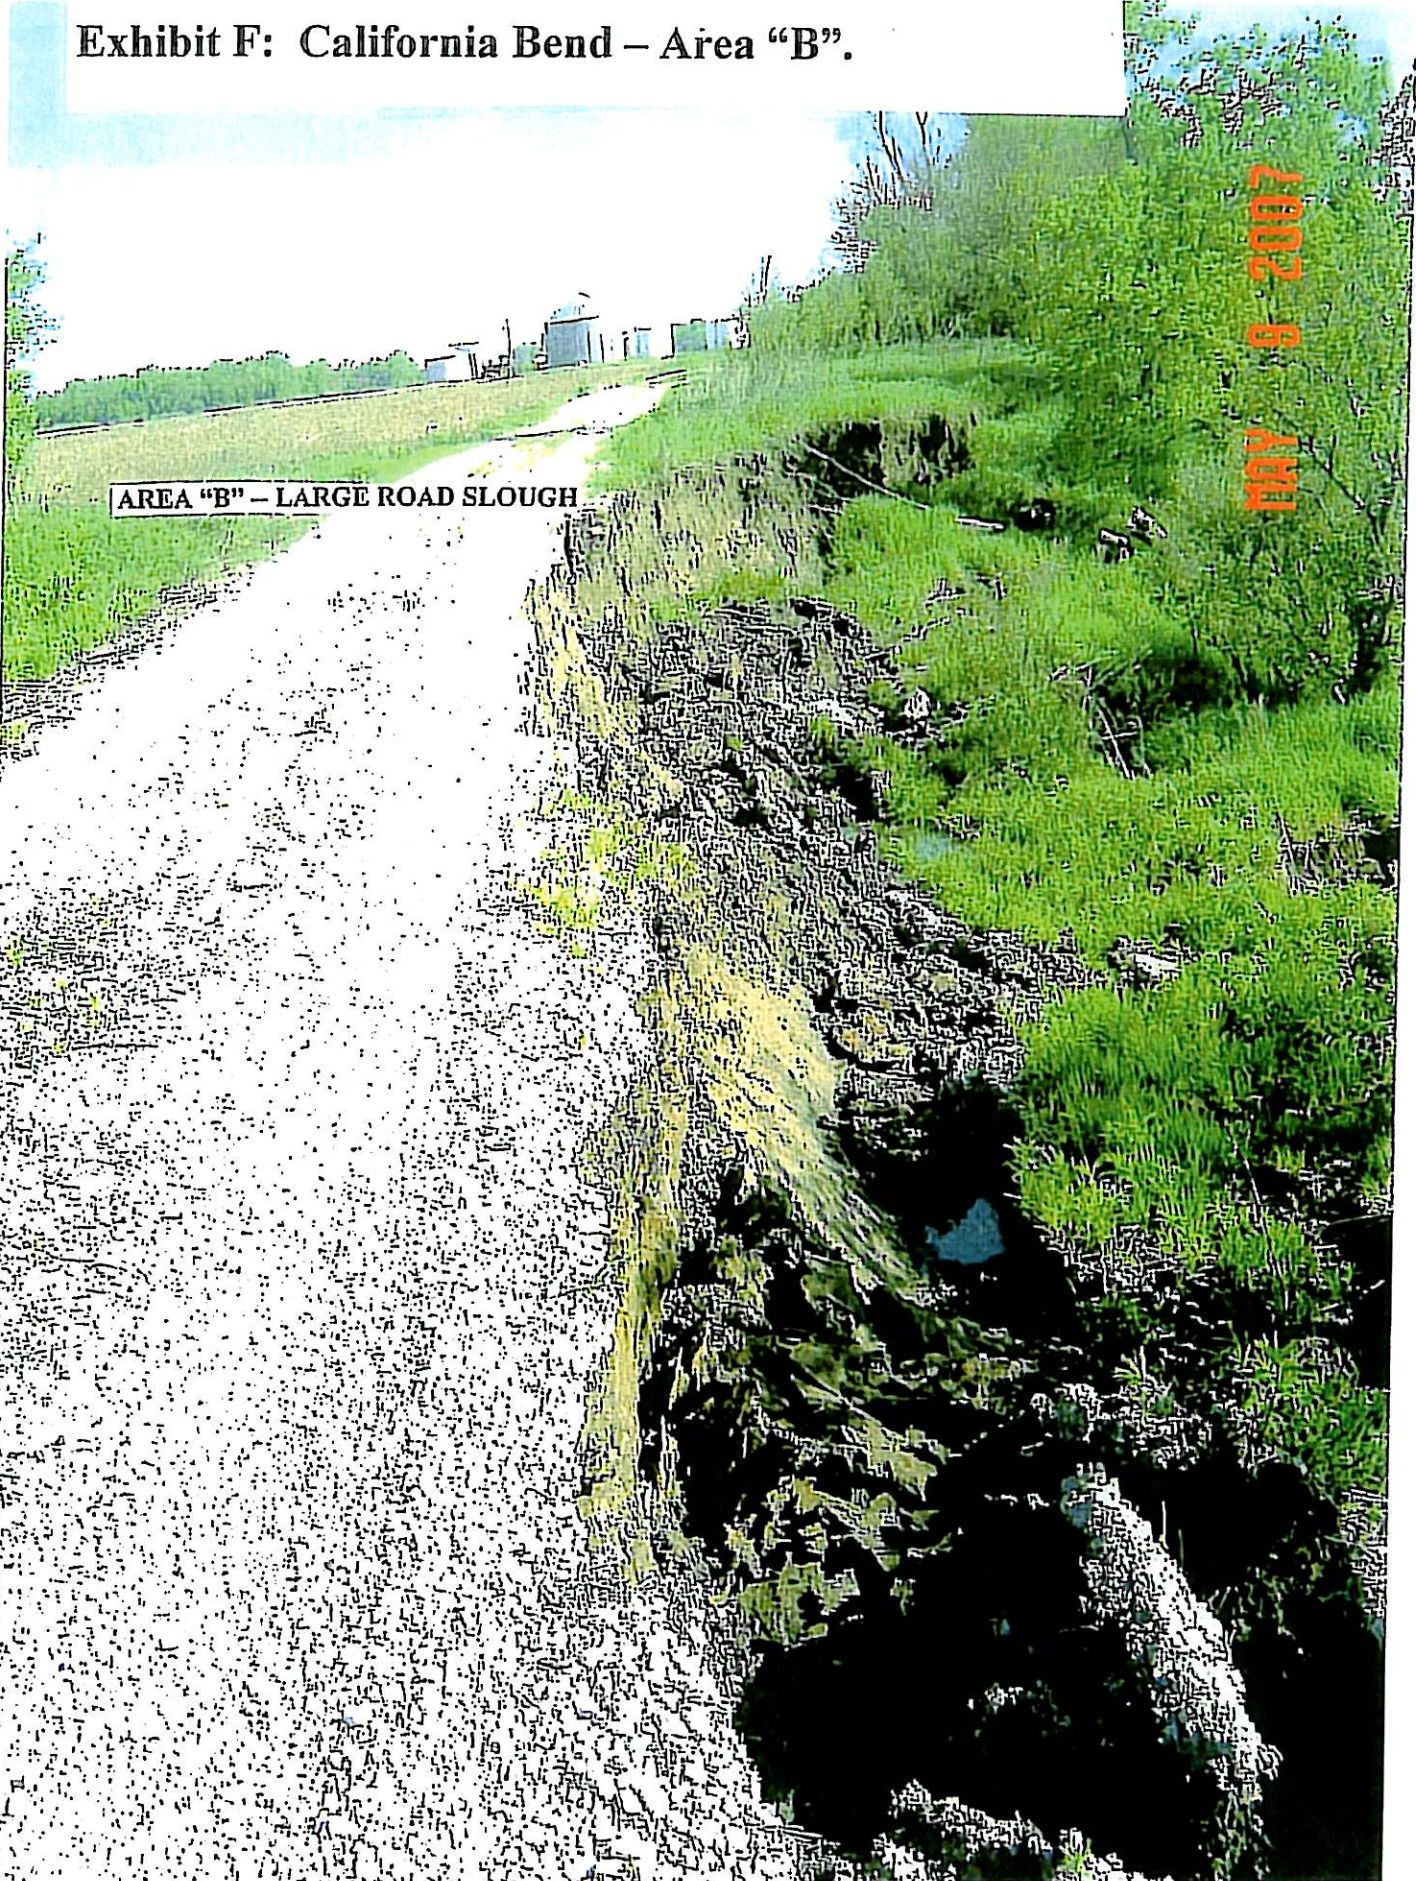
Exhibit F: California Bend – Area “B”.

AREA "B" – LARGE ROAD SLOUGH

MAY 9 2007

We understand the project to consist of repairing a slope failure. This failure is located between the channel and the access road, approximately 4,000 feet north of Optimist Park. The failed area is approximately 250 feet long, and has dropped as much as 4 feet. Many cracks were observed at the ground surface in the failed area. These cracks paralleled the channel, and were up to 12 inches wide and 5 feet deep. This area failed in the spring of 2007, and was repaired in May and June 2008. It began failing again before the repairs were completed. The repairs included placing a rock revetment at the toe of the slope, and rebuilding the slope to a 2H:1V configuration. Four transverse rock filled trenches tied into the longitudinal trench and ran to the east. Rock for the revetment and the trenches was stockpiled at the top of the slope during repairs. Project documents indicate that the compaction requirement for the fill was a minimum of 90 percent Standard Proctor (ASTM D698). A longitudinal rock filled trench was constructed on the east edge of the road. An old railroad right of way exists on the west edge of the roadway.

It is Management's plan to leave slope as is and monitor it for changes along with minor grading to allow good access and smooth the area with District equipment (Option 2). If the slope fails again in the future it is likely to occur along the same vertical slip-plane and not likely impact the adjacent landowner initially. Repair designs and construction bids could then be sought to address the situation more permanently.

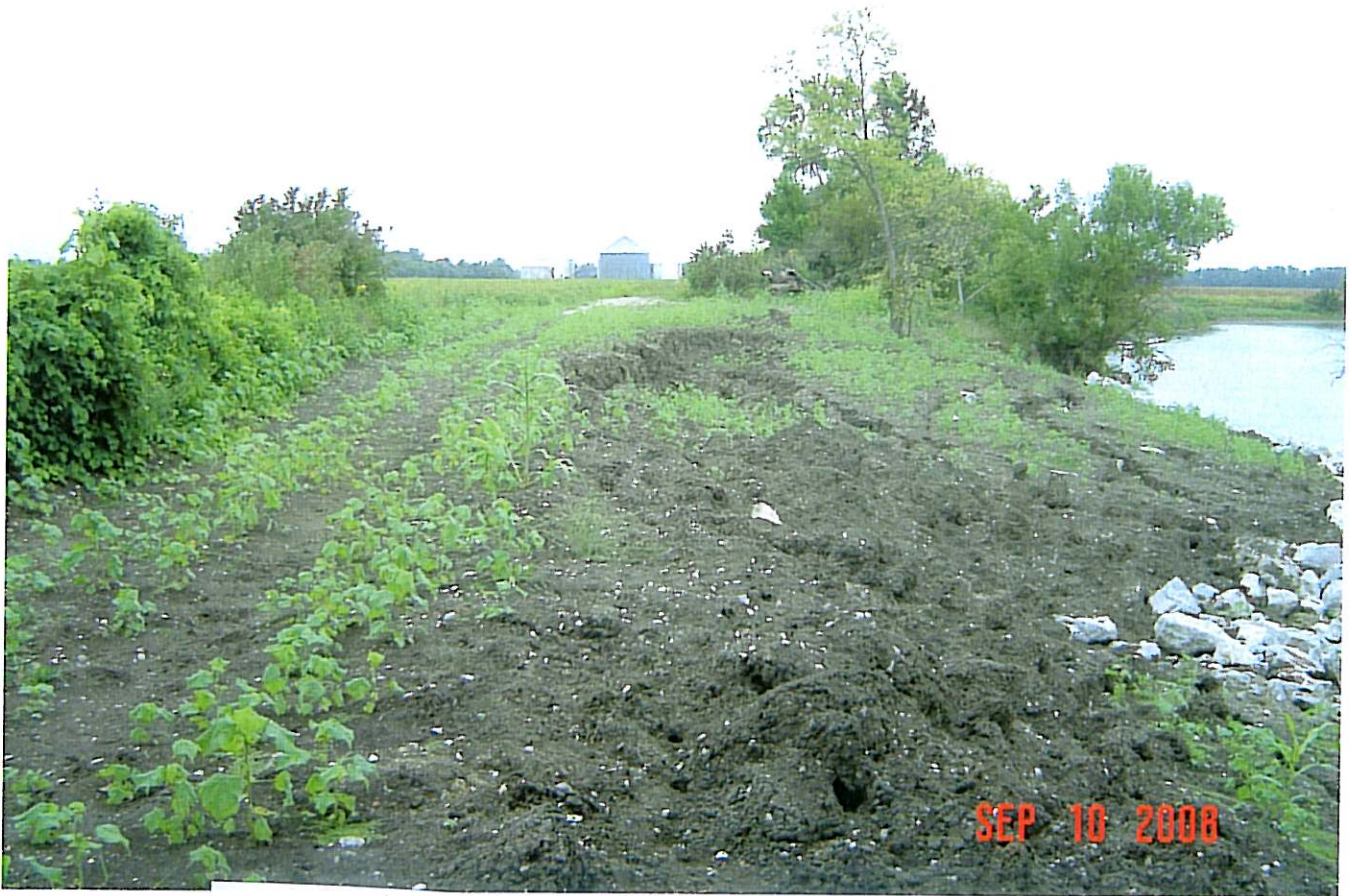
California Bend – Slough Area B – Sept. 2008

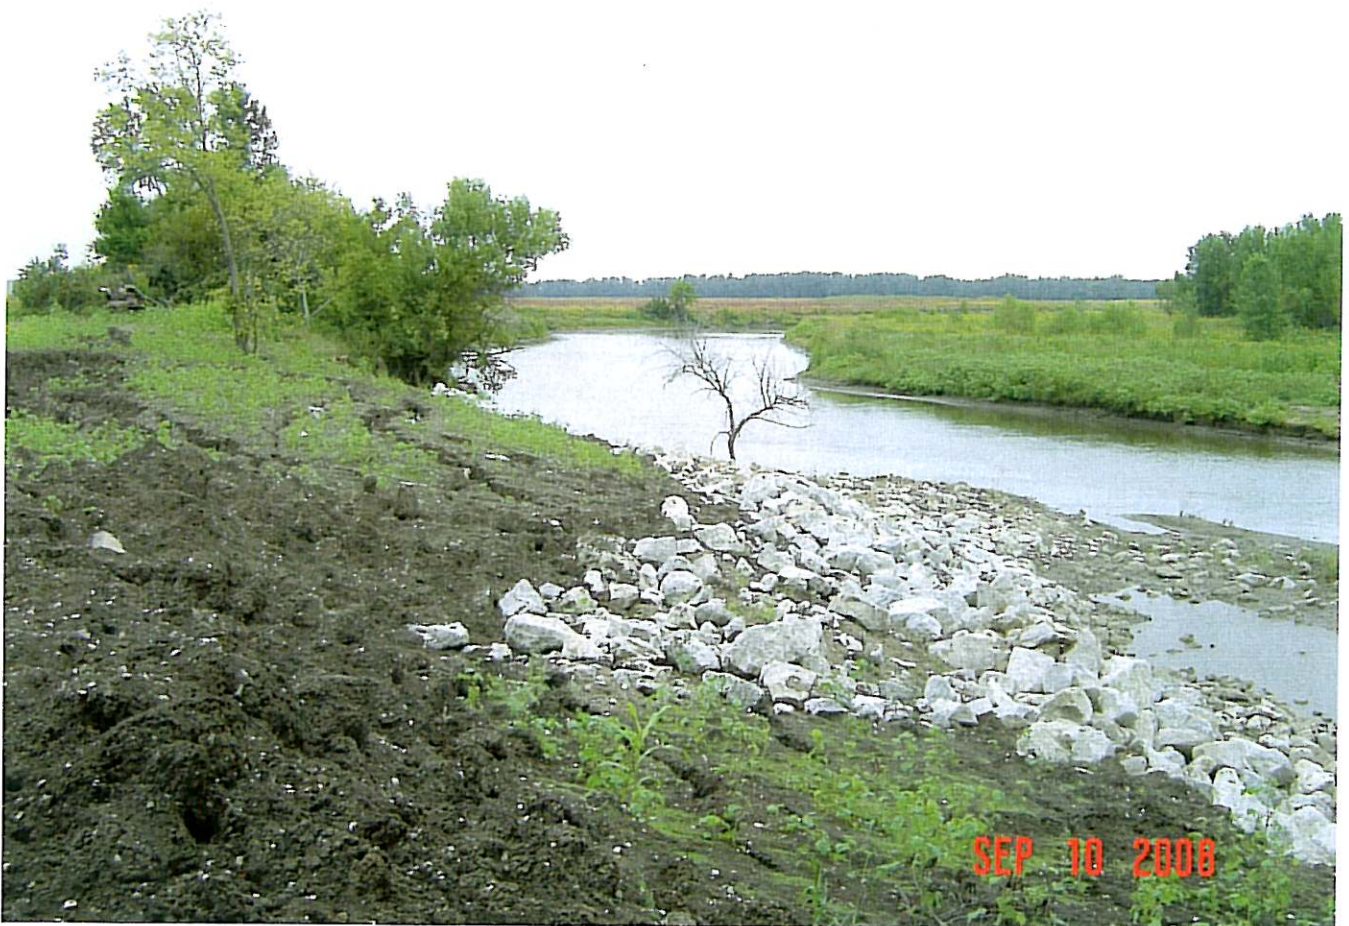
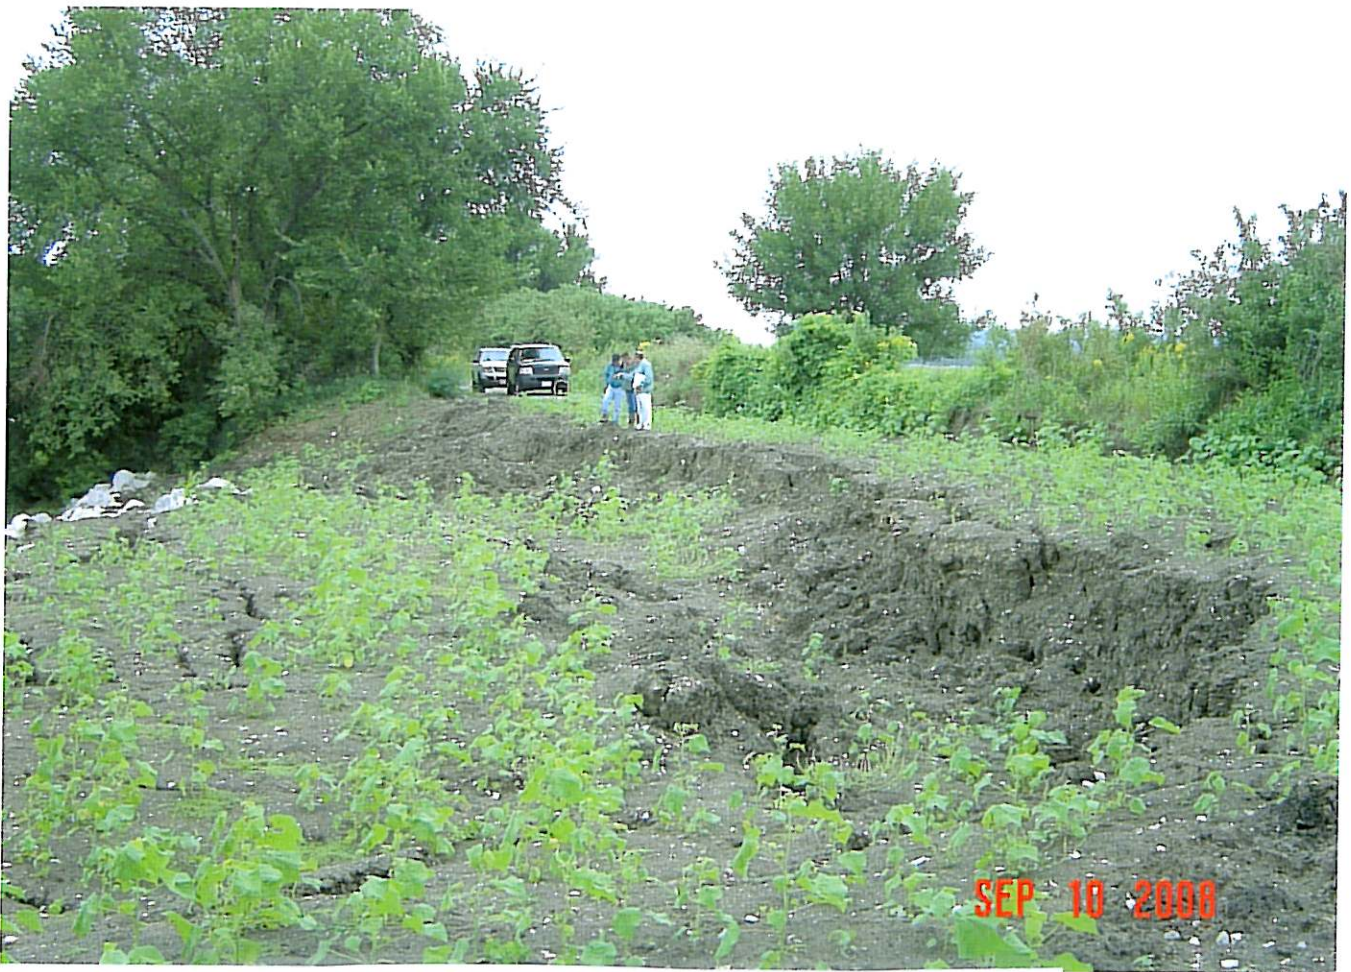
California Bend – Slough Area B – Sept. 2008
