# Urban Drainageway Guidance

DATE: December 20, 2010

PROJECT NUMBER: 403688

This technical memorandum (TM) provides guidance material for the District when ranking Urban Drainageway Program grant applications, while considering the Stormwater Management Policies. Three Levels of Design are identified for the District to use in evaluating and prioritizing funding applications and when determining allocations for each project. This TM also provides an overview of stream channel design practices that can be used to enhance environmental sustainability.

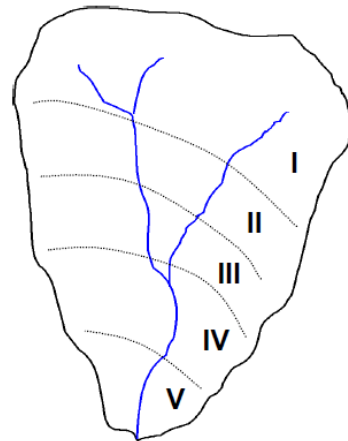
FIGURE 2 -Spatial process - stages of the CEM are distributed in a watershed (Fischenich and Morrow, 2000)

Stream classification is the process of documenting a channel's physical characteristics and categorizing a particular reach within a standard classification system. Several classification systems exist, and many are related to the stream's current status in an evolutionary process. Schumm et al. (1986) presented the Channel Evolution Model (CEM), which is used to characterize the incision process for streams, describing five stages of channel response (Fischenich and Morrow, 2000). These stages can be viewed as a temporal process (Figure 1), in which the changes occur at a point on a stream over time, or as a spatial process in which the five stages are distributed in a watershed (Figure 2).

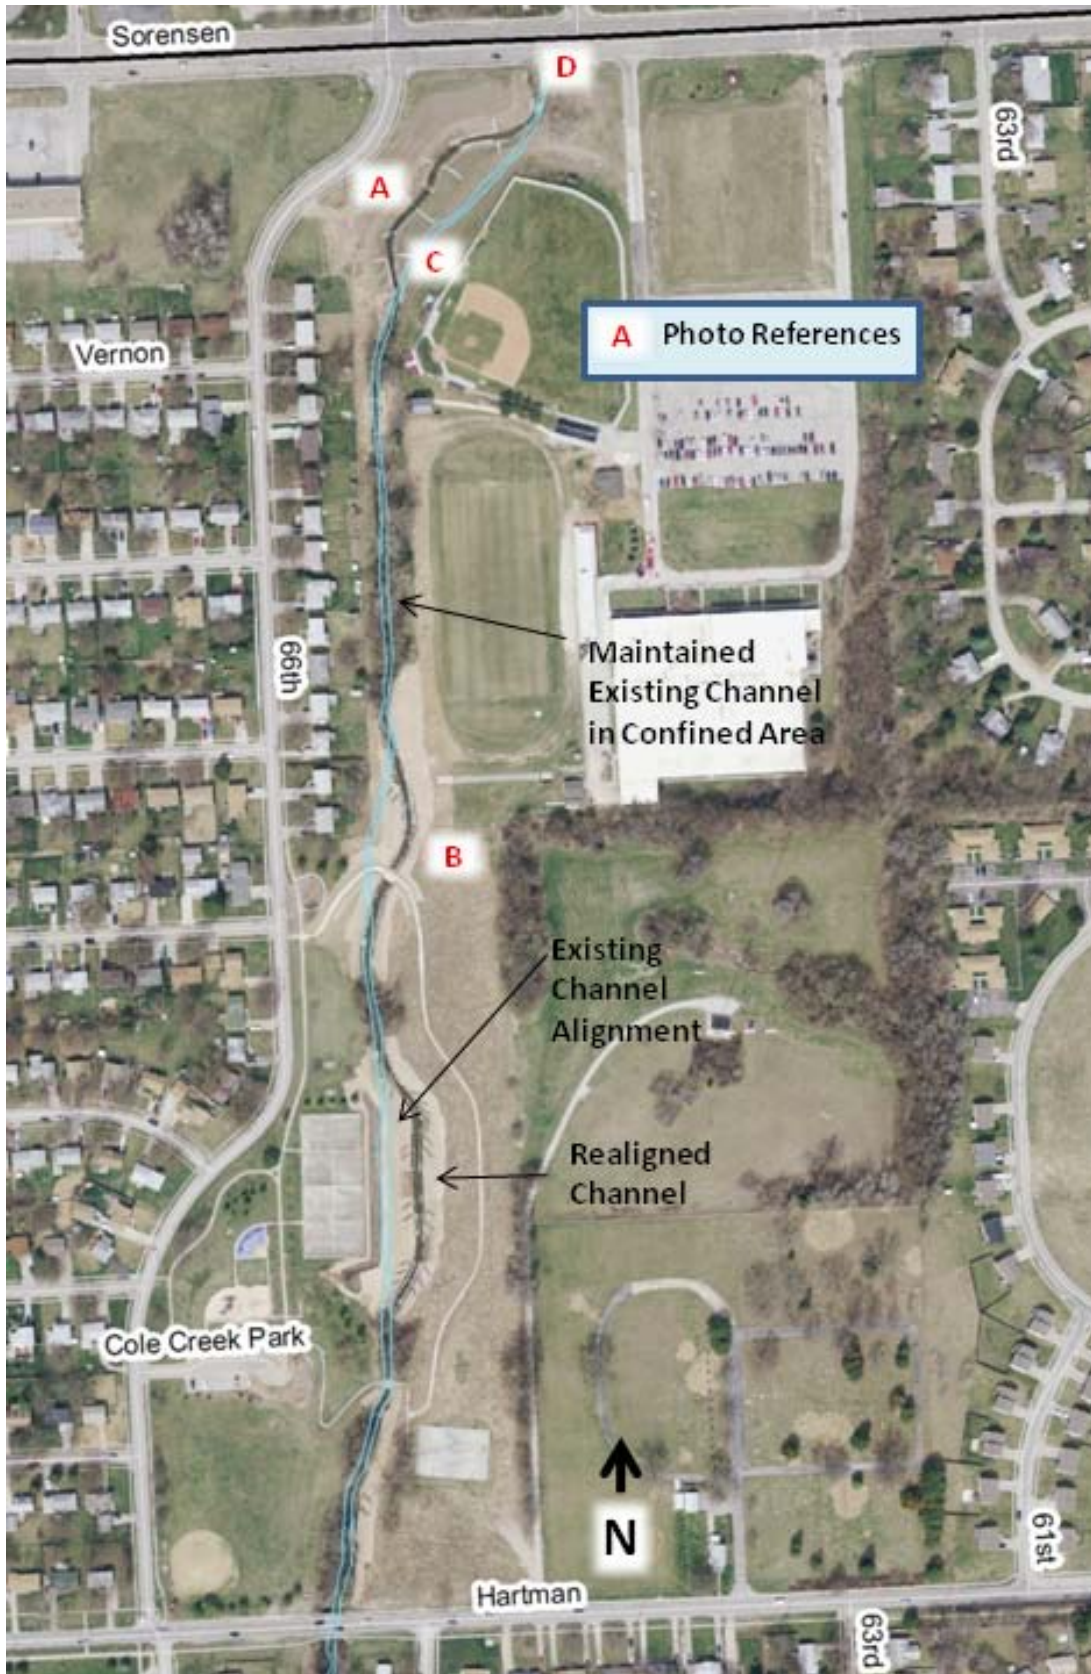
Cole Creek at Sorensen Parkway, Not to Scale (NTS) (April 2010 aerial, courtesy of City of Omaha)

The project goal was to accelerate the channel evolution process by restoring the stream's physical dimensions to mimic historical (pre-agriculture and development) conditions. Therefore, the stream design approach for Cole Creek was to adjust the cross section dimensions, channel pattern, and longitudinal grade of the channel to re-establish the hydrologic connection to the floodplain. Meanders were constructed in the stream channel, the banks were re-graded, non-native vegetation was removed from banks, and a floodplain bench was created. Native vegetation is preferred because it is well suited to the climatic conditions of the area and will provide bank stabilization through their deep root systems. The floodplain bench allows storm flows to access a wider area stabilized with vegetation to dissipate some of the erosive energy of the flowing water. Several stormwater outfalls were reconstructed and several types of structures were installed (Table 2).

A mixture of structural and bioengineering bank protection, flow retention, flow redirection, and grade control techniques were used on this project (Table 2). The Cole Creek project was a Level 1 (Restoration) project because the channel alignment was modified to include more meander along a continuous reach using primarily bioengineering techniques. Table 2 summarizes the assessment, design approach, and stream improvement techniques that were implemented at Cole Creek.

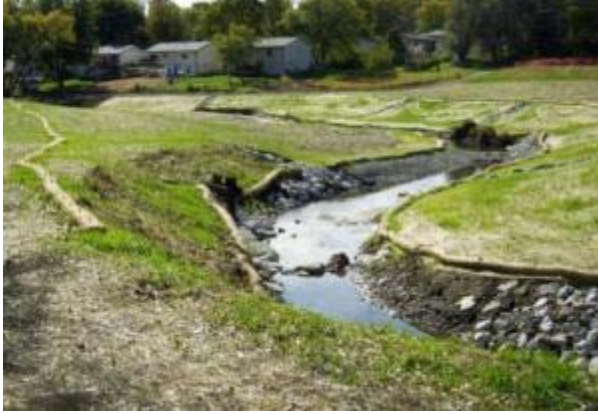
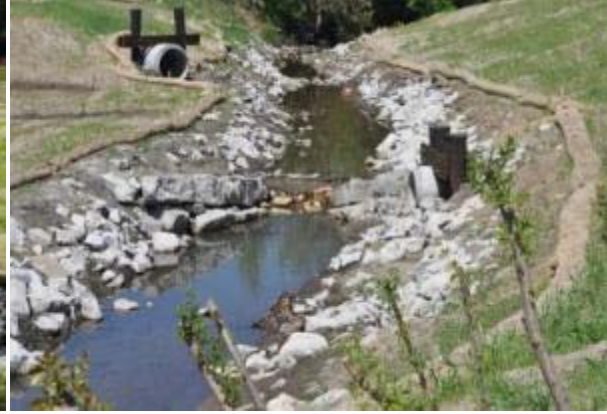
A. Re-graded banks and native vegetation downstream of Sorensen Pkwy    B. Cross vane grade control structure and stormwater outfall

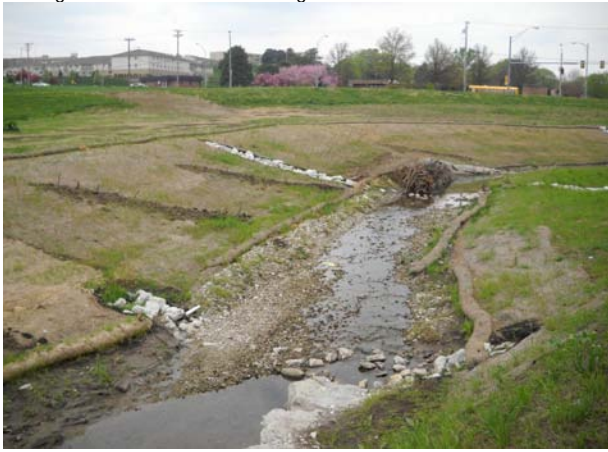
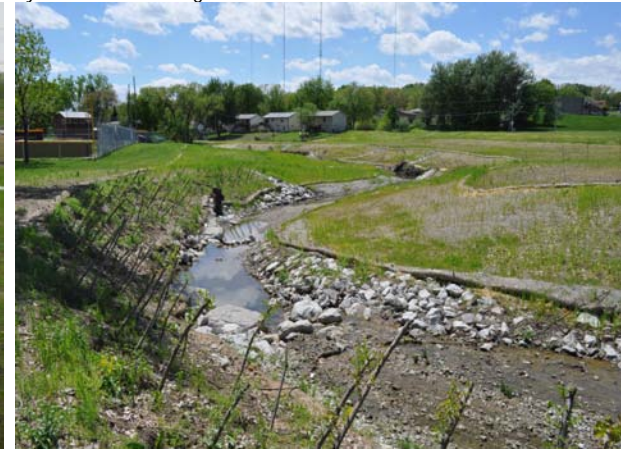
C. Re-graded banks and native vegetation looking toward Sorensen Pkwy    D. Re-graded banks and native vegetation by Sorensen Pkwy

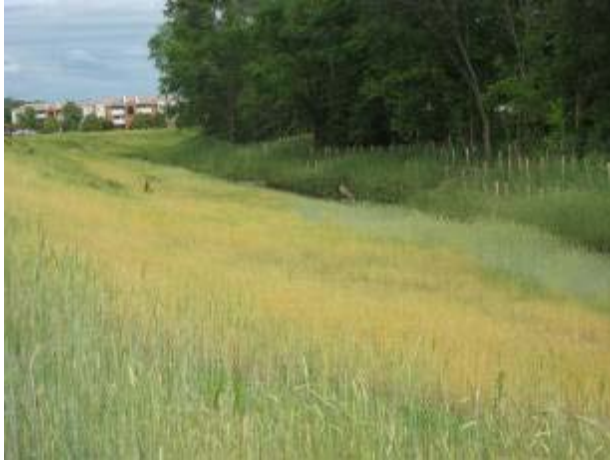
A. Re-graded banks and native vegetation downstream of 25<sup>th</sup> St

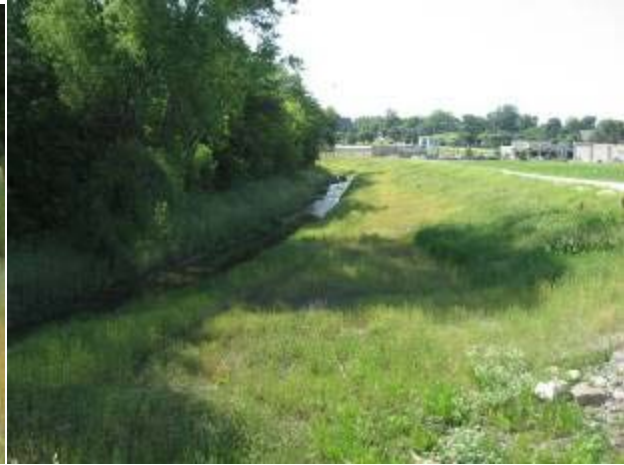
B. Re-graded banks & native vegetation upstream of Scarborough Dr

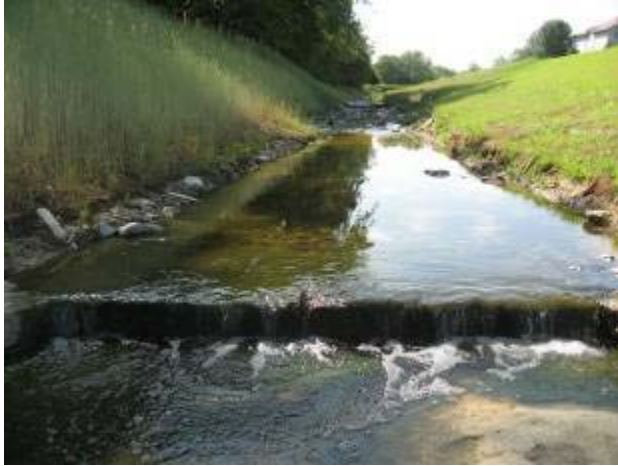
C. Series of cross vane grade control structures

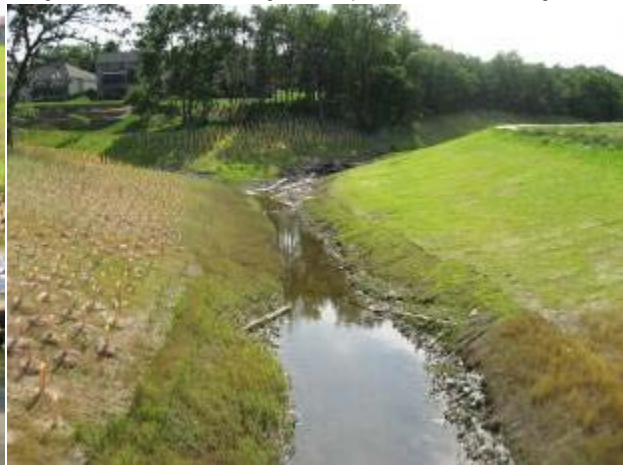
D. Re-graded banks and native vegetation upstream of golf cart bridge

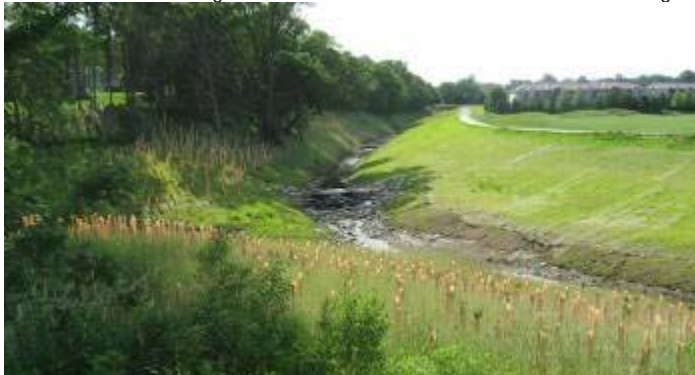
E. Re-graded banks, native vegetation, grade control structures

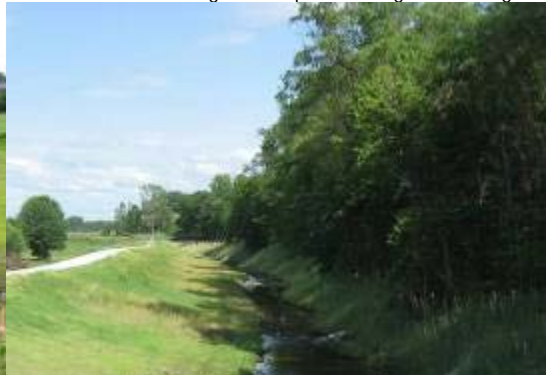
F. Re-graded banks & native vegetation downstream of Scarborough Dr
