SUBJECT: Review and recommendation on the Pigeon Creek Levee Emergency Repair

SUBJECT: Review and recommendation on the Pigeon/Jones Creek Levee Repair

Pigeon Creek Levee Breach, Dakota County

June 15 and June 30, 2014

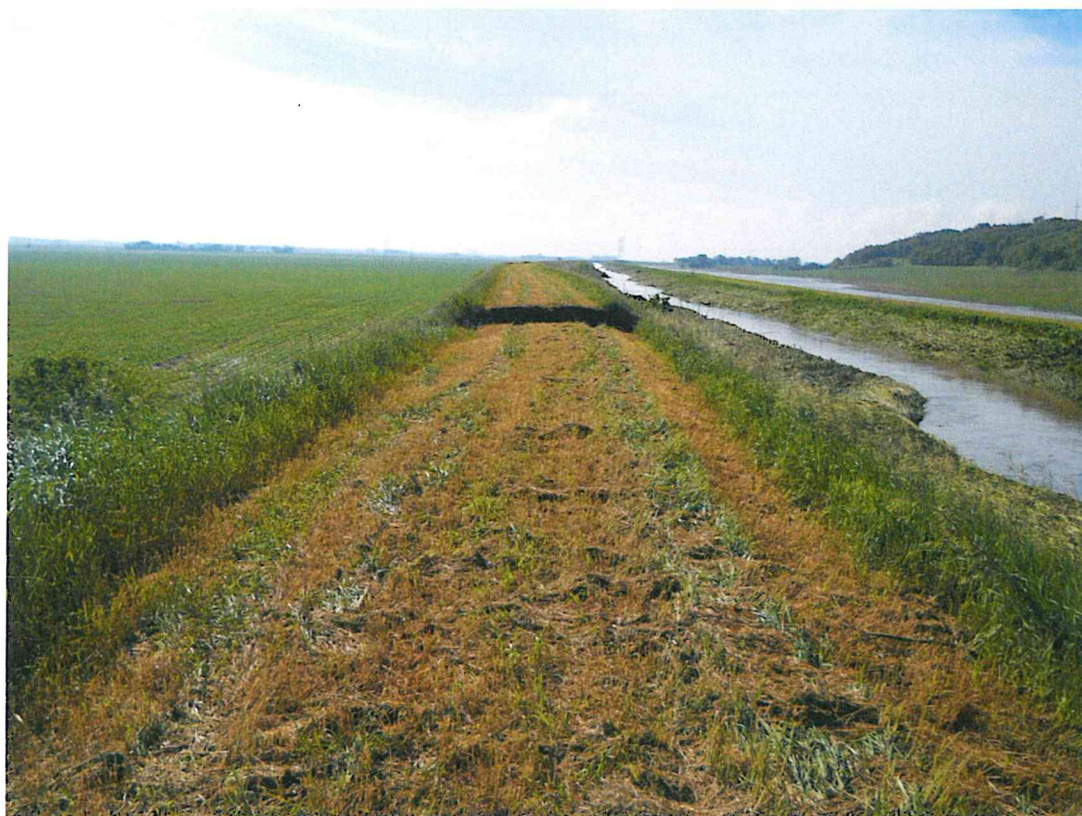
#1 - 6.15.2014 - breached area looking west

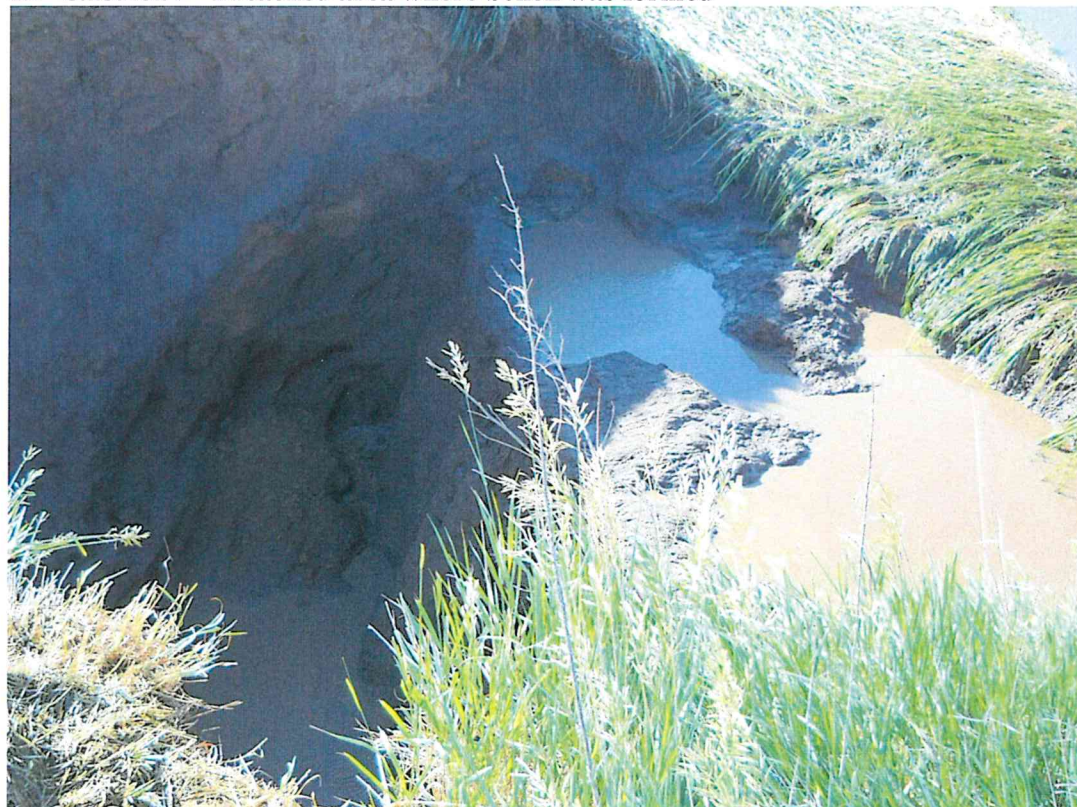
#2 - 6.15.2014 – Breached area where bench was formed

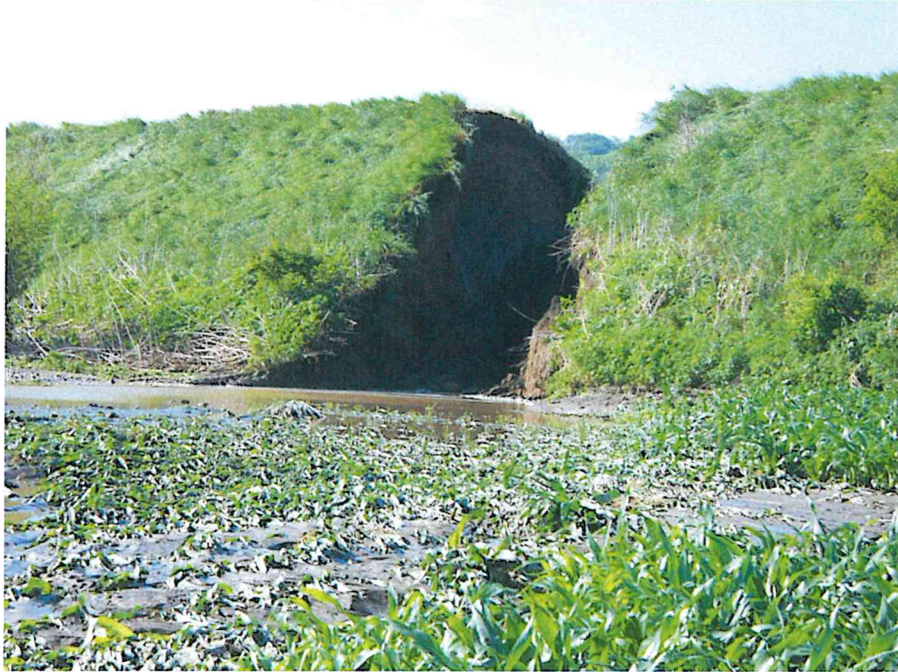
#3 - 6.15.2014 – looking south towards breached area

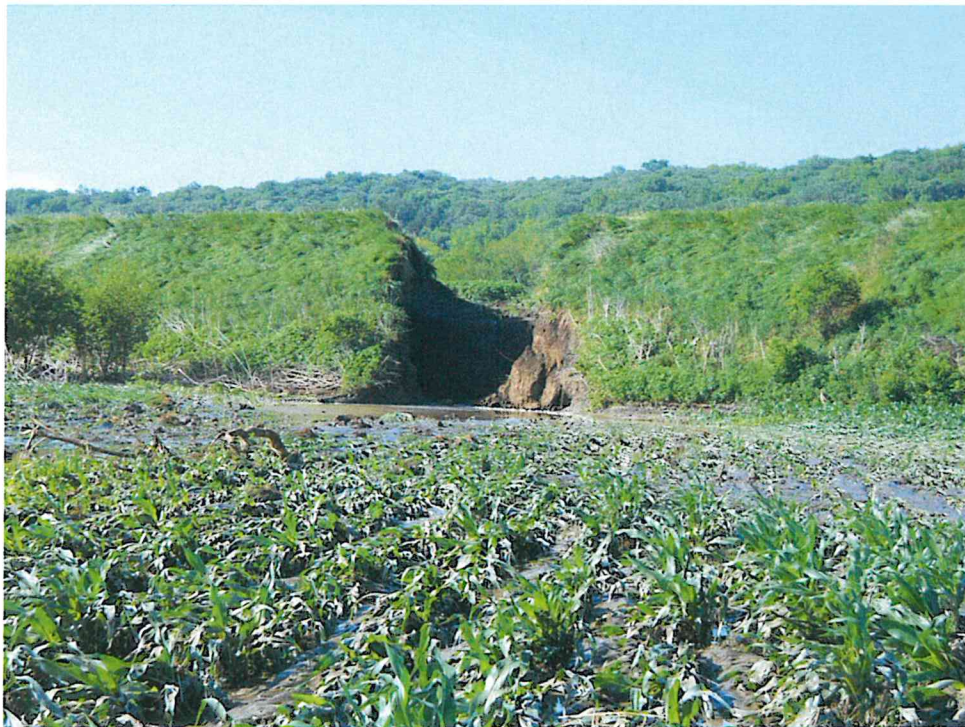
#4 - 6.15.2014 – looking south towards breached area

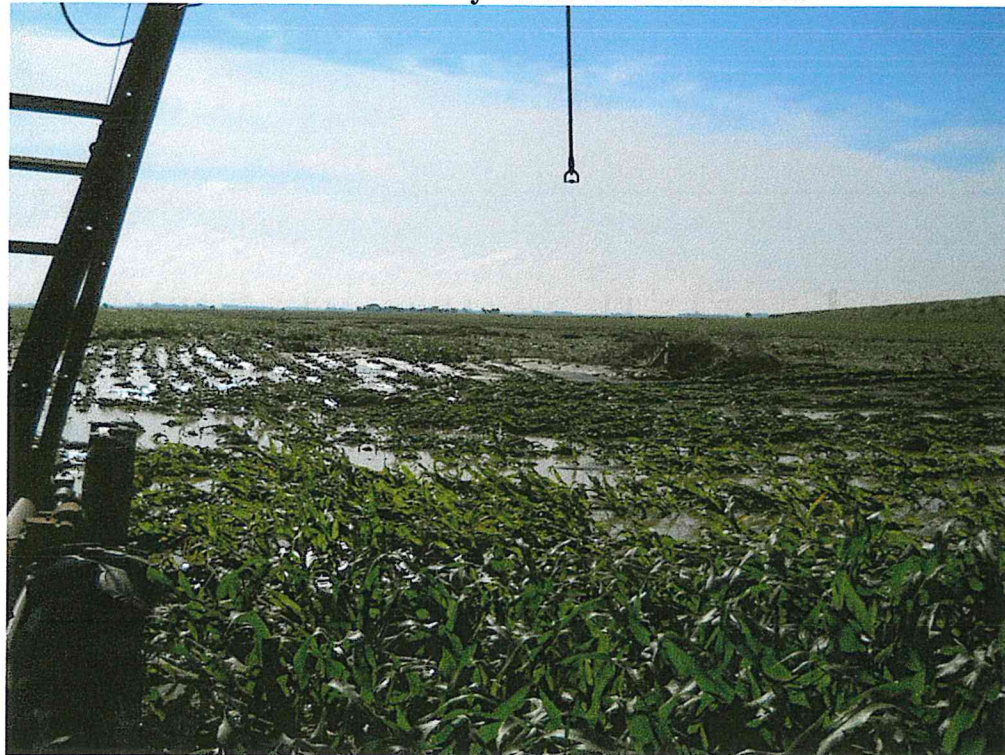
#5 - 6.15.2014 – Farmland directly north of breached area

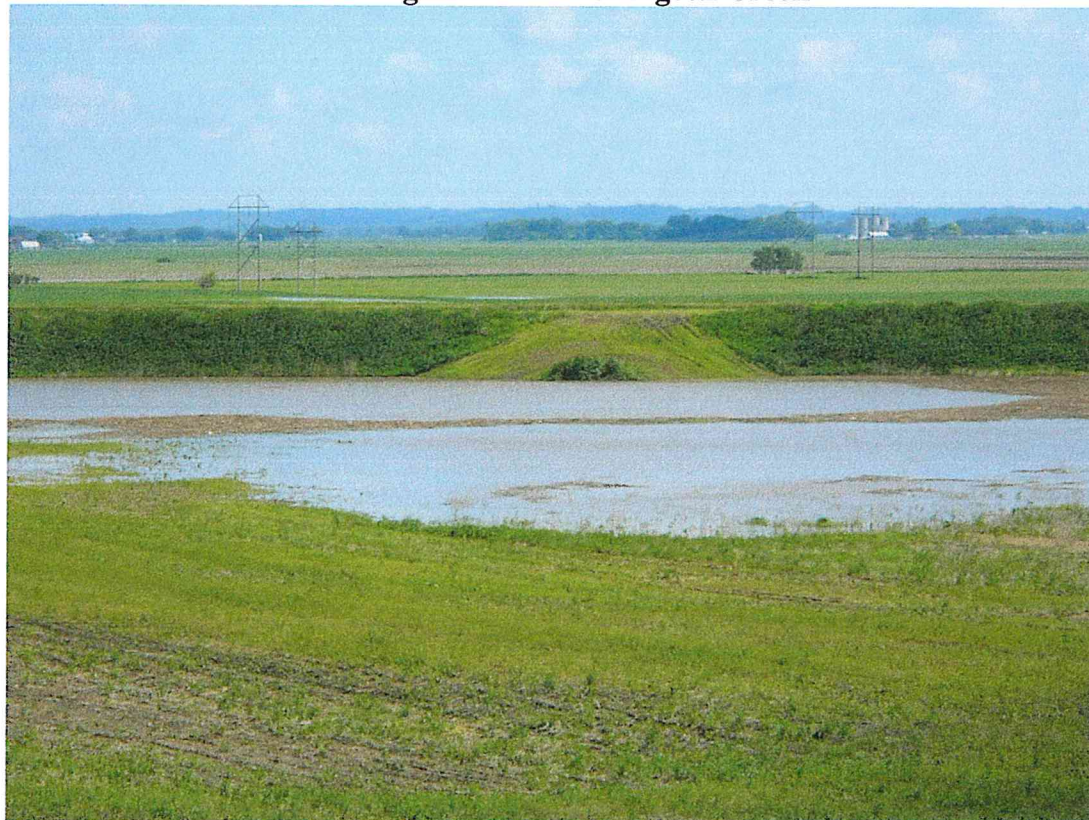
#6 - 6.15.2014 – Offline storage area south of Pigeon Creek

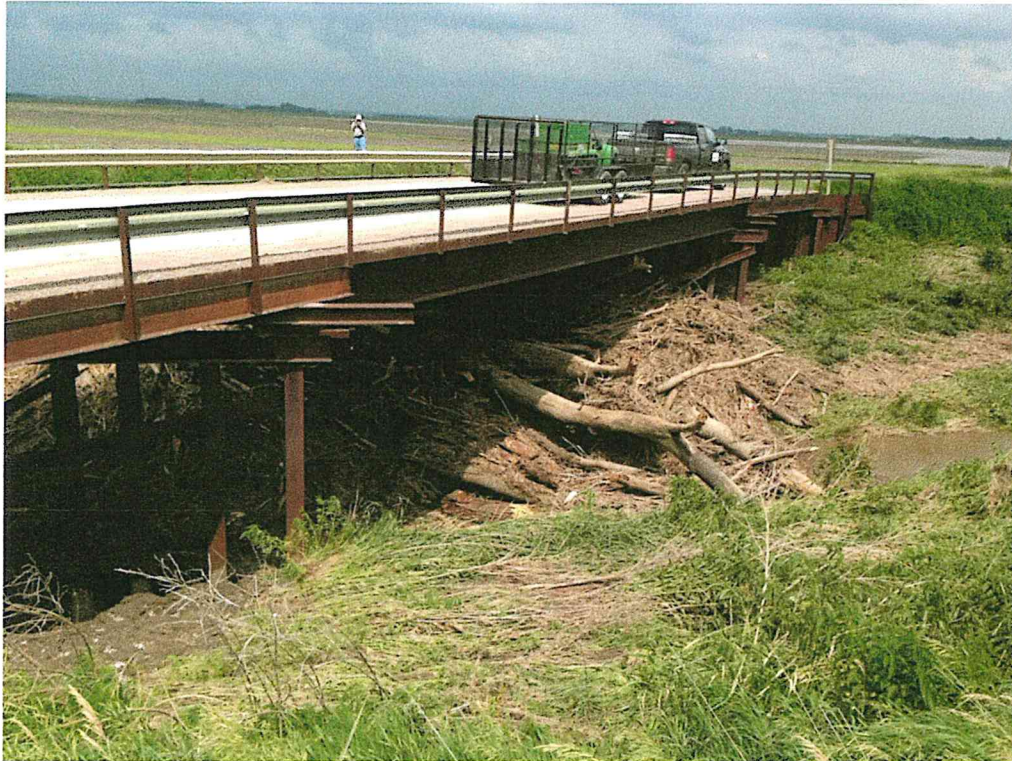
#7 – 6.16.2014 – Debris at 200th Street Bridge

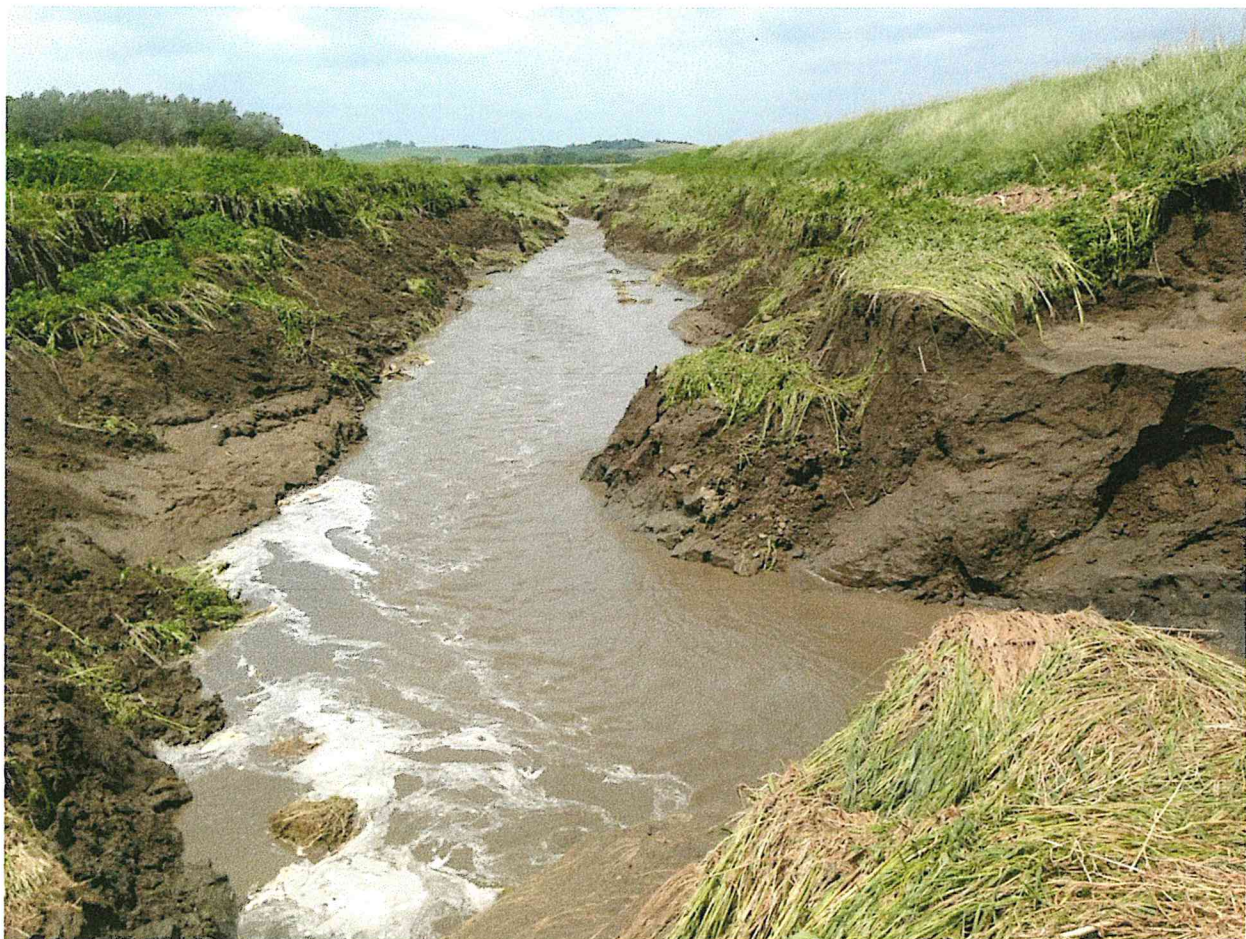
At 7:30 am on June 17, 2014, District staff Lowell Roeber and Lance Olerich inspected the Pigeon Creek Levee and identified that the area of the breach had eroded further and that 100% of the water from the creek was flowing into the adjacent farm ground. (*see pictures 8 and 9*) District Management was notified immediately. Two local contractors were called immediately to begin emergency repair work. Leeber Construction, who was performing work for the District at Kramper Lake, mobilized an excavator and dozer to the levee to begin repairs. Oban Construction, who had also performed work for the District in the past, mobilized a long reach excavator and regular excavator to the 200th Street Bridge to remove debris from the creek channel. (*see picture 10*)

#8 – 6.17.2014 – Area of breach looking upstream

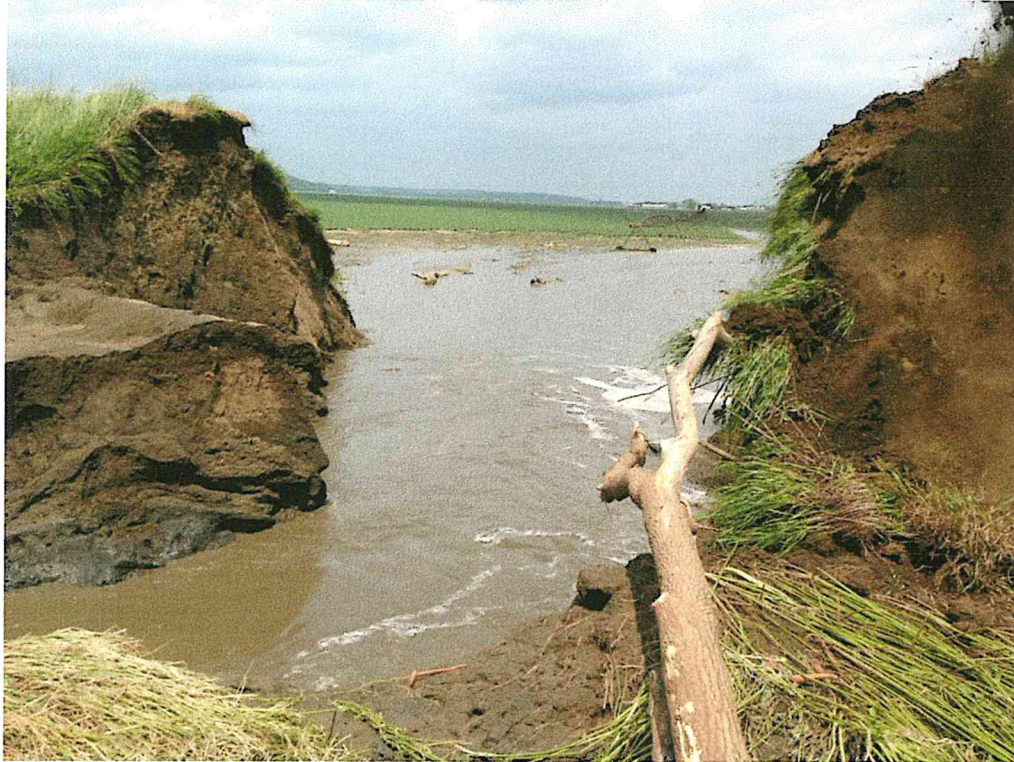
#9 – 6.17.2014 – Area of breach looking north

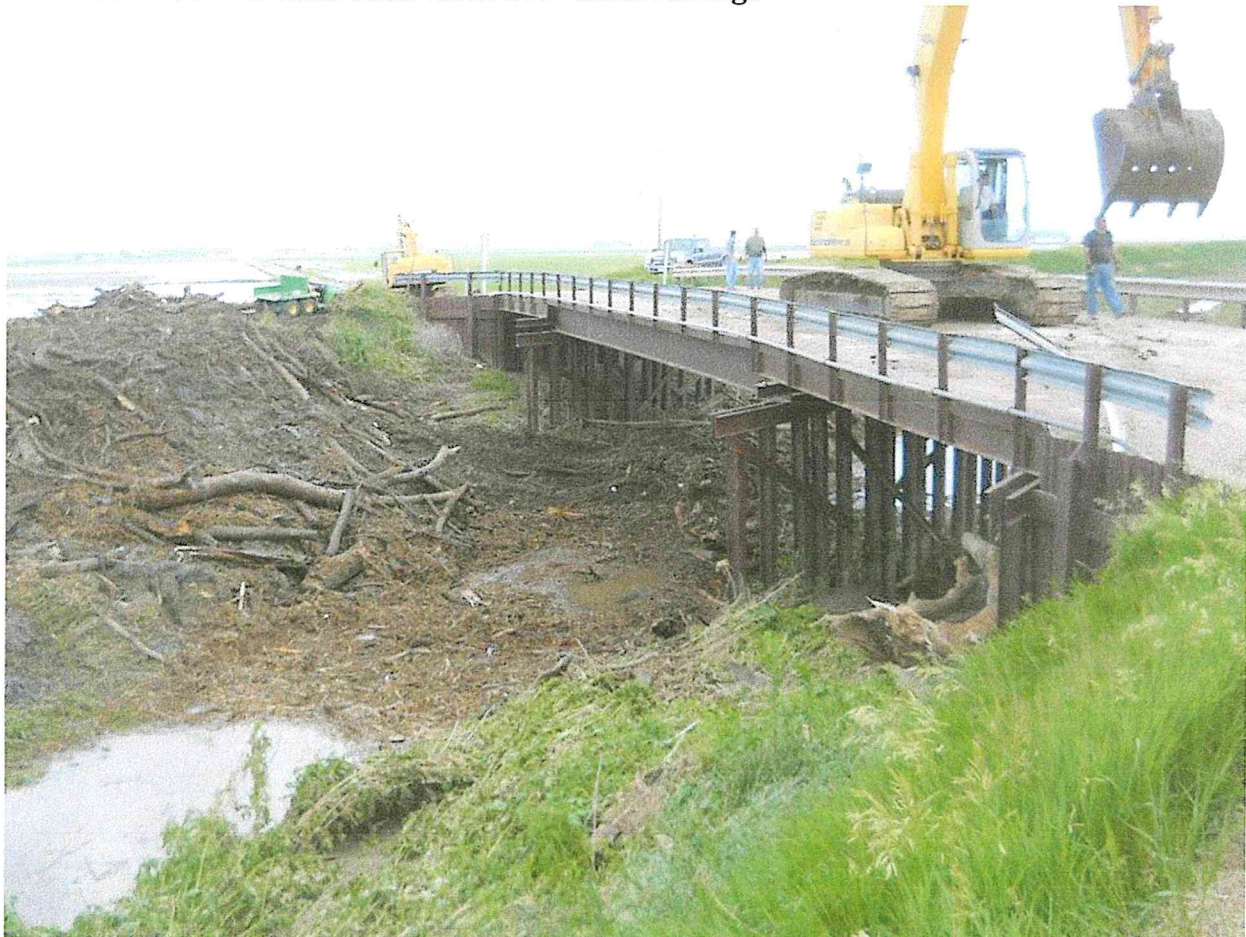
#10 - 6.17.2014 – Debris removal at 200th Street Bridge

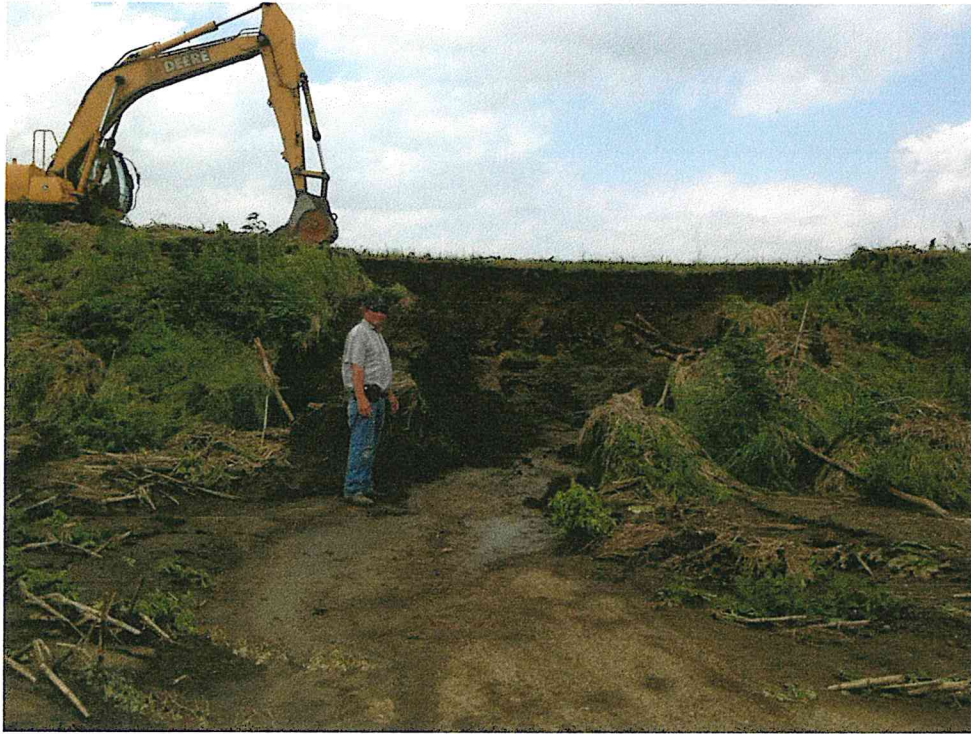
11 – 6.17.2016 – Existing erosion before relief outlet was cut into left (south) bank

At 2:30 pm, Marlin Petermann and Chuck Leinen with the NRCS arrived onsite to inspect the repairs. At that time it was determined to cut a relief outlet on the right bank of the levee, which would allow water to flow into the offline water storage area on the south side of the levee during a high water event. Staff surveyed the levee and determined that an area $\frac{1}{4}$ of a mile downstream of the South Bluff Road Bridge on the right bank of the levee was the best location to cut a relief outlet. The area of the levee that was chosen to cut the relief outlet had experienced significant erosion on the back slope as a result of water overtopping it during the last high water event. Oban Construction was instructed to mobilize a third excavator onsite to open the relief outlet. The relief opening was cut 50 feet wide at an elevation roughly

three feet above the normal water line. This would allow for normal water levels to continue to flow in the creek channel, but flow into the offline storage area during a high water event. *(see picture 11)*

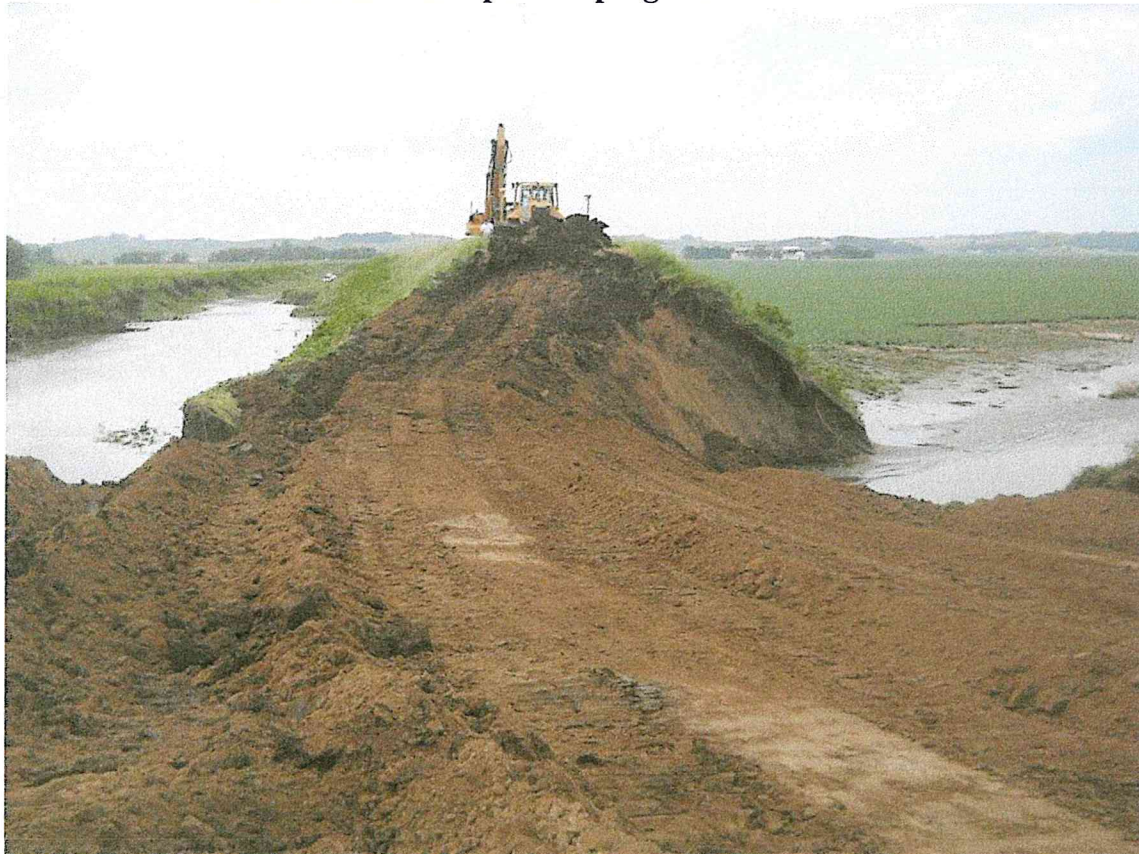
#12 – 6.17.2014 – Breached area repairs in progress

At 6:00 pm Leeber finished moving dirt at the area on the left bank where the breach had occurred. The repair work left the levee elevation approx. four feet lower than the right bank. *(see pictures 12 and 13)* At the same time, Oban had completed the excavation of the relief opening on the left bank and had removed most of the large debris from under the 200th Street Bridge, allowing for normal creek flow.

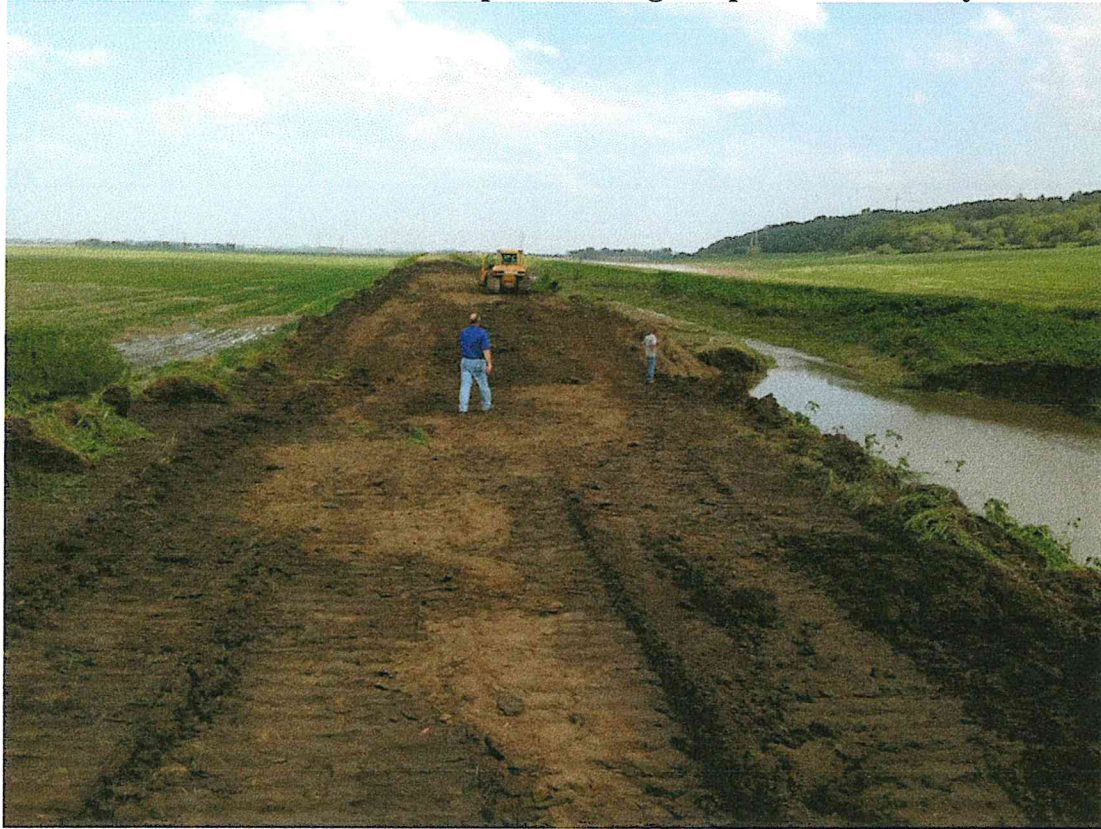
#13 – 6.17.2014 – Breached area repairs nearing completion for the day

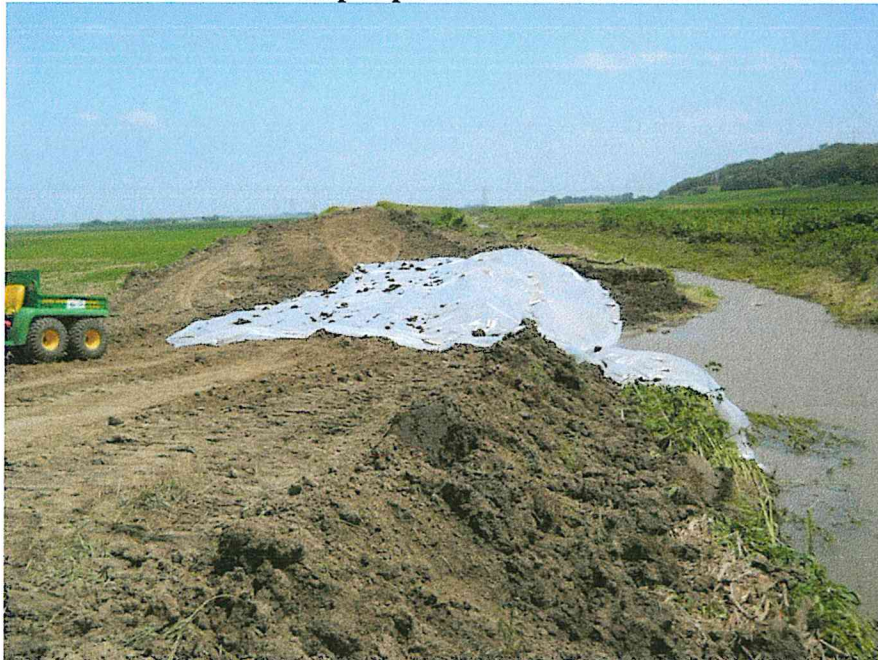
#14 - 6.19.2014 – Crews put plastic over breached area to reduce rainfall erosion

On 6.19.2014 District staff placed a plastic liner on the channel face of the breached area in an attempt to reduce erosion caused from rainfall runoff. *(See picture 14)*

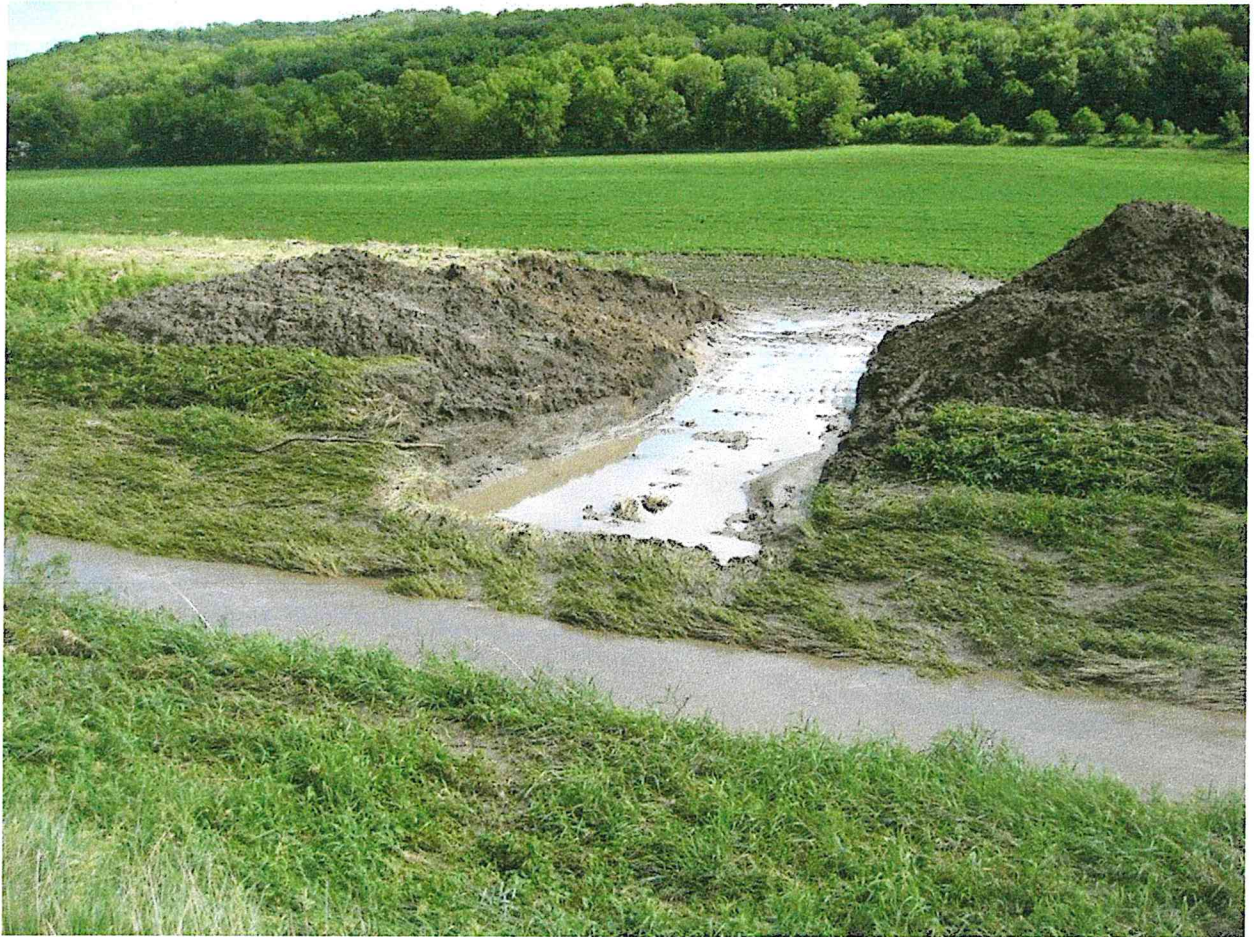
At 9:00 am on 6.22.2014 Lance Olerich and Lowell Roeber inspected the Pigeon Creek Levee following a rain event that resulted in 1"-2" of rainfall in the surrounding area. They confirmed that the repaired breach area on the left bank was not damaged and that water had flowed thru the relief outlet that was excavated on the right bank. *(See picture 15)*

#15 – 6.22.2014 – View of relief opening in south bank following a 2” rainfall

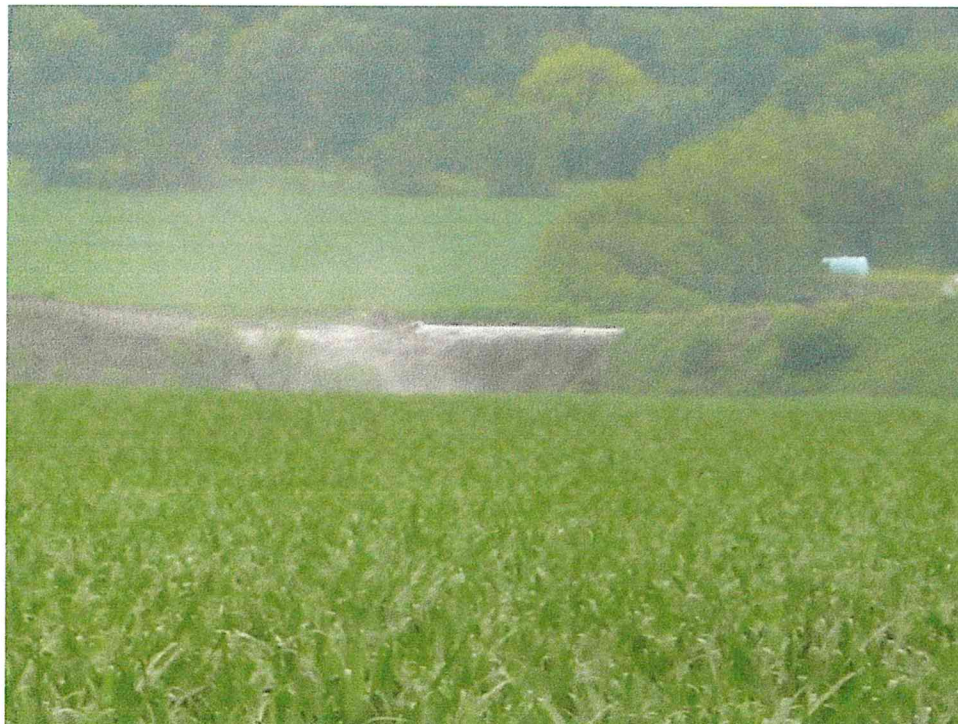
At 7:30 am on 6.30.2014 District staff inspected the levee following 1-2" of rainfall in the area. Water was flowing into the offline storage area and the repaired breach area was intact. The same observation was made at 11:00 am that morning. Over the noon hour, the area received 2-3" of rainfall. Water levels in the creek rose quickly. Water flowed into the offline storage area; however it began to overtop the repaired breach area. By 3:00 pm, the repaired breach area had completely eroded and 100% of water was flowing into the farmland to the north. District management was notified immediately. *(See picture 16)*

#16 6.30.2014 – View of creek overtopping breached area

On 7.1.2014, Zach Nelson, Lance Olerich, Lowell Roeber, and NRCS Engineer, Chuck Leinen, inspected the area to assess the damage. It was determined that creek flow would need to be diverted 100% into the offline storage area and back into the creek channel downstream, which would allow the breached area to dry out. A temporary dam would be built across the creek channel near the outlet into the offline storage area, which would divert creek flow. Downstream of the breached area, there are two 48" dia culverts that allow water to drain from the offline storage area back into the creek channel. In order to accommodate the increased amount of water flowing into the offline storage area, a 25' wide outlet would be cut into the levee to allow for water to drain more rapidly.
