PAPIO-MISSOURI RIVER
NATURAL
RESOURCES
DISTRICT

Memorandum

Subject: Flood Emergency Activities on the Platte, Elkhorn and Missouri Rivers
March 2010

Date: April 5, 2010

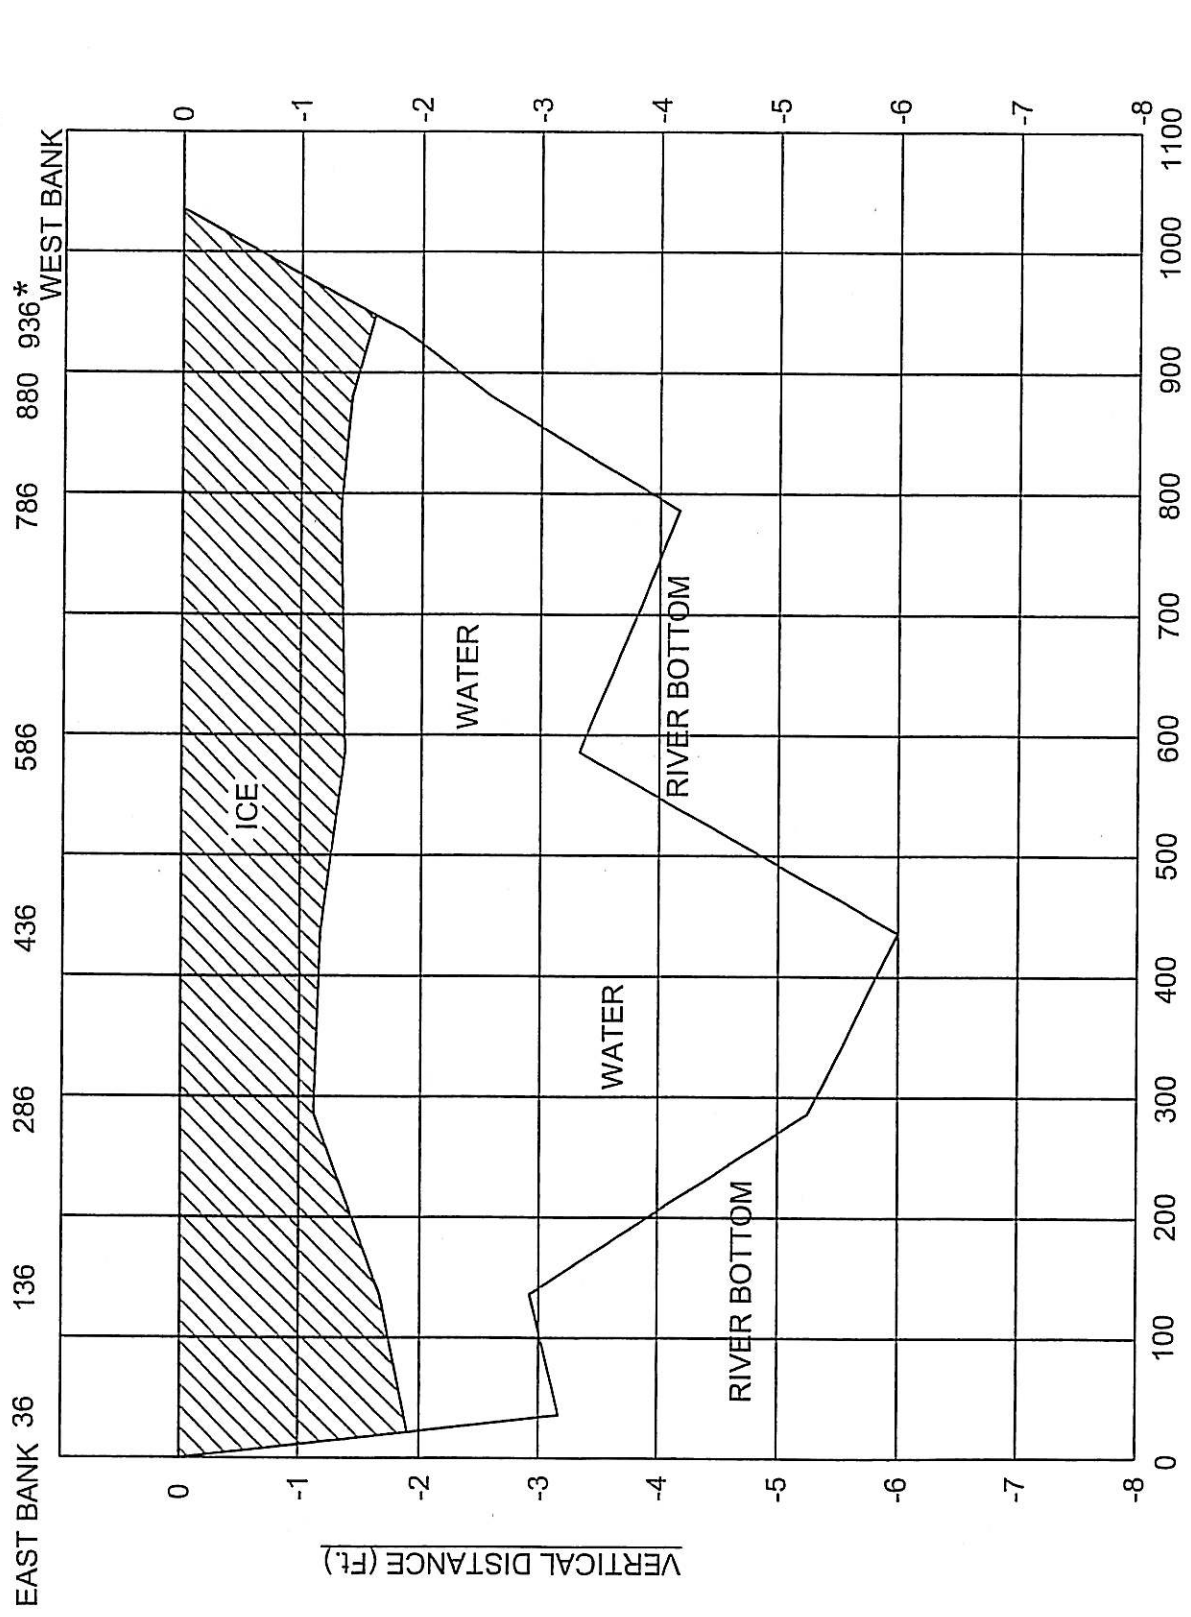
PLATTE RIVER: 1.2 Miles Upstream of Hwy. 64 (STA. 160+00, UNION DIKE)

On March 3, 2010, the writer performed ice thickness measurements on the Platte River. The measurements were taken perpendicular to the river flow, near the Dike's 10 jetties project location, near Werner's Property south line, at approximately Station 160+00 (1.2 miles upstream of Highway 64).

A gas powered auger was used to drill the holes. The location of the holes on the table below were measured (stepped off) from the east bank of the Platte River. There was 3 inches deep snow cover on river ice.

Distance From East Bank (Feet)	Ice Thickness (Inches)	Depth From Top of Ice to River Bed (Inches)
36	22.5	38
136	20.5	35
286	13.5	63
436	14.0	72
586	16.5	40
786	16.0	50
880**	17.0	31
936*	19.0	22

The average ice thickness is **17.4 inches**.

*This hole is located about 75 feet from the west bank of the river.

** The ice thickness at this boring centered in the 60 ft. ice dusting strip has not changed since the river was dusted on February 18th. However, there is evidence that the dusting is helping, as it did melt the 3 inches or so of snow cover on the ice and looks like it is starting to melt into the ice now. Photos were taken.

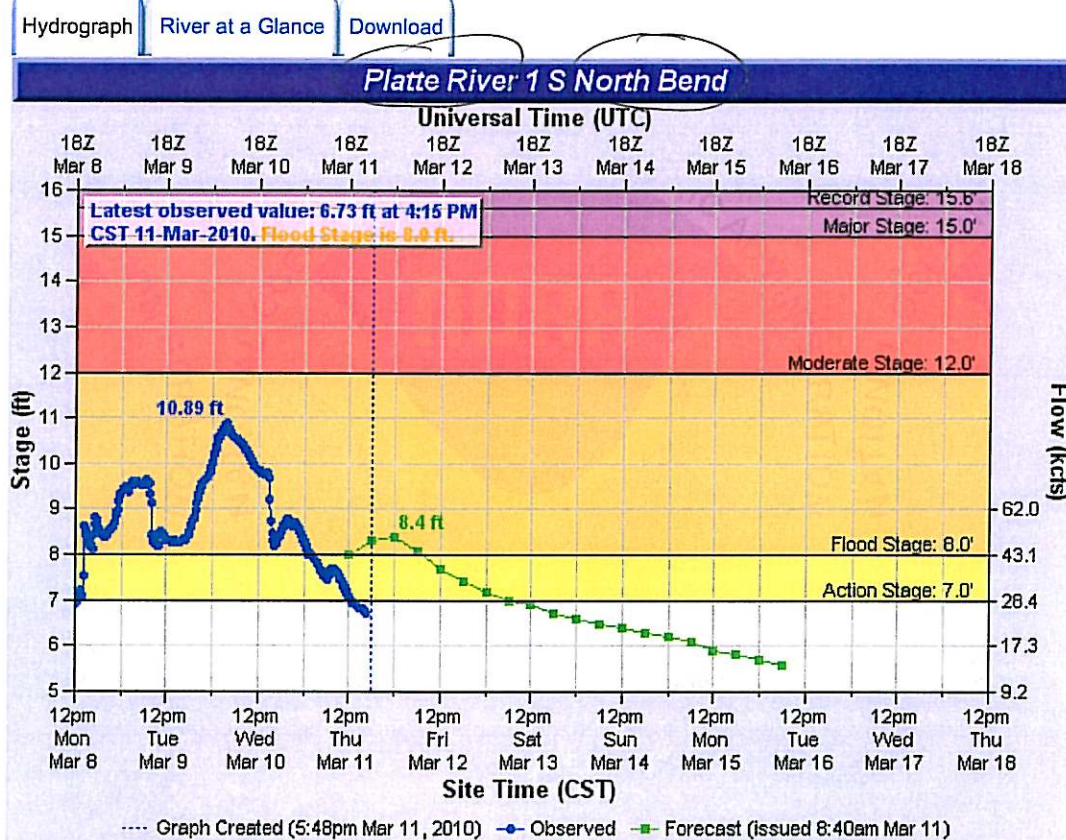
NBDN1 (plotting HGIRG) "Gage 0" Datum: 1262.32'

[Metadata](#)**NOTE: Gauge reading may be affected by ice.****Default Hydrograph**

Major Flood Stage: 15
 Moderate Flood Stage: 12
 Flood Stage: 8
 Action Stage: 7

(1) 15.55 ft on 03/19/1978
 (2) 12.24 ft on 02/20/1971
 (3) 10.97 ft on 03/08/1993

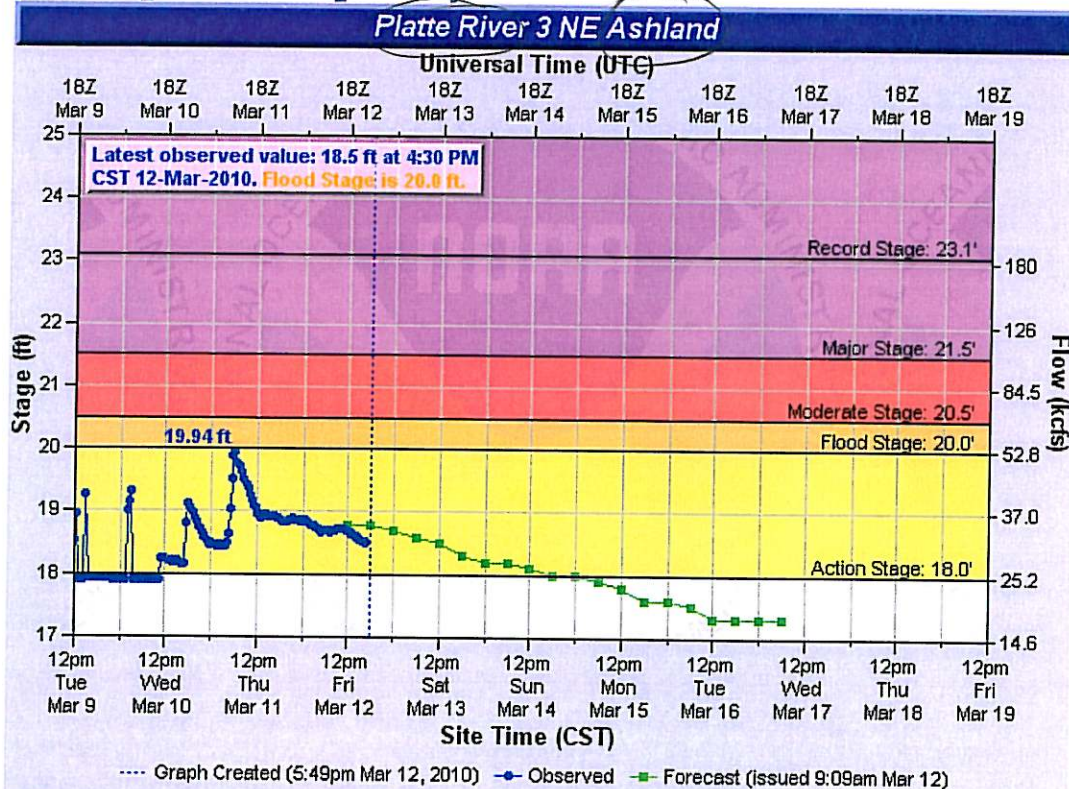
ASLN1 (plotting HGIRG) "Gage 0" Datum: 1040.00'

[Metadata](#)**NOTE: Gauge reading may be affected by ice.**

Major Flood Stage: 21.5
 Moderate Flood Stage: 20.5
 Flood Stage: 20
 Action Stage: 18

(1) 23.05 ft on 02/20/1997
 (2) 21.45 ft on 07/25/1993
 (3) 21.39 ft on 03/15/2001

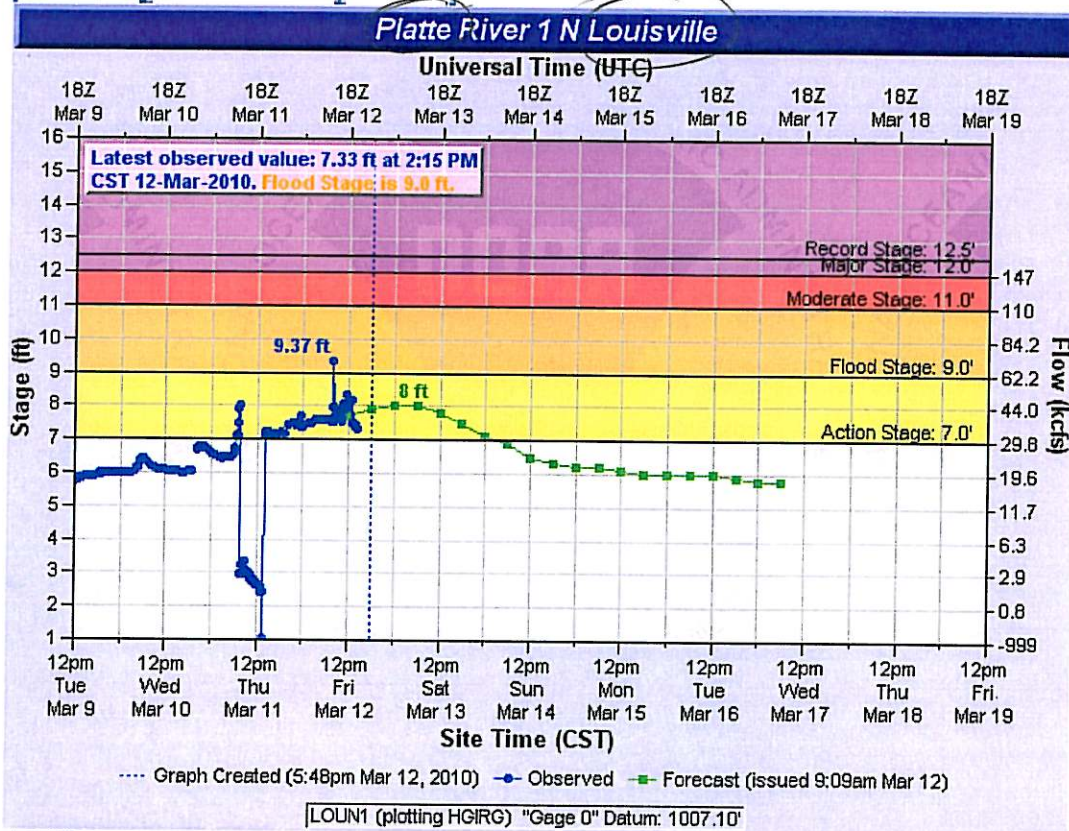
[Metadata](#)**NOTE: Gauge reading may be affected by ice.**

NOTE: Forecasts for the Platte River near
Louisville are issued as needed during times of
high water, but are not routinely available.

Major Flood Stage: 12
 Moderate Flood Stage: 11
 Flood Stage: 9
 Action Stage: 7

(1) 12.45 ft on 03/30/1960
 (2) 11.90 ft on 07/25/1993
 (3) 11.47 ft on 03/10/1993

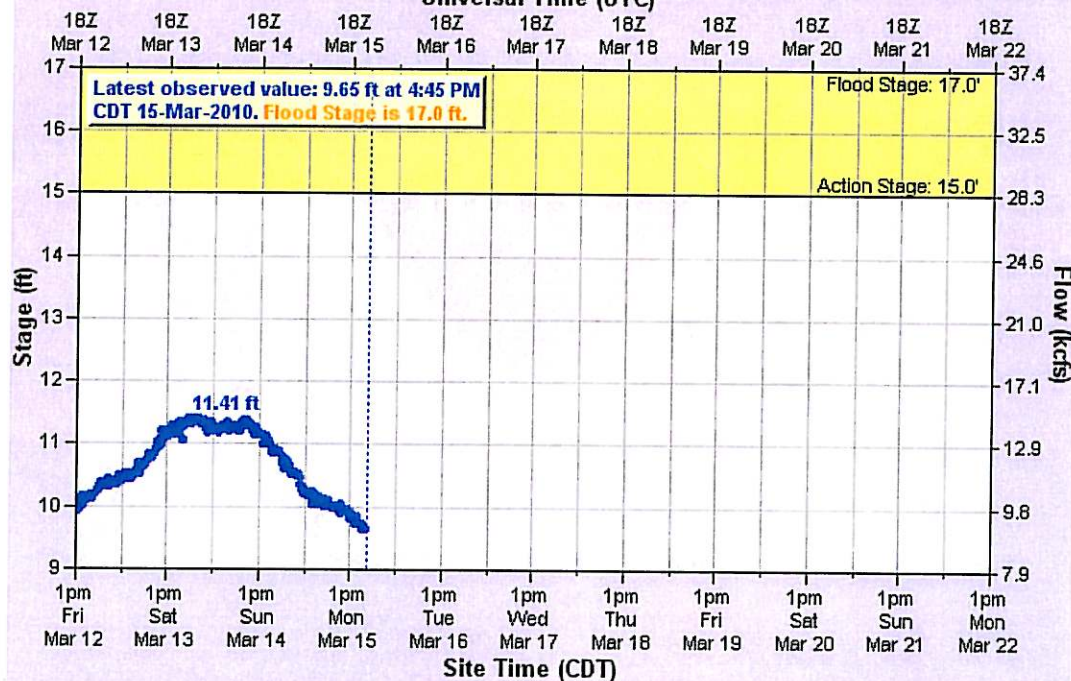
Elkhorn River AT Waterloo

WTRN1 (plotting HGIRG) "Gage 0" Datum: 1104.73'

NOTE: Gauge reading may be affected by ice.

Major Flood Stage:	21
Moderate Flood Stage:	18
Flood Stage:	17
Action Stage:	15

(1) 19.12 ft on 03/29/1962
(2) 19.11 ft on 04/02/1960
(3) 18.22 ft on 02/22/1971
(4) 18.12 ft on 06/18/1984
(5) 17.80 ft on 06/16/1967

Although ice free, stages on the Elkhorn River continued to rise as upstream snowmelt progressed through the system. At approximately 2:00 pm on the 12th, floodwaters started entering the District's Elkhorn Crossing Recreation Area south of Hwy 36. The Waterloo gauge at Hwy 64 was reading approximately 10.2 feet at that time. The river peaked at 11.4 feet on the

13th, but did not recede until the 15th. Elkhorn Crossing was not severely flooded but all of the District's Platte and Elkhorn River public access locations were flooded and will require some cleanup.

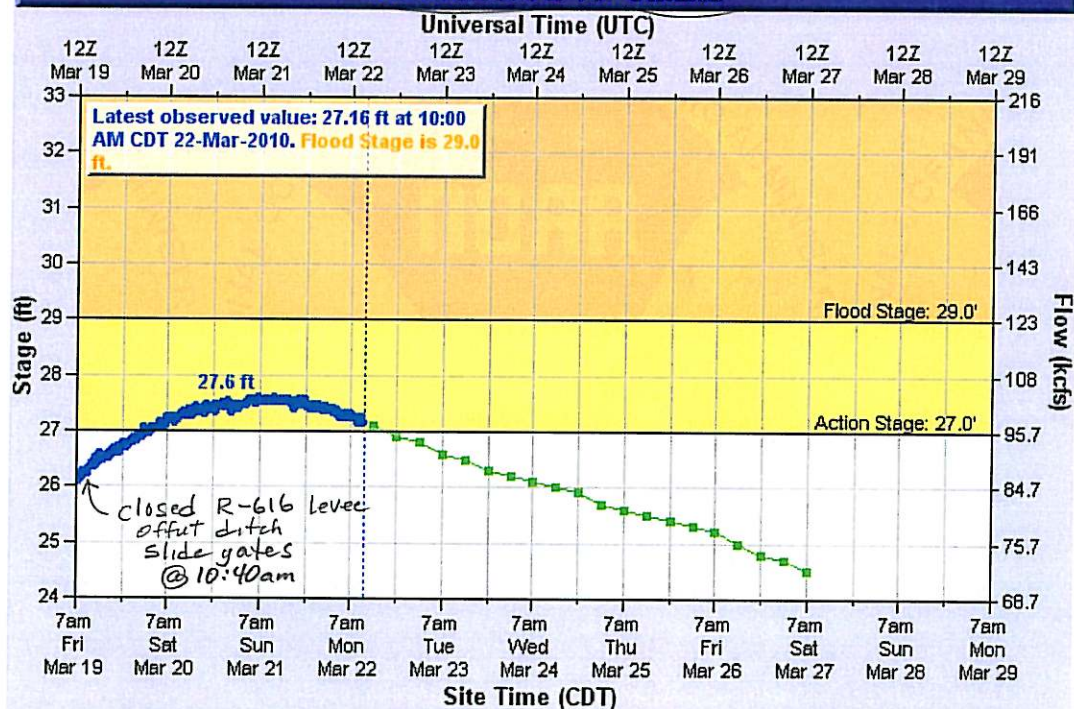
Missouri River AT Omaha

OMHN1 (plotting HGIRG) "Gage 0" Datum: 948.24'

NOTE: Gauge reading may be affected by ice.

[Return to Area Map](#)[← Upstream Gauge](#)[Downstream Gauge →](#)**Flood Categories (in feet)**
 Major Flood Stage: 40
 Moderate Flood Stage: 35
 Flood Stage: 29
 Action Stage: 27
Historical Crests
 (1) 0 ft on 04/01/1960
 (2) 40.20 ft on 04/18/1952
 (3) 36.65 ft on 04/25/1881

Due to extremely high snowfall amounts in Northwest Iowa and the Dakota's, high water from the tributary rivers downstream of Gavin's Point Dam, including the Platte River caused the Missouri River to rise to very near flood stage at Omaha and well above it at Nebraska City and other areas downstream of the Platte River confluence (see attached graphs). As a result there was flooding in some low spots in the Omaha area and along the District's R-616 and 613 Missouri River levees downstream of Bellevue. The District did close a couple of slide gates, including the one at the Offutt Ditch to help reduce the possibility of flooding Offutt Air Force Base, roads, agricultural ground, commercial buildings and the Paradise Lakes housing area that are all protected by the levee. The slide gates were closed at 10:40 am on 3-19-10 when the riverside staff reading was 5.6 feet and the landside staff reading was 2.0 feet. The Missouri River peaked sometime on the 21st when staff gage readings at 3:30 pm were 7.0 on the riverside of the levee and 1.6 on the landside of the levee. The slide gates were open at 11:00 am on 3-29-10 when the riverside read 2.75 feet and the landside staff read 1.45 feet. No flooding occurred landward of the levees that we are aware of.

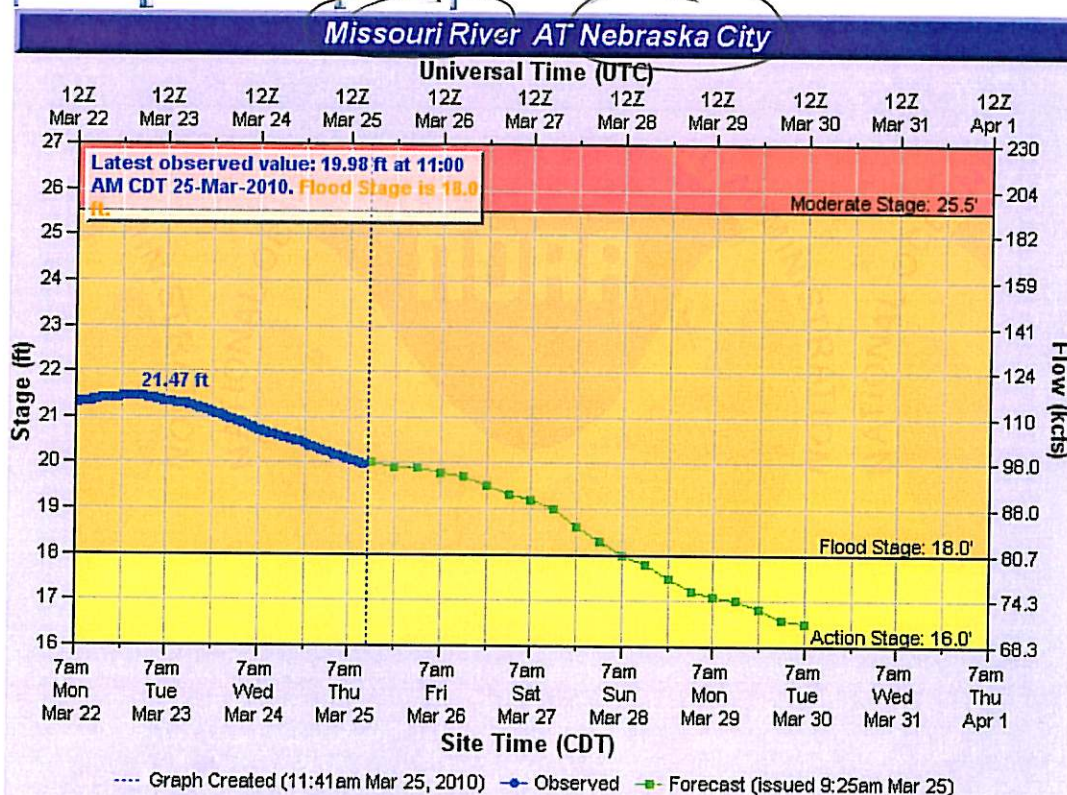
NEBN1 (plotting HGIRG) "Gage 0" Datum: 905.36'

NOTE: Forecasts for the Missouri River at Nebraska City are issued routinely year-round.

Flood Categories (in feet)
 Major Flood Stage: 29.6
 Moderate Flood Stage: 25.5
 Flood Stage: 18
 Action Stage: 16
