Memorandum

SUBJECT: Papillion Creek Watershed Structure W-2 Repair Project Design Services Contract

**PRELIMINARY
GEOTECHNICAL EVALUATION
OF PIPE DISTRESS AND
FOUNDATION SEEPAGE**

**PAPILLION CREEK
WATERSHED STRUCTURE W-2**

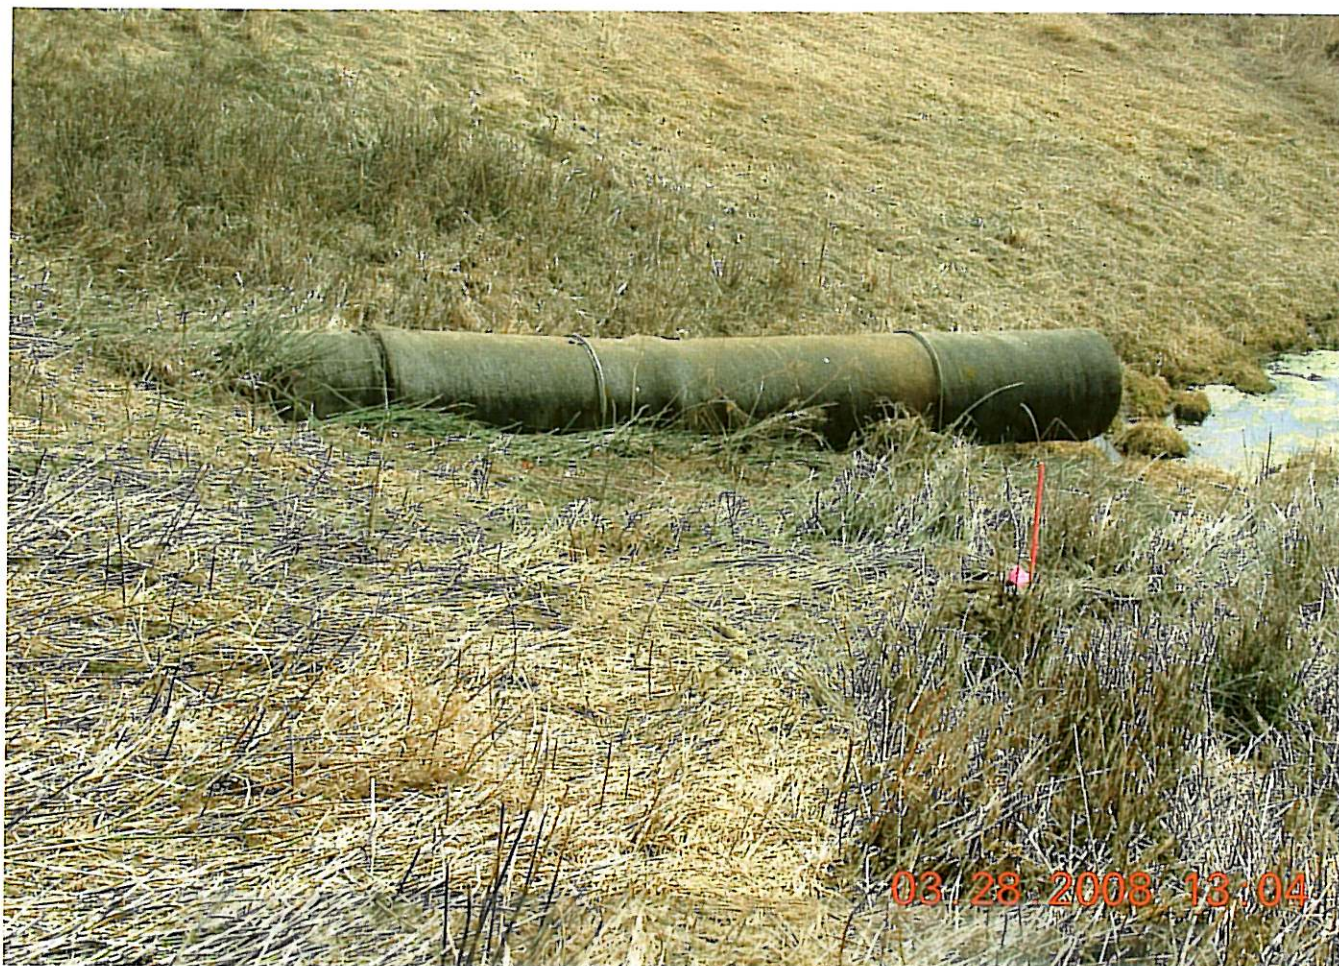
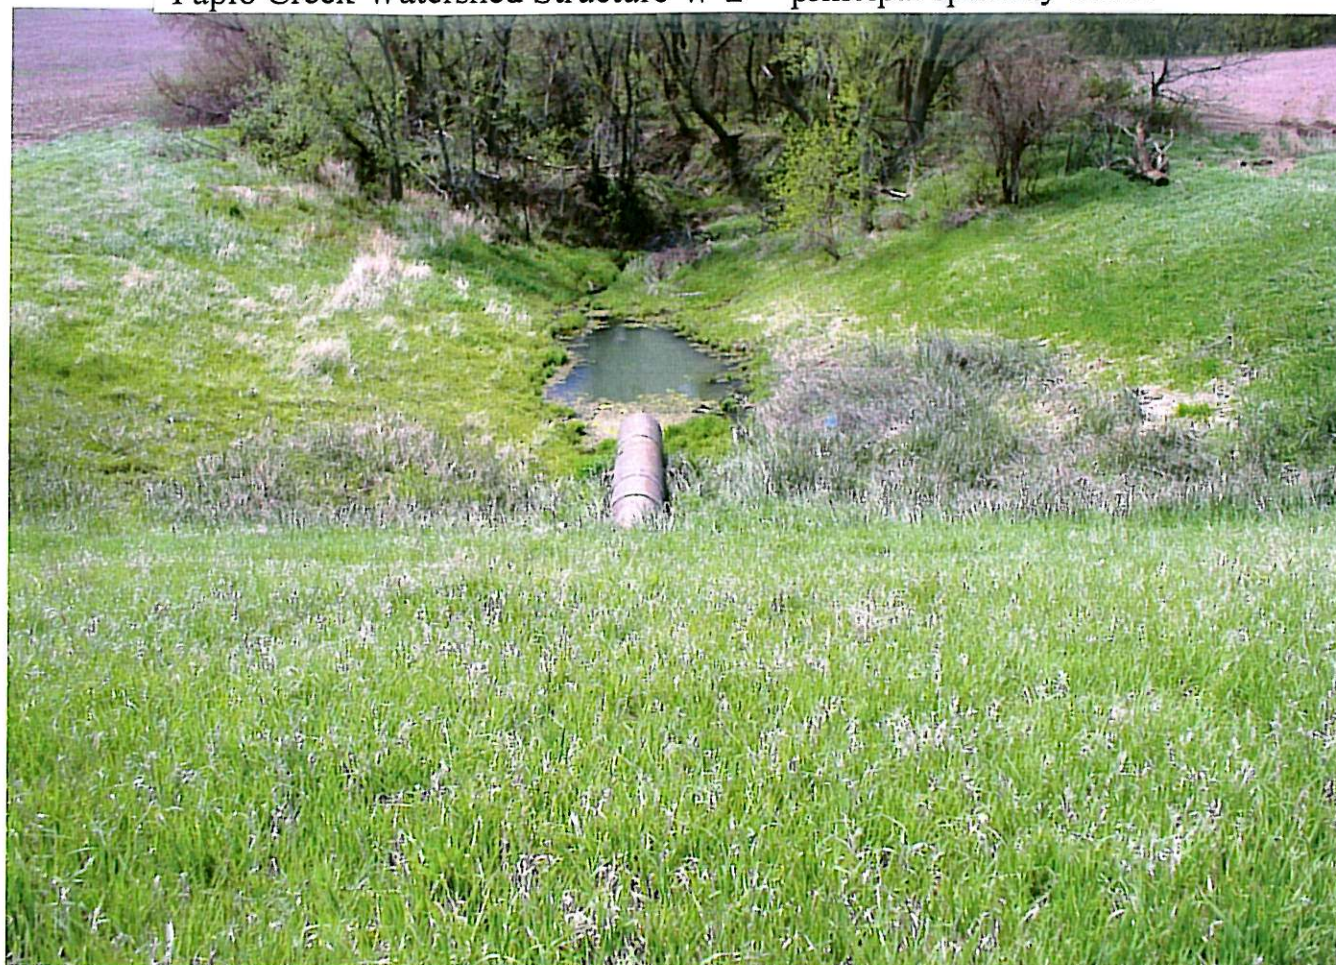
Papio Creek Watershed Structure W-2 ---principal spillway outlet

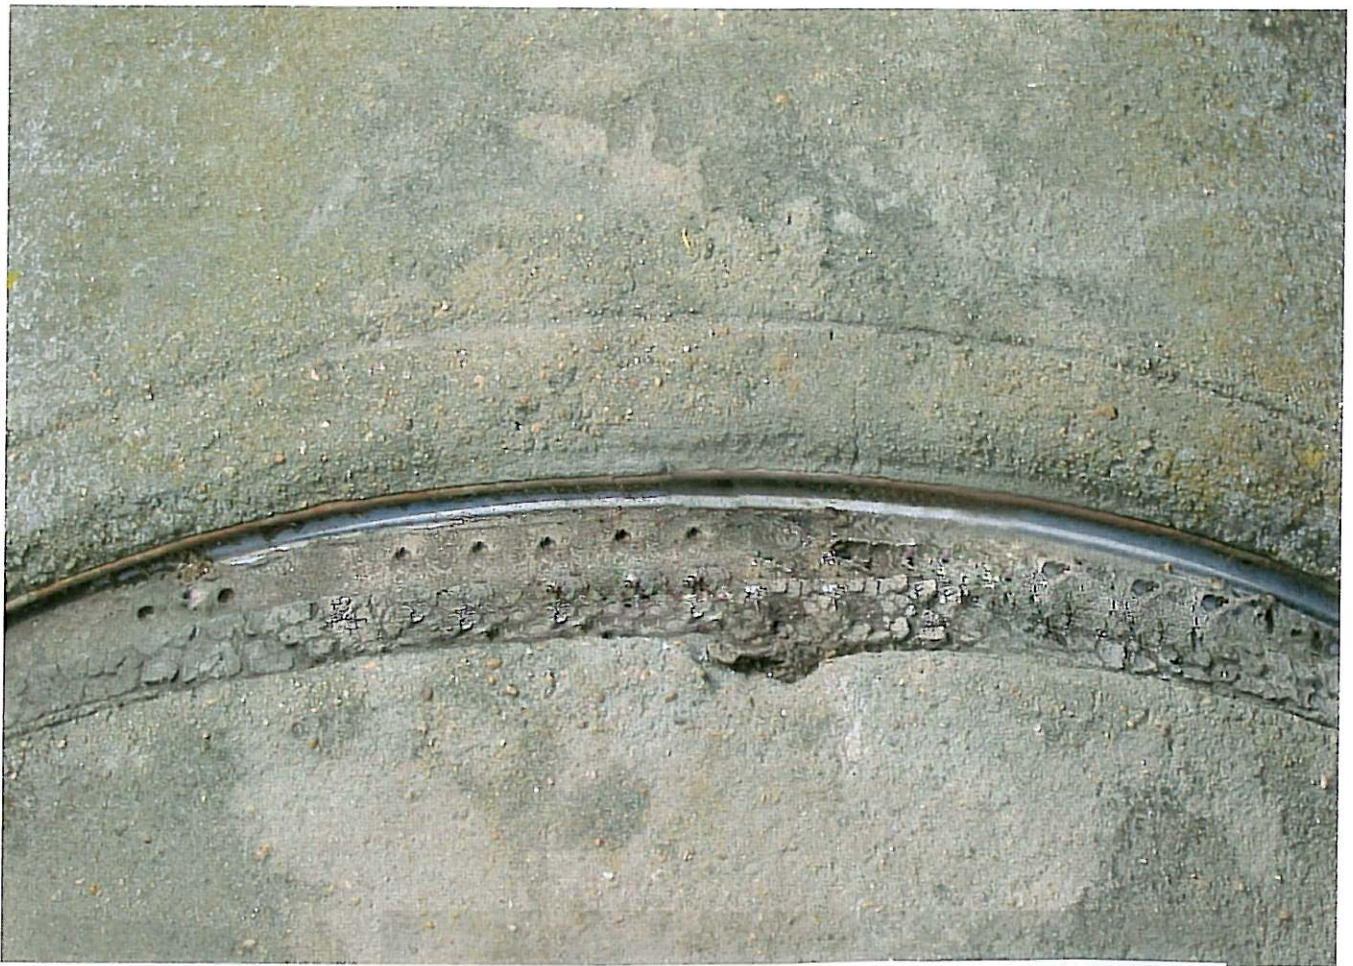
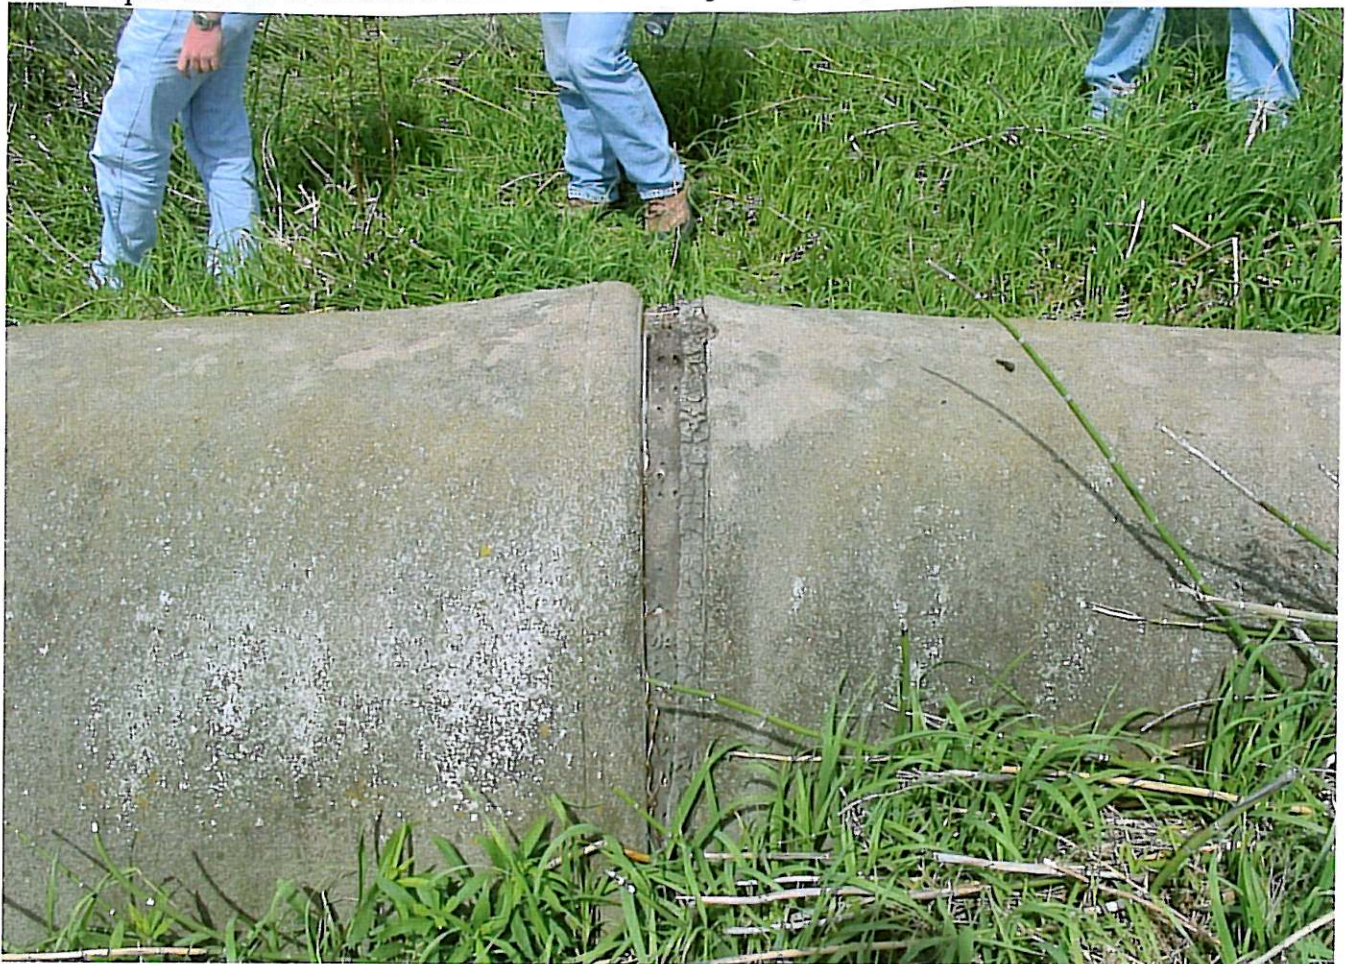
Papio Creek Watershed Structure W-2 ---principal spillway outlet pipe joint

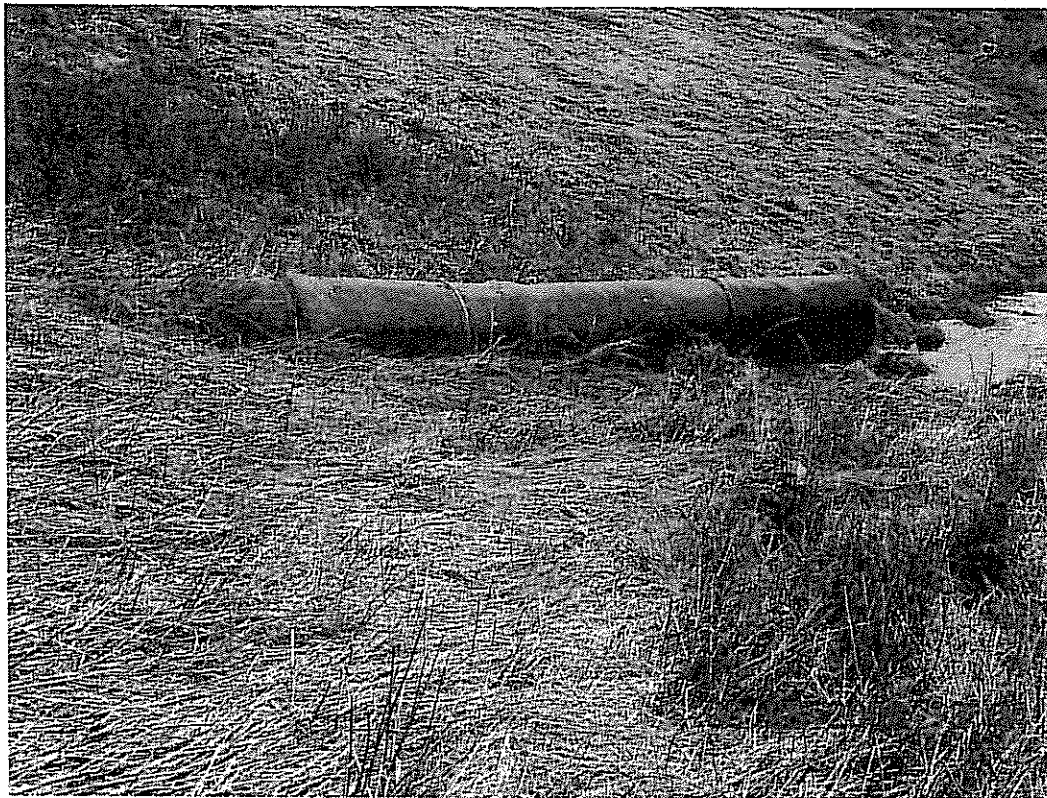
In the August 20, 2007 Nebraska Department of Natural Resources inspection report, it was noted that Joint Nos. 2, 3 and 4 were elongated. Joint No. 2 has exceeded the maximum joint elongation of the manufactured joint, Joint No. 3 has elongation of 2.2 inches, with approximately 0.5 inches of remaining water tightness and Joint No. 4 has elongation of 2.2 inches, with approximately 0.5 inches of remaining water tightness. These joints were measured and recorded over a year ago and with the extreme amounts of rainfall in 2008, there is reason to assume additional rotation and elongation of the joints may occur. NRCS TR-60 requires a margin of safety of not less than 0.5 inches. Joints No. 3 and No. 4 are at their extreme limits and it would be prudent to repair these at this time.

It appears from the survey data of the joints and our visual observation of the pipe segments that the observed distress has resulted from either (1) a bearing failure of the downstream pipe support, or (2) settlement of the foundation soils from the weight of the embankment fill. Both of these scenarios are considered plausible as an explanation of the downward movement of the downstream section of pipe.

View of Pipe Distress in Principal Spillway

- The interior of the entire existing principal spillway should be inspected with a camera to verify its integrity prior to the development of the final recommendations for the pipe.

- The exterior of the exposed portion of the principal spillway should be inspected at the time of excavation of the new outlet drain.
- The scope of the geotechnical investigation completed for this study is considered adequate to properly characterize the subsurface conditions at the site and that no additional borings, CPT's or lab work are needed to complete the evaluation.

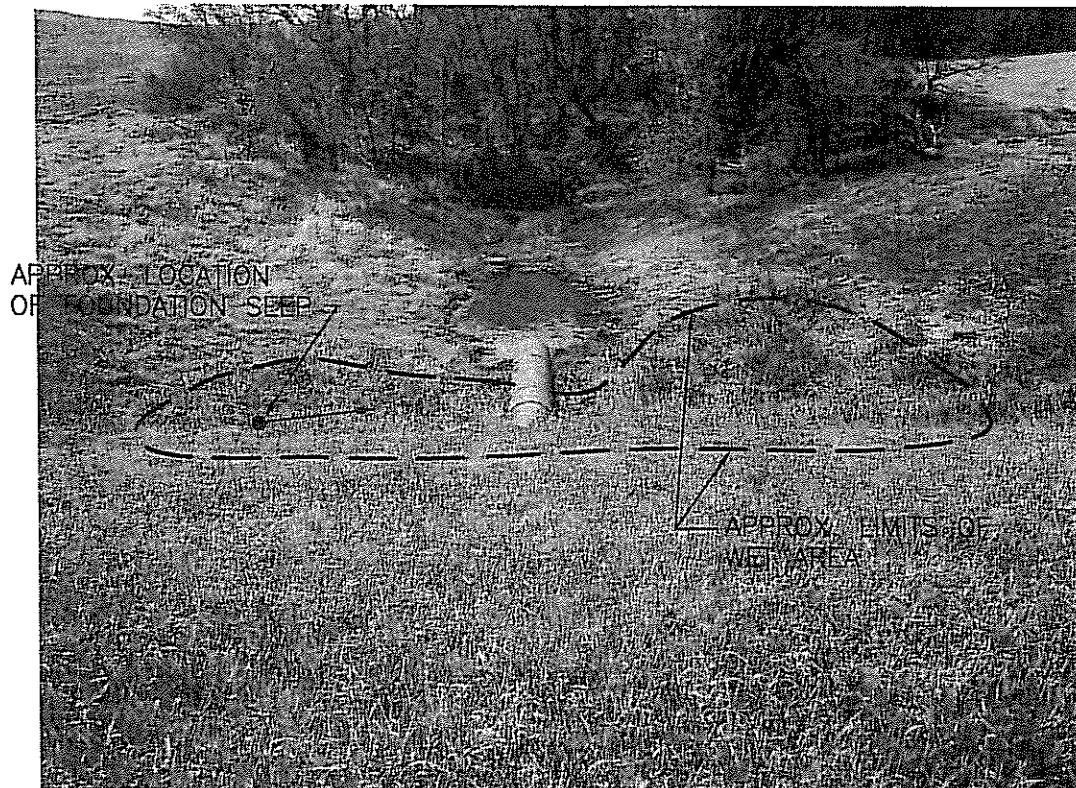
The presence of wet ground conditions that was noted in past inspection reports was confirmed from the results of the geotechnical investigation. The wet areas are characterized by the growth of a local phreatophyte called snake grass, which is prevalent in continuous wet areas. The approximate location of the wet ground is shown on Figure 3. In addition to the wetness, an area of foundation seepage was identified and is noted on the referenced figure.

View Looking Downstream of Wet Area and Seepage

- The existing 4-inch solid pipe drain outlet should be completely removed and replaced. The installation of a new outlet drain system is recommended as a means to increase the capacity of the foundation drain system.

- A drainage blanket should be installed to provide drainage to the entire area of the observed wetness and seepage. The blanket should be a minimum of 2 feet in thickness and should drain into the proposed outlet drain and the plunge pool. The approximate limits of the proposed blanket are shown on Figure 3. The actual plan dimensions of the blanket will be determined during final design.

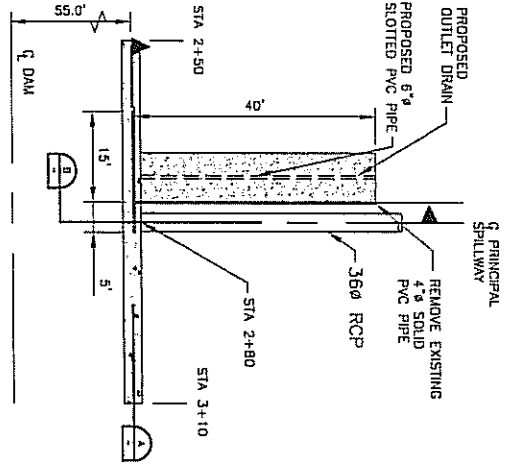
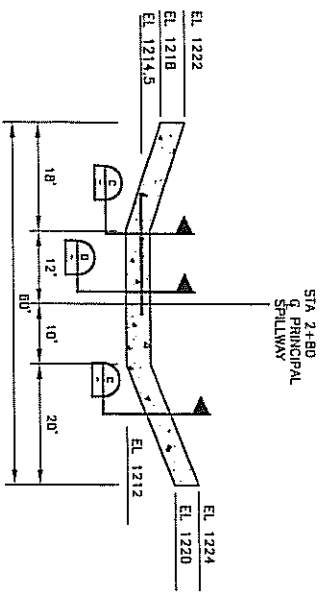
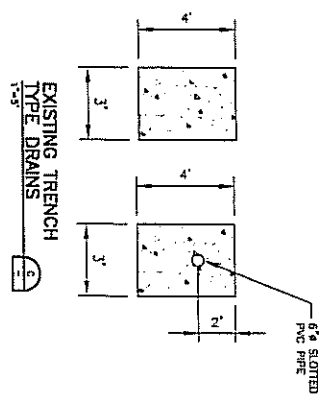
HDR	Foundation Drain System Papillion Creek Watershed Structure W-2 Washington County, NE	DATE
		May 2008
Geotechnical Assessment	FIGURE	4

Internal drainage for the dam is provided by a **foundation drain system** consisting of a trench type drain extending across the old channel and a 4-inch solid PVC outlet pipe. The existing foundation drain is 4-foot high, 3-foot wide and the drain extends about 60 feet in length along the axis of the dam. The drain material is comprised of Nebraska Department of Roads (NDOR) road gravel. A 4-inch perforated PVC collector pipe is present along the base of the trench drain which is situated at elevation 1212 feet. The outlet for the foundation drain is provided by a solid 4-inch PVC pipe with an invert elevation of 1213.95 feet. The outlet drain was not found during the site investigation. A schematic of the existing foundation drain system is presented on Figure 4.

PLAN VIEW OF
FOUNDATION DRAIN SYSTEM
1\"/>

PROFILE ALONG
EXISTING FOUNDATION DRAIN
1\"/>

PROFILE ALONG EXISTING
OUTLET SYSTEM
1\"/>

EXISTING TRENCH
TYPE DRAINS
1\"/>

- The existing perforated pipe should be inspected to verify its ability to collect and transmit seepage intercepted. The existing foundation drain should be inspected for signs of clogging at the time of excavation. The proposed perforated pipe should be spliced into the existing perforated foundation drain pipe and wrapped with a non-woven geotextile.

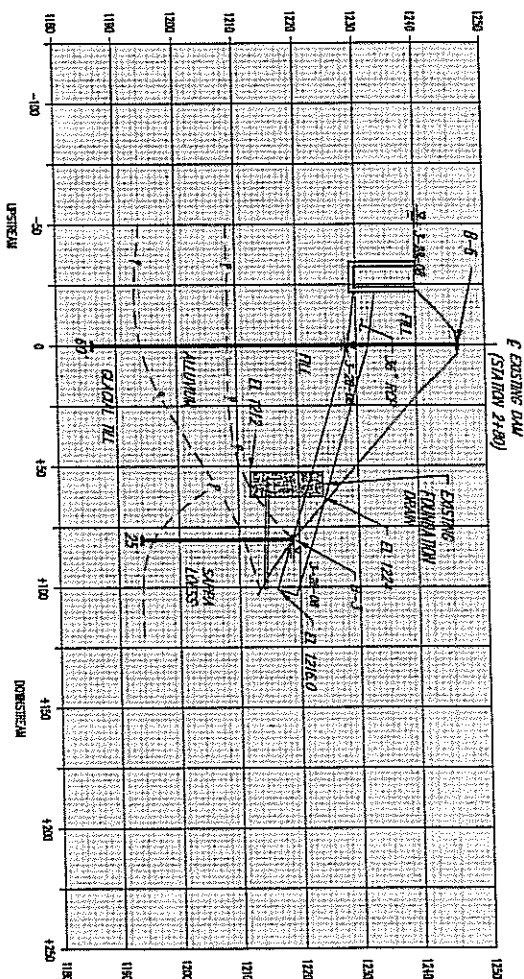
DATE	May 2008
FIGURE	5

NOTES:
1. SEE FIGURE 2 FOR LOCATION OF SECTIONS A-A' AND B-B'
2. ~~2~~ READINGS TAKEN ON MARCH 28, 2008.

**Subsurface Profile Along Downstream
Toe of Dam and Principal Spillway
Papillion Creek Watershed Structure W-2
Washington County, NE
Geotechnical Assessment**
