PAPIO-MISSOURI RIVER NATURAL RESOURCES DISTRICT

Re: District Program 17.41 Stormwater Best Management Practices Evaluation

PERFORMANCE ASSESSMENT OF TWO STORMWATER BEST MANAGEMENT PRACTICES FOR INFILTRATION, WATER QUALITY, AND VEGETATIVE GROWTH

A REPORT COMPLETED FOR THE CITY OF OMAHA, NEBRASKA

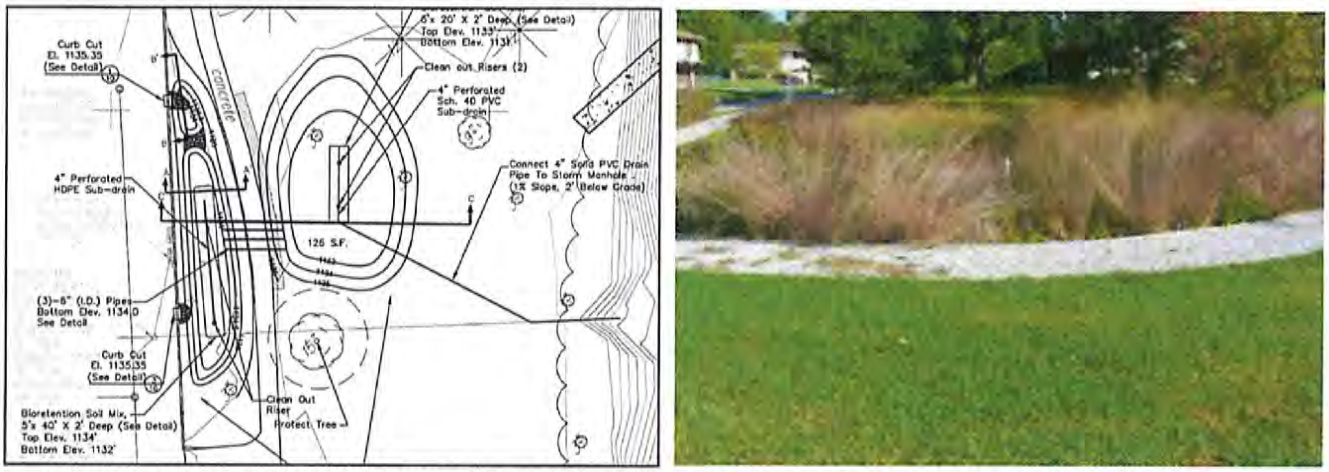
Figure 2-1: The Orchard Park Bioretention cell, with design features shown, and the primary structure showing plant growth in the third year of operation

The Orchard Park bioretention garden exhibits very good vegetative establishment and growth. In 2011, the garden was entering its third year of growth. Grasses planted in the garden including big blue stem, switch grass, Indian grass, little blue stem, bulrush, and herbaceous plants such as black-eyed susan, liatrus, monarda, and prairie cone flower, were well-established. Little blue stem on the north and west sides of the garden does not exhibit growth vigorous as grasses on the south and east sides of the garden, and grasses in the middle of the garden, within the "infiltration cell" demonstrate excellent growth and establishment.

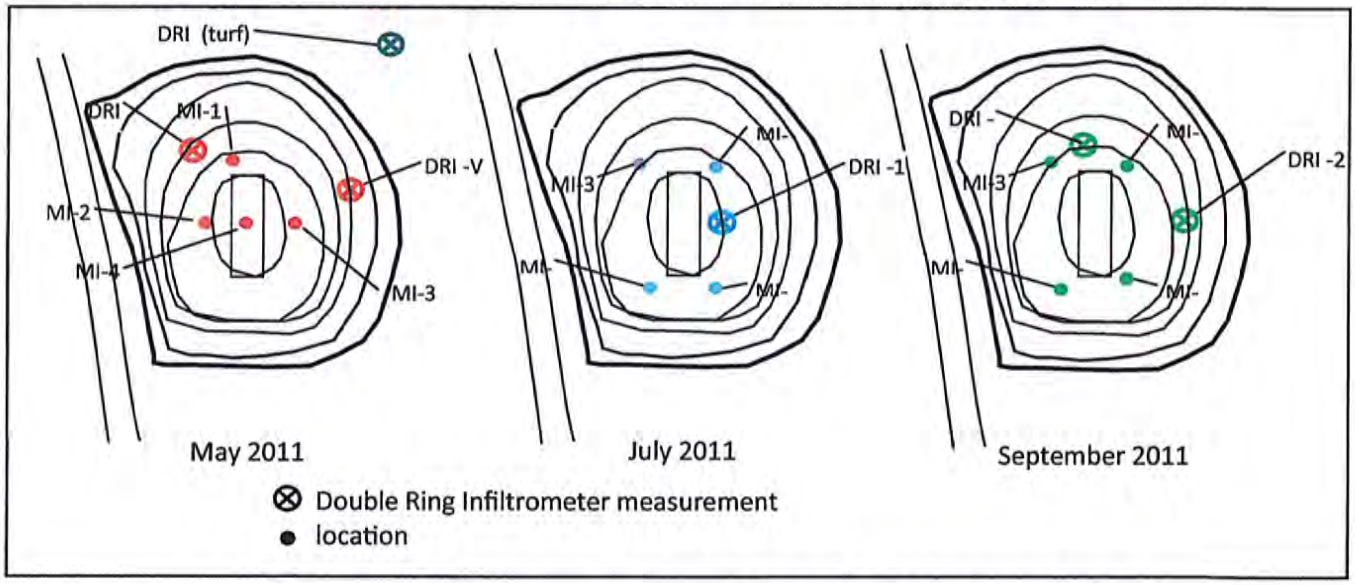
Figure 4-1: Infiltration measurement locations – Orchard Park Bioretention Garden

In general, the infiltration rates in the native soil of the Orchard Park bioretention garden ranged from 0.38 inches per hour on the north side of the infiltration cell, to 0.75 to 0.81 inches per hour on the west and east sides of the cell, and greater than 40 inches per hour within the sand/compost mix of the infiltration cell. The infiltration rate in native soil between plants averaged approximately 0.41 inches per hour, or 1.65 inches per hour including the two very rapid infiltration measurements shown in Table 4-1. The average infiltration rate excluding the two very rapid measurements is nearly equal the rate measured in the nearby park turf grass area (0.38 inches per hour). The data show that infiltration incorporating vegetation in the measurement showed a rate of 3.0 inches per hour.

The data show very slow infiltration rates, with variability in the rates of infiltration measured at different locations in the garden. Measurements from the south end of the bioretention garden had faster infiltration than readings collected on the north (0.62 – 1.12 in/hr on the south end compared to 0.00 to 0.18 in/hr on the north end in July. The garden also had typically faster infiltration on the west side (southwest and northwest corners) of the infiltration cell compared to the east side of the infiltration cell.

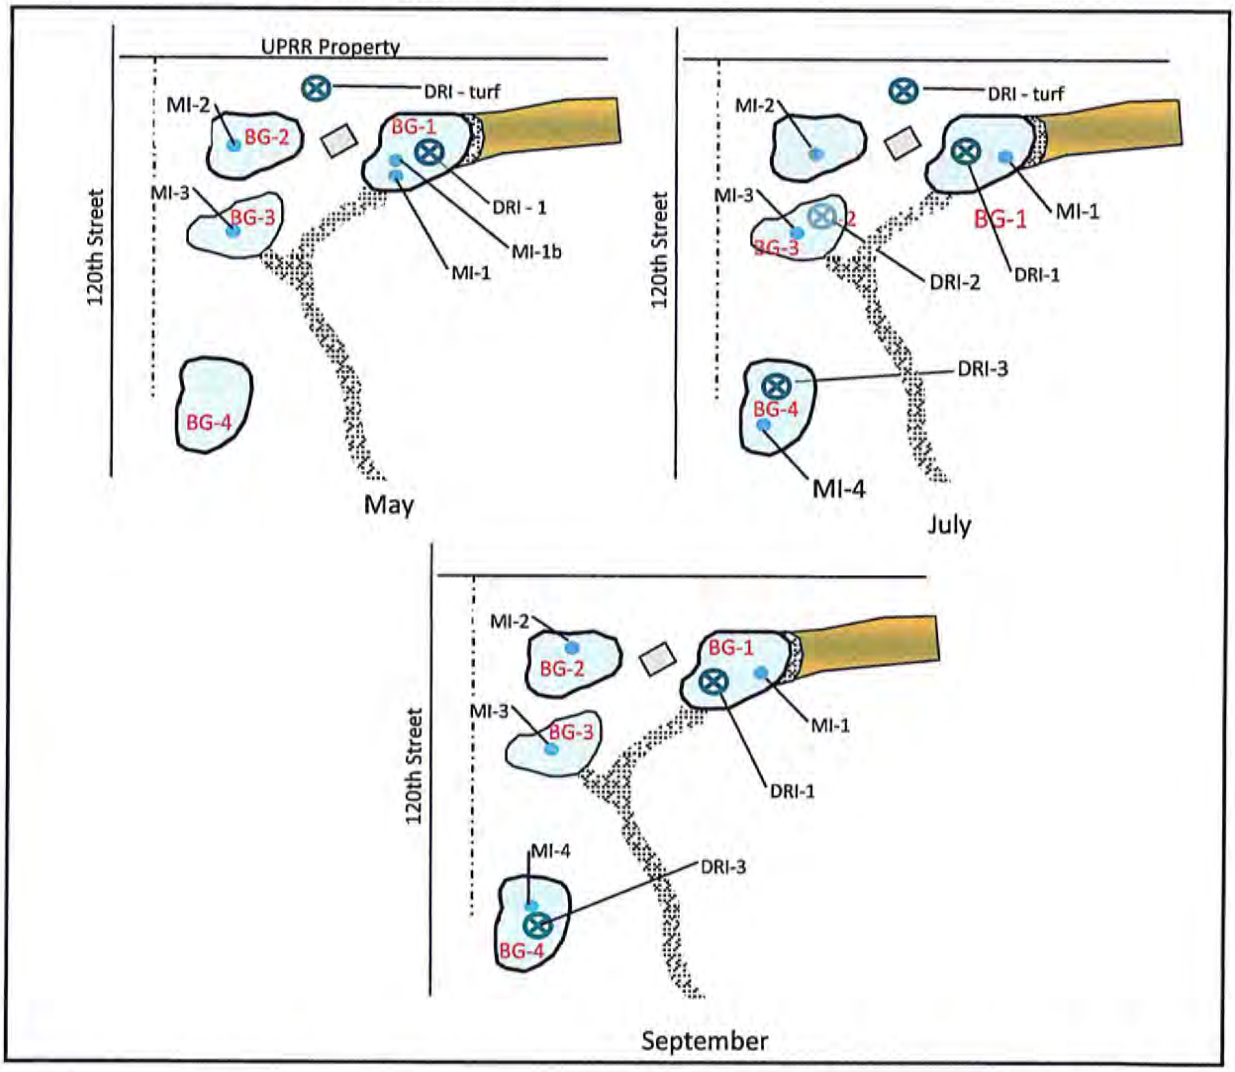
Figure 4-3: Infiltration Measurement Locations at the Under the Sink Bioretention Gardens

Infiltration measurements collected at the Under the Sink facility in May included examination of the northeast-most bioretention garden (BG-1) that had been covered with approximately 1.5 – 2 inches of silt. Infiltration measurements in this garden, collected with the silt in place, demonstrated reasonable infiltration rates (3.9 in/hr using the double ring infiltrometer, and 2.3 in/hr using the mini-infiltrometer). Infiltration rates in this same garden in July and September showed variable infiltration rates through the silt-covered material, including rates of 16.2 in/hr and 9.1 in/hr with the double ring infiltrometer, and 3.5 in/hr and 6.5 in/hr with the mini-infiltrometer. The variability in these measurements likely reflects varying thickness of the silt as well as possible edge effects from water seeping along the sides of the infiltrometer tools used. An additional measurement of infiltration into the garden with silt scraped away (MI-1b) resulted in an excessively rapid rate, greater than 40 in/hr.

Infiltration measurements collected in the two adjacent gardens, where silt had not accumulated were 21.5 in/hr in BG-2 (MI-2 in Figure 4), and greater than 40 in/hr in BG-3. Infiltration remained rapid in July and September in BG-2 (28 in/hr and 5.5 in/hr, respectively) and BG-3 (>40 in/hr in both July and September). The fourth garden (BG-4) had infiltration rates greater than 40 in/hr for both mini-infiltrometer and double ring infiltrometer measurements in July and September.
