MEMORANDUM

SUBJECT: Little Papio Channel (Center Street to Grover Street) Stabilization Project
Professional Services Contract with HDR Engineering

DATE: May 5, 2015

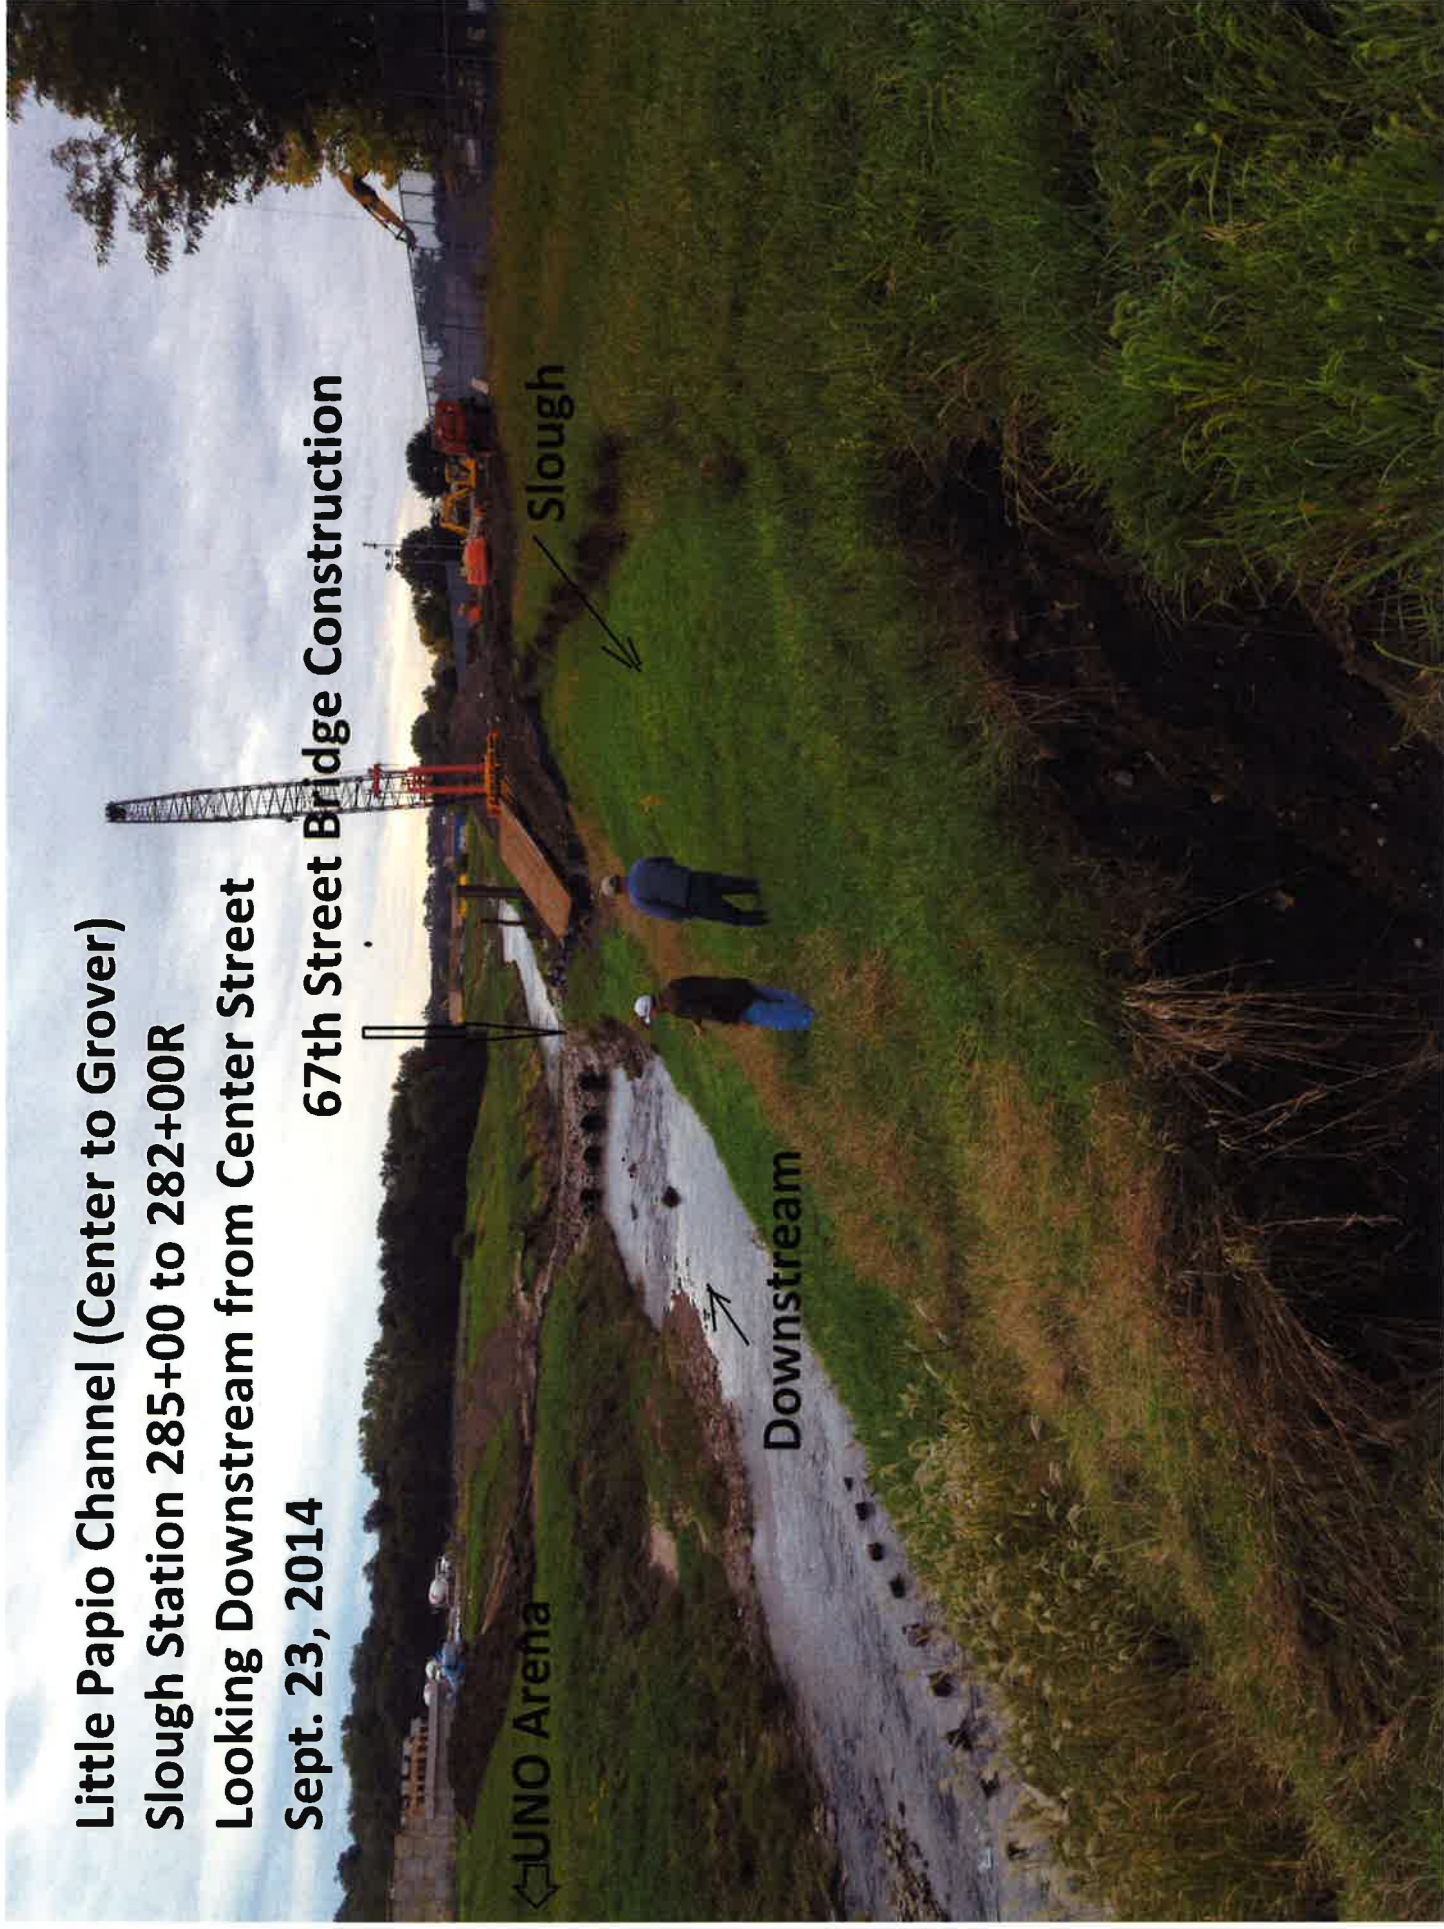
Slough

Downstream

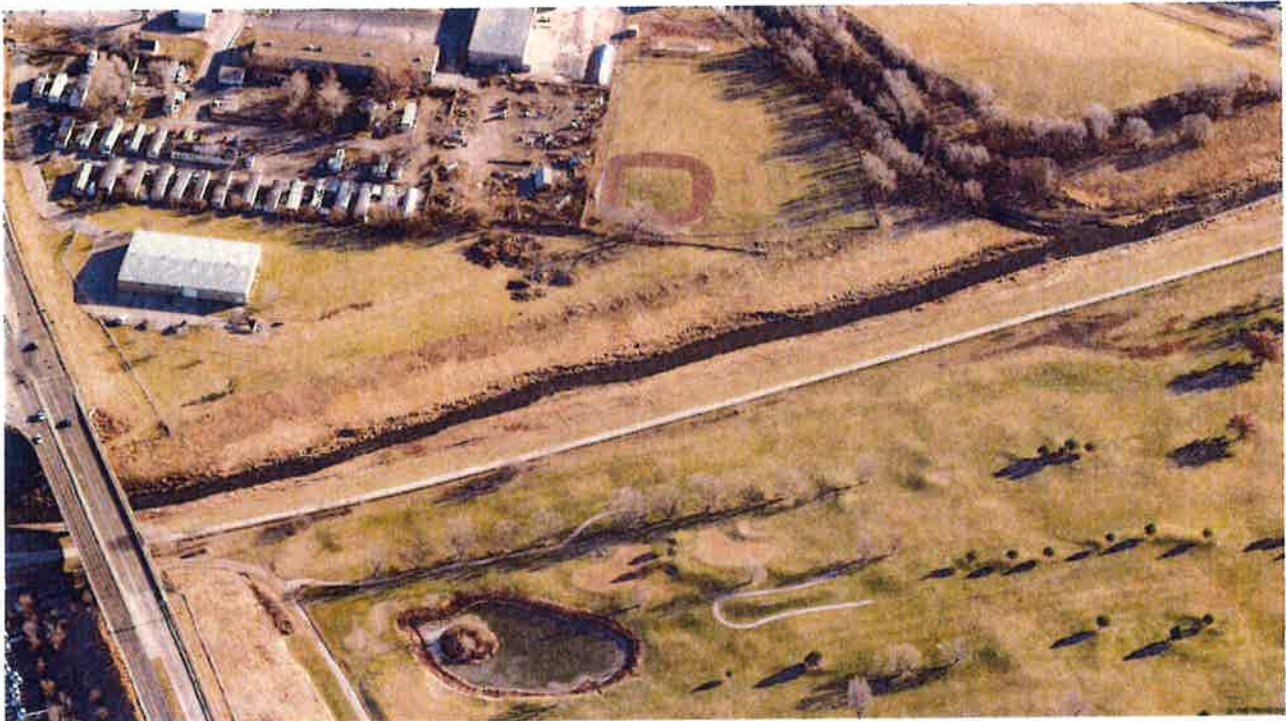
Photo documentation of the project site from December 2006 through September 2014 is provided in Appendix F. As depicted in Photos 1 through 5, 7, 9, 10, and 13, there were no observable signs of slope distress on the right (west) bank at the project site prior to September 2014.

1. 12/13/2006 View of Project Site looking East.

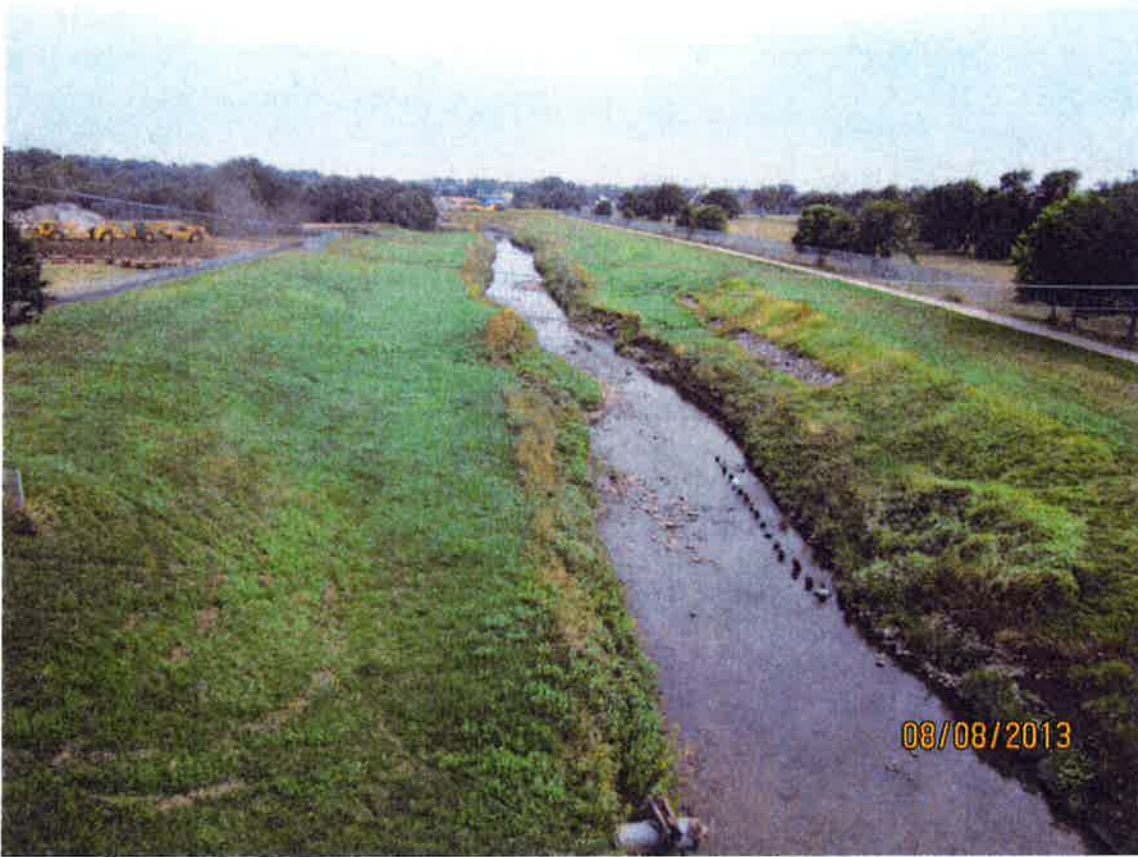
9. 8/8/2013 View of channel from Center Street Bridge.

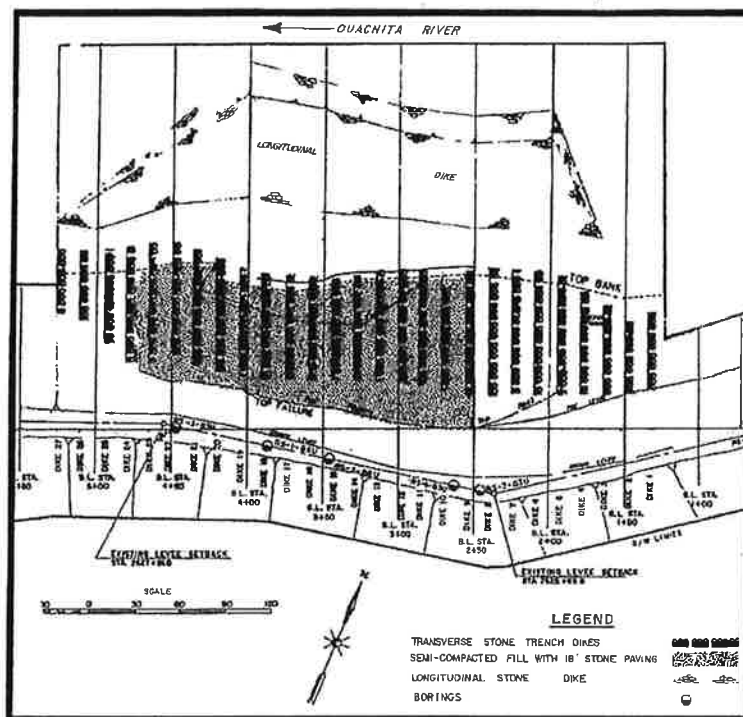
Figure 3. Site Plan

Exploration Program. The investigation of the soil conditions at the site consisted of three undisturbed borings taken in September 1983 and two undisturbed borings taken in June 1988. The borings indicated a silt layer of the natural levee deposit and a backswamp clay deposit consisting of a layer of very stiff clay (CL) overlying a medium to very stiff clay (CH). The generalized soil and slide profile is presented in Figure 2. The borings which were made through the existing levee are shown in plan on Figure 3.

Construction of the stone-fill trench stabilization was accomplished by contract for the U.S. Army Engineer District, Vicksburg, in December 1988. The contract required that 27 transverse stone-fill trenches (Figure 3) be constructed
