To: Gerry Bowen
Papio-Missouri River Natural Resources District (PMRNRD)

Date: January 10, 2011

Subject: Preliminary Observations and Recommendations for Repairs to Elkhorn River IPA

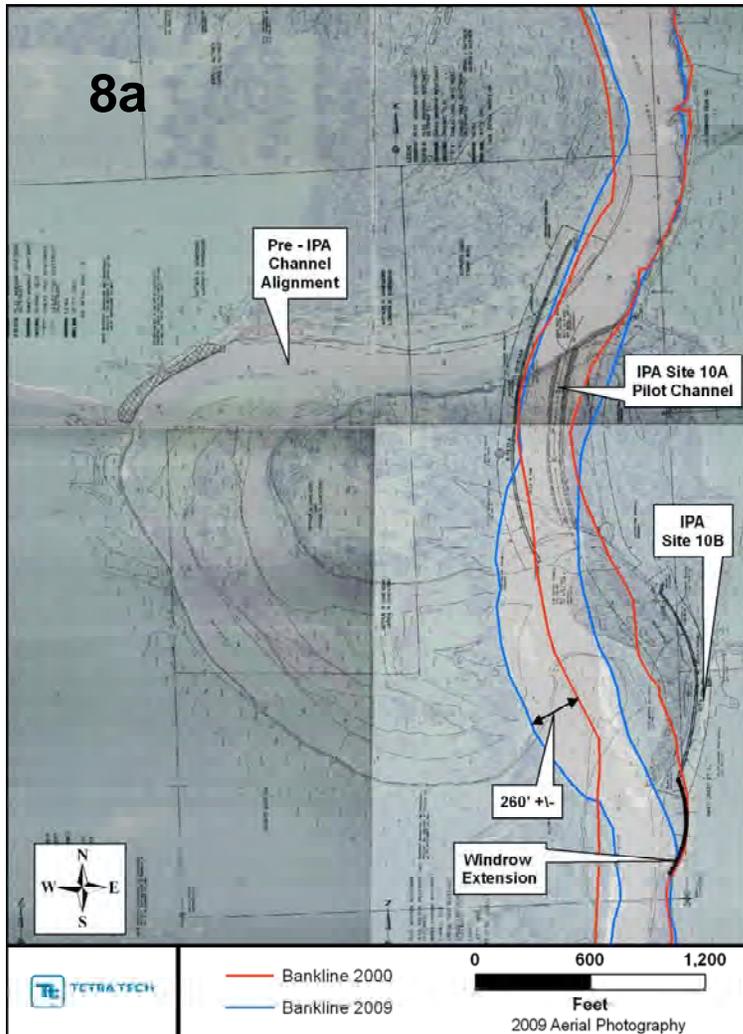
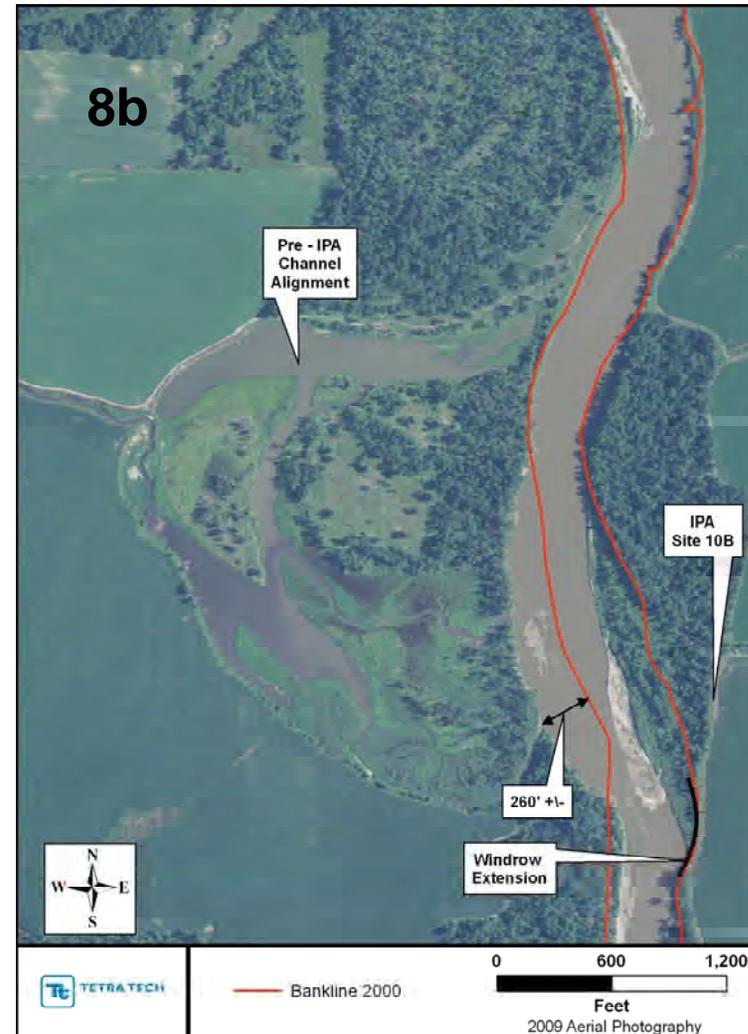
Field Site 1 is located on the left bank just downstream from the original IPA Site 10B, and consists of an approximately 500-foot long extension of the windrow revetment that was installed as part of the original project (**Figures 8a and 8b**). According to Mr. Bowen, the extension was constructed in the early 1990s after completion of the original project to stop erosion of the unprotected bank downstream from Site 10B. As the channel through the meander cutoff that was constructed as part of IPA Site 10A has continued to develop since construction, the river along the original Site 10B and most of the extension site has shifted toward the west through lateral erosion into the right bank, forming a vegetated bankline along the toe of the left bank and abandoning the protection. Based on the 2009 aerial photograph, the river was in direct contact with the bankline along the extension prior to the 2010 high flow, but a large sand bar is now present along the site (**Figure 9**). The rock riprap on the point in the left bank at the downstream end of the windrow extension appears to be intact and functioning as intended, although the rock appears to be relatively thin. The right bank upstream from Field Site 1 will continue to erode to the west and south, approximately as shown by the dashed red lines and arrow in **Figure 10**, expanding the size of the left-bank sandbar. The overbank area into which the river is eroding is the remnant of the former meander bend that was cutoff as part of the original IPA and a small wooded area directly to the south. Whether continued erosion into this area is a potential problem is uncertain, but it is recommended that the area, including the rock point on the left bank (**Figure 11**), be monitored and corrective actions taken if required. These actions could include windrow revetment along the right bank and maintenance of the rock points.

Figure 8a. Elkhorn IPA construction plans at Sites 10A and 10B (Field Site 1) overlaid on the September 22, 2009 aerial photograph. Also shown is the approximate extent of the windrow extension and the river banklines in October 2000 and 2009.

Figure 8b. September 22, 2009 aerial photograph of Field Site 1 (IPA Sites 10A and 10B) (discharge ~1,040 cfs) with construction plan overlay removed. Also shown are the banklines from the October 2000 aerial photograph.

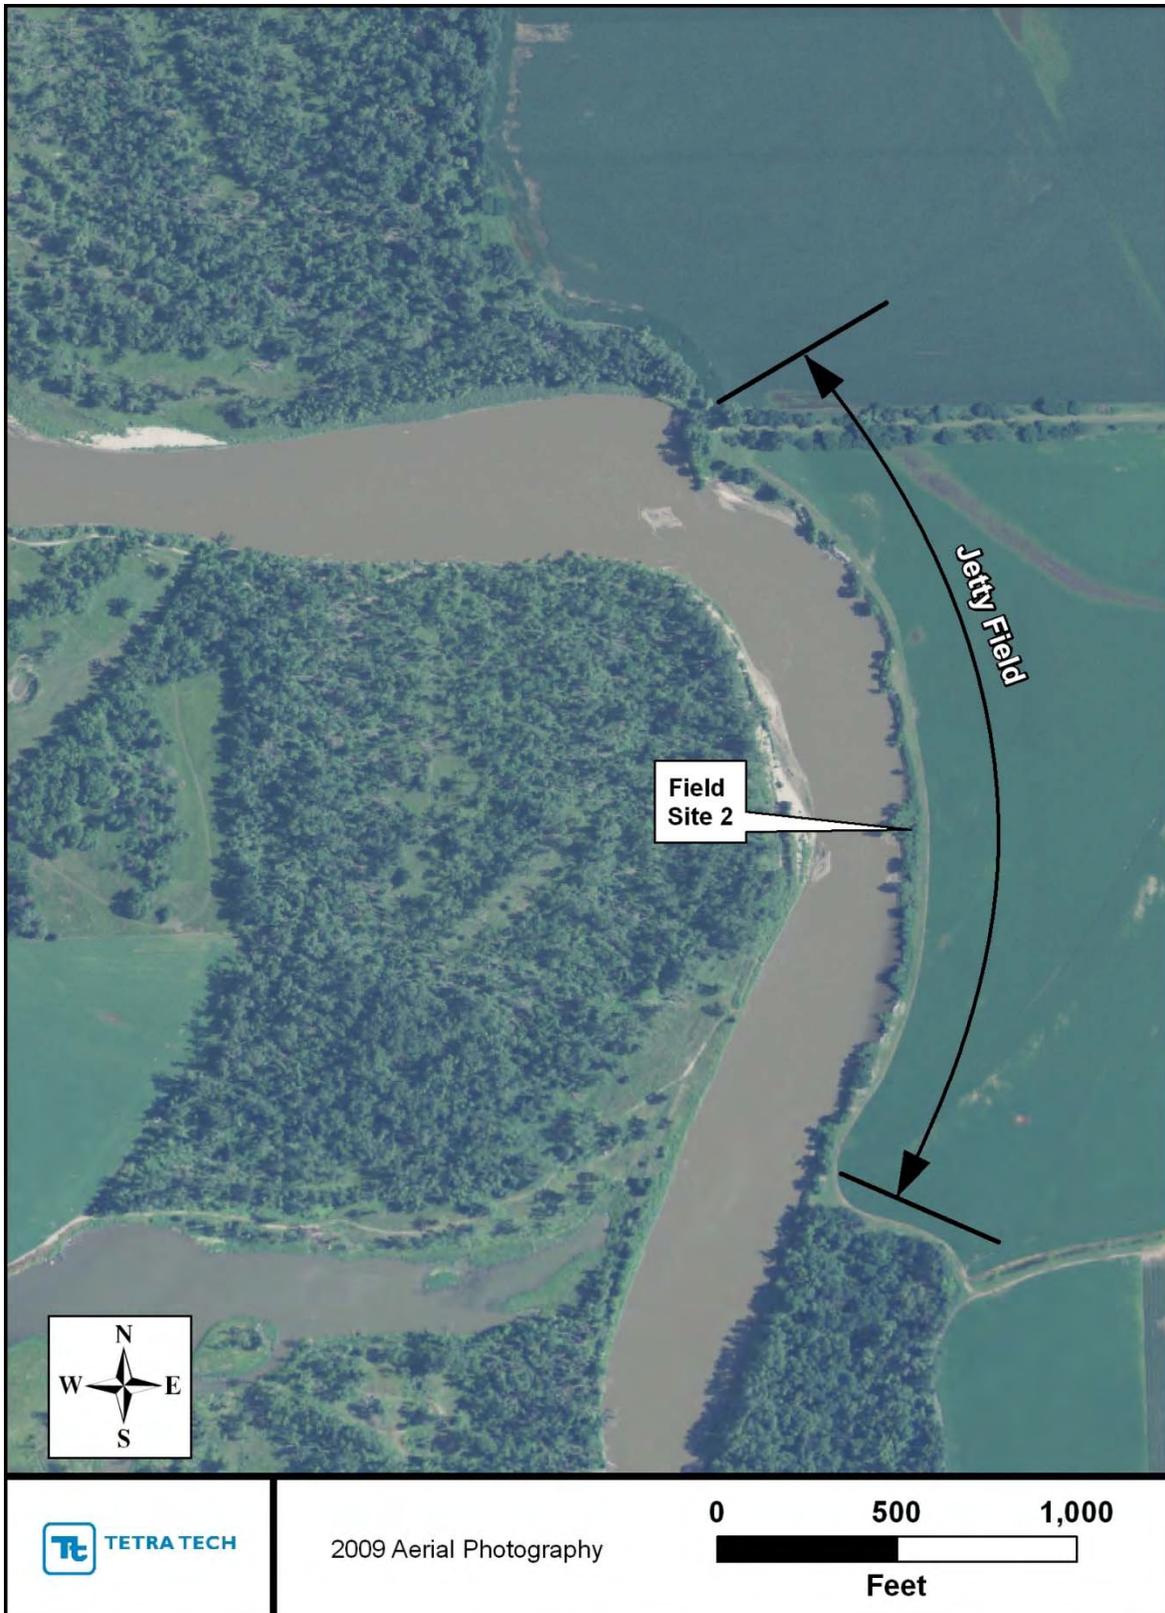
Field Site 2 is located near the middle of a left-bank jetty field that was constructed prior to the IPA project (**Figure 12**). The jetty field appears to be very stable and is functioning as intended (**Figure 13**). The problem area occurs just downstream from a large jetty near the middle of the jetty field where surface runoff has created a headcut and gully that is eroding back into the adjacent field (**Figures 14 and 15**). Sufficient information is not available to be certain about the source of the runoff that has caused the gulying, but it appears to have developed during the 2010 high-flow event, most likely due to overbank flows returning to the channel. Since it has developed in the low area/minor swale in the overbank area, both future overbank flows and local runoff from the adjacent field will continue to erode and expand the gully. Although expansion of the gully will damage the field, it is unlikely to endanger the stability of the overall dike field and bankline in this area; thus, this problem is not likely to affect the overall stability of the IPA reach.

Figure 12. Aerial photograph of the left-bank jetty field and Field Site 2 taken on September 22, 2009, when the discharge was ~1,040 cfs.

Given the available topography, the second solution is recommended. For this solution, the existing bank would be graded to develop a more defined drainage swale and then protected by the placement of rock riprap of an appropriate size along the surface (**Figure 16**). It is also recommended that a granular filter be placed under the rock rather than filter fabric, which has caused rock to launch in nearby locations. Care will need to be taken to tie the upstream and downstream ends of the revetment into the existing spur dike rock and channel bank, respectively, as well as to continue the placement of rock down to an appropriate toe-down depth below the channel to protect against local scour. The layer of riprap should extend up to the top of bank, where it should be thickened and keyed into the bank to prevent overtopping flows from undercutting the revetment.

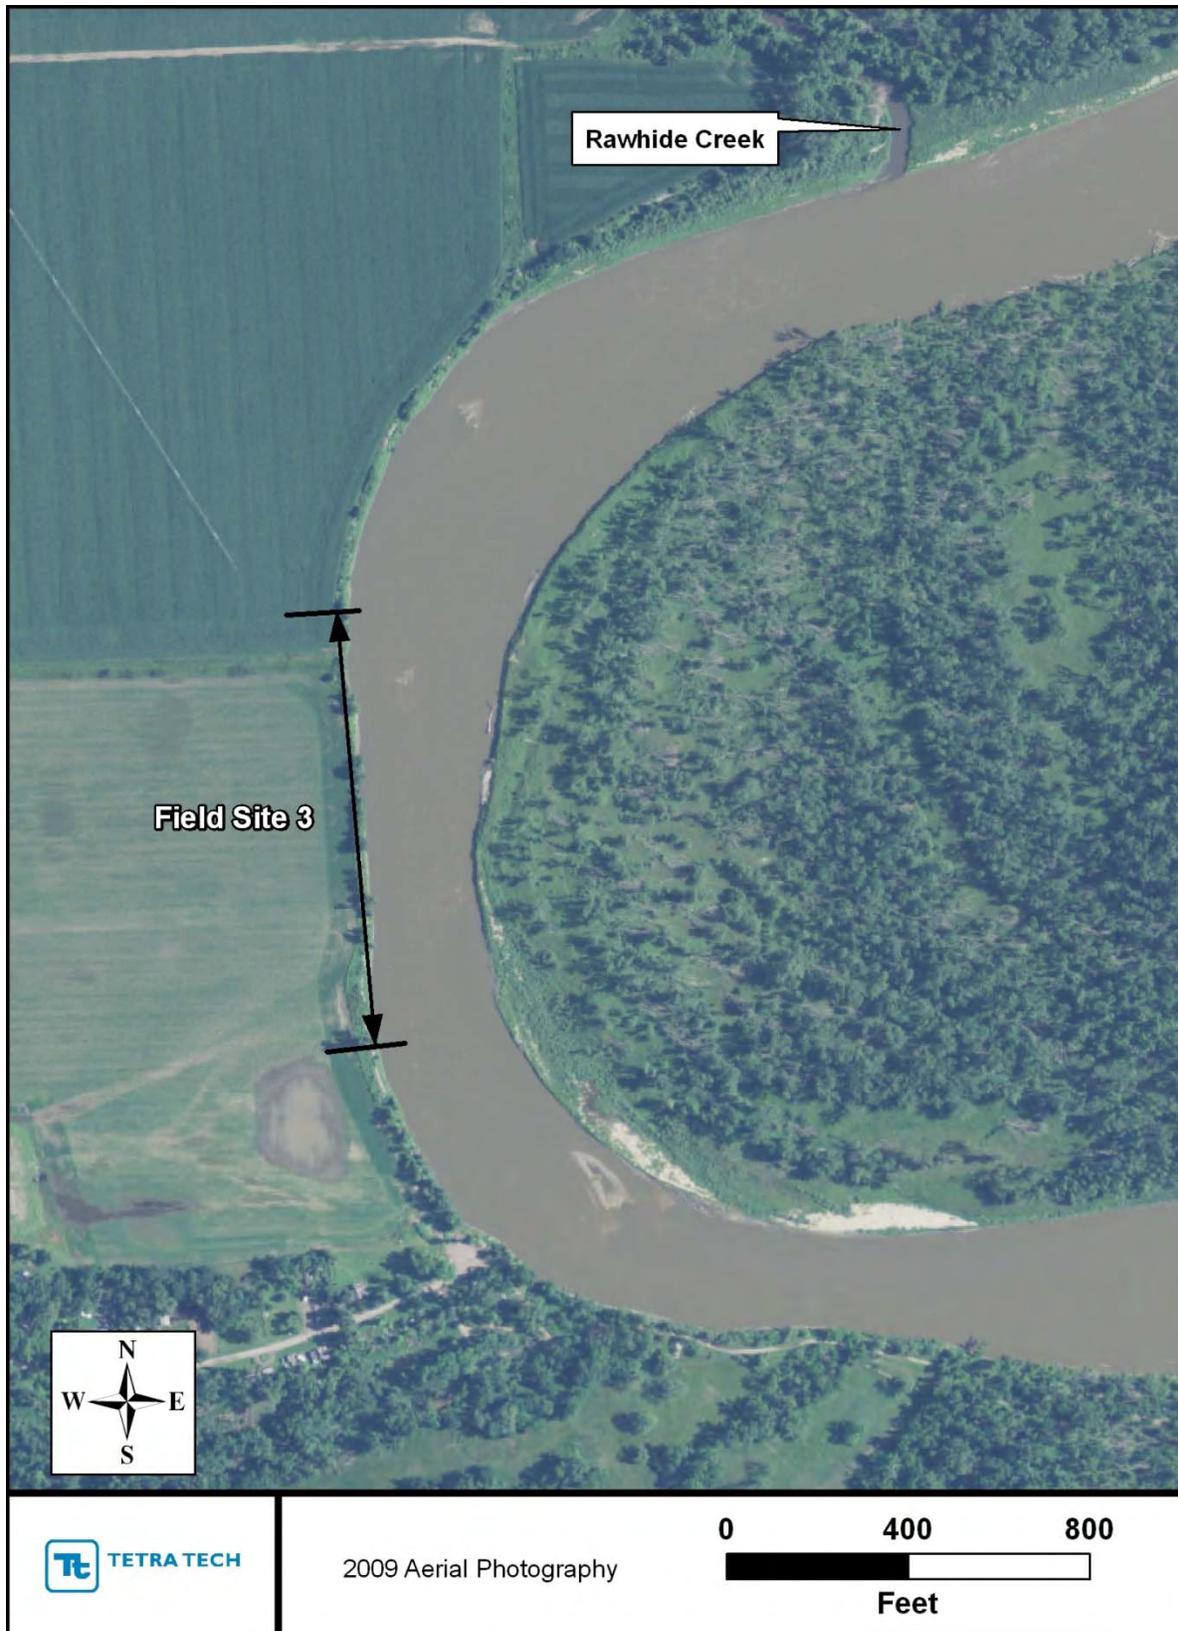
Field Site 3 is located along an approximately 900-foot reach in the middle of IPA Site 11 where the windrow revetment that was applied at a rate of 3.0 tons/foot has been fully launched (**Figure 17**) and there are now gaps in the rock that could allow undesirable bank erosion during future high flows (**Figure 18**). At the upstream end of the site, the rock is in place at the toe of the bank, but the part of the bank above the ~1,500 cfs water-surface is retreating behind the rock (**Figure 19**). With additional upper-bank retreat at this location, the channel will expand on the back side of the ridge formed by the rock, and the existing bank protection will no longer be effective. The bankline along the entire length of IPA Site 11 has shifted very little since the project was constructed (**Figure 20**). Approximately one-fourth of the rock in the windrow revetment in the portion of IPA Site 11 downstream from Field Site 3 remains to be launched, and this portion of the site appears to be stable and functioning as intended (**Figure 21**). Most of the rock has launched in the portion of IPA Site 11 between Field Site 3 and the mouth of Rawhide Creek and this bankline also appears to be stable (**Figure 22**). It is recommended that additional rock be added to the bank at Field Site 3 at a rate of 2.5 to 3 tons/foot over a total length of about 900 feet to prevent additional erosion of this bank that could impact the adjacent overbank area, and potentially allow flanking of the downstream portion of IPA Site 11.

Figure 17. Aerial photograph of Field Site 4 taken on September 22, 2009, when the discharge was ~1,040 cfs.

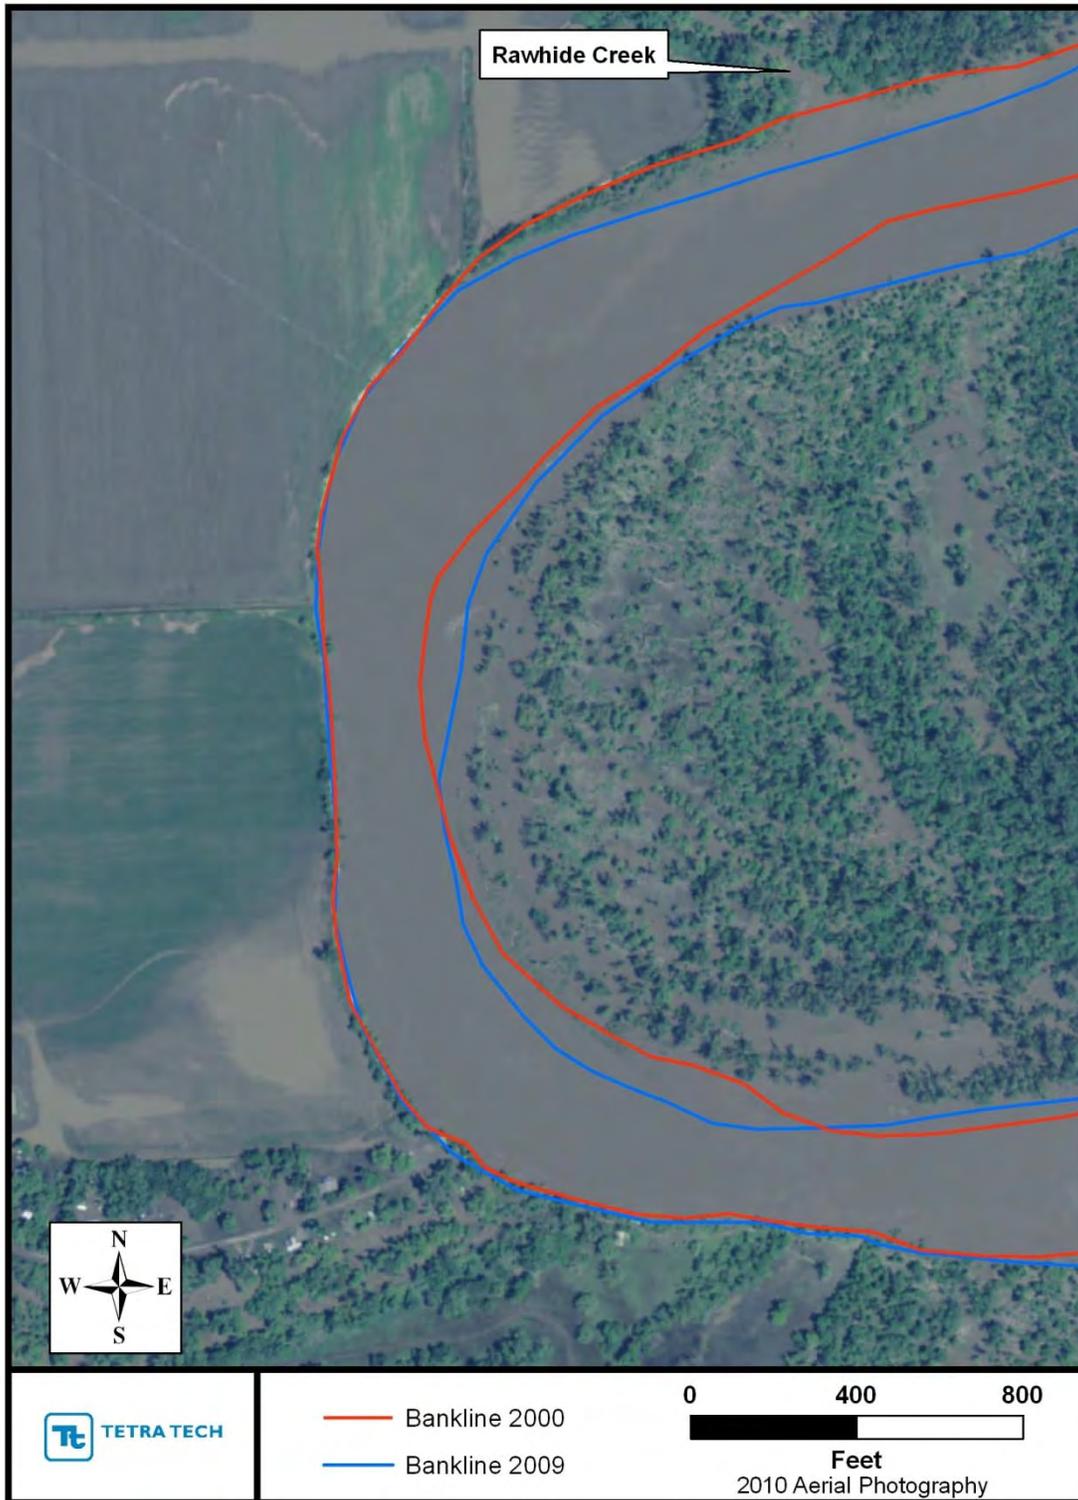
Figure 20. Aerial photograph at IPA Site 11 taken on June 16, 2010, when the discharge was ~37,250 cfs. Also shown are the banklines from the October 2000 and September 2009 photographs.

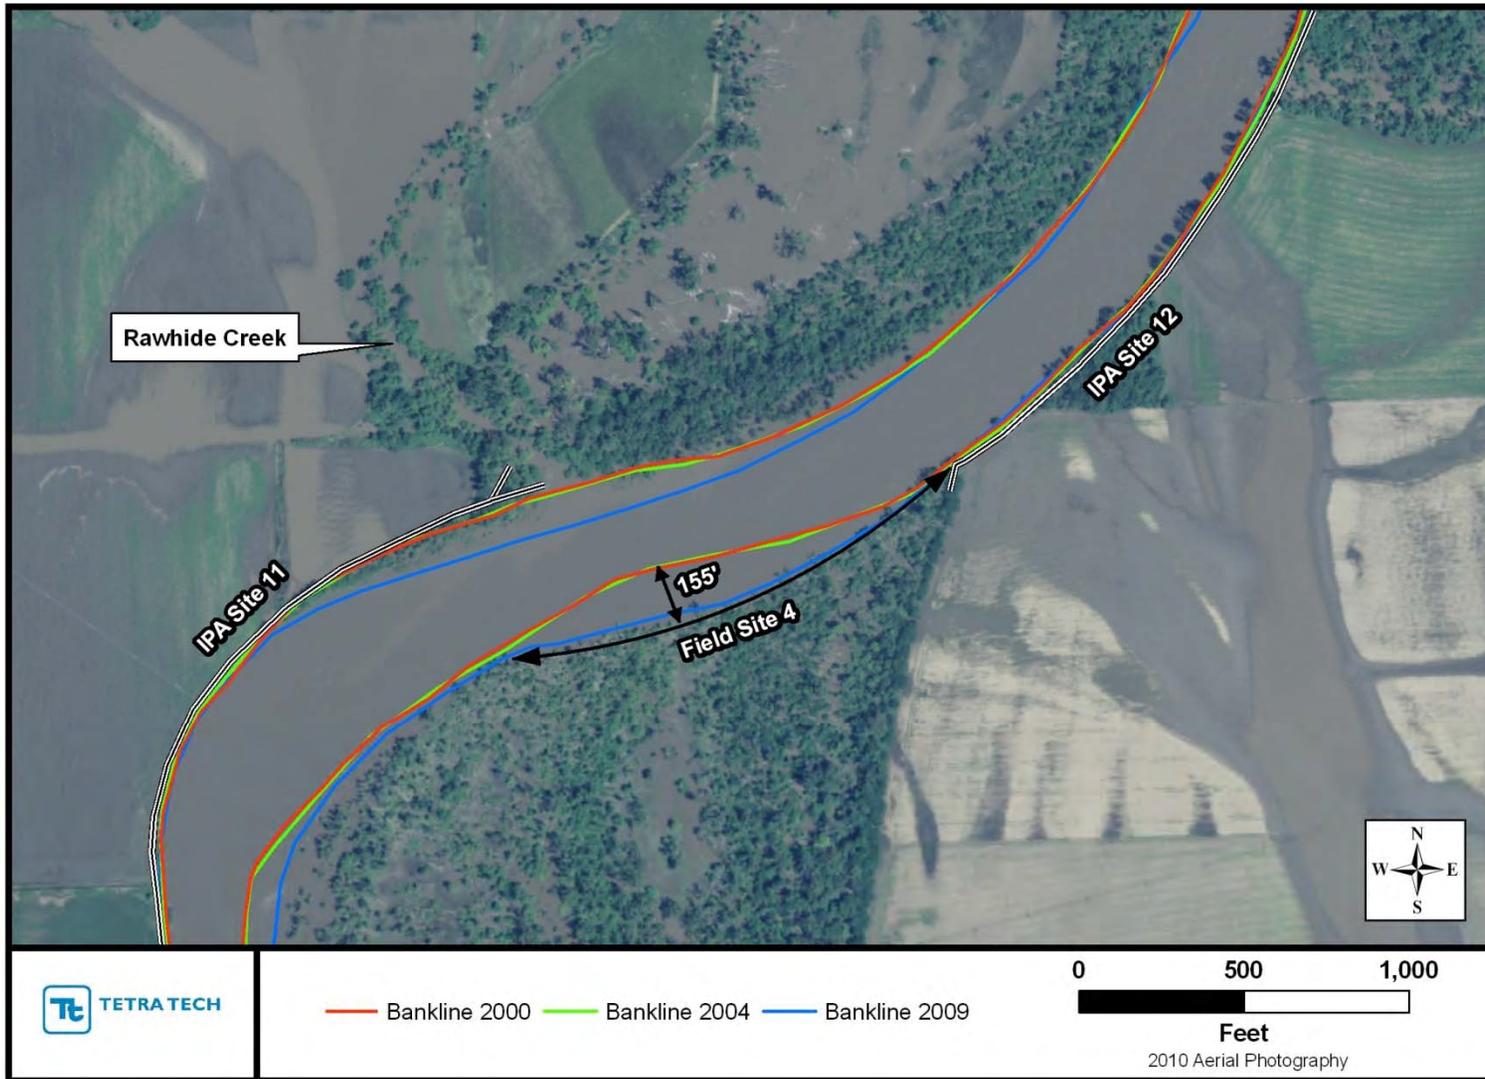
Figure 23. Aerial photograph of the downstream end of IPA Site 12 and Field Site 4 taken on June 16, 2010, when the discharge was ~37,250 cfs. Also shown are the banklines from the October 2000 and September 2009 photographs.

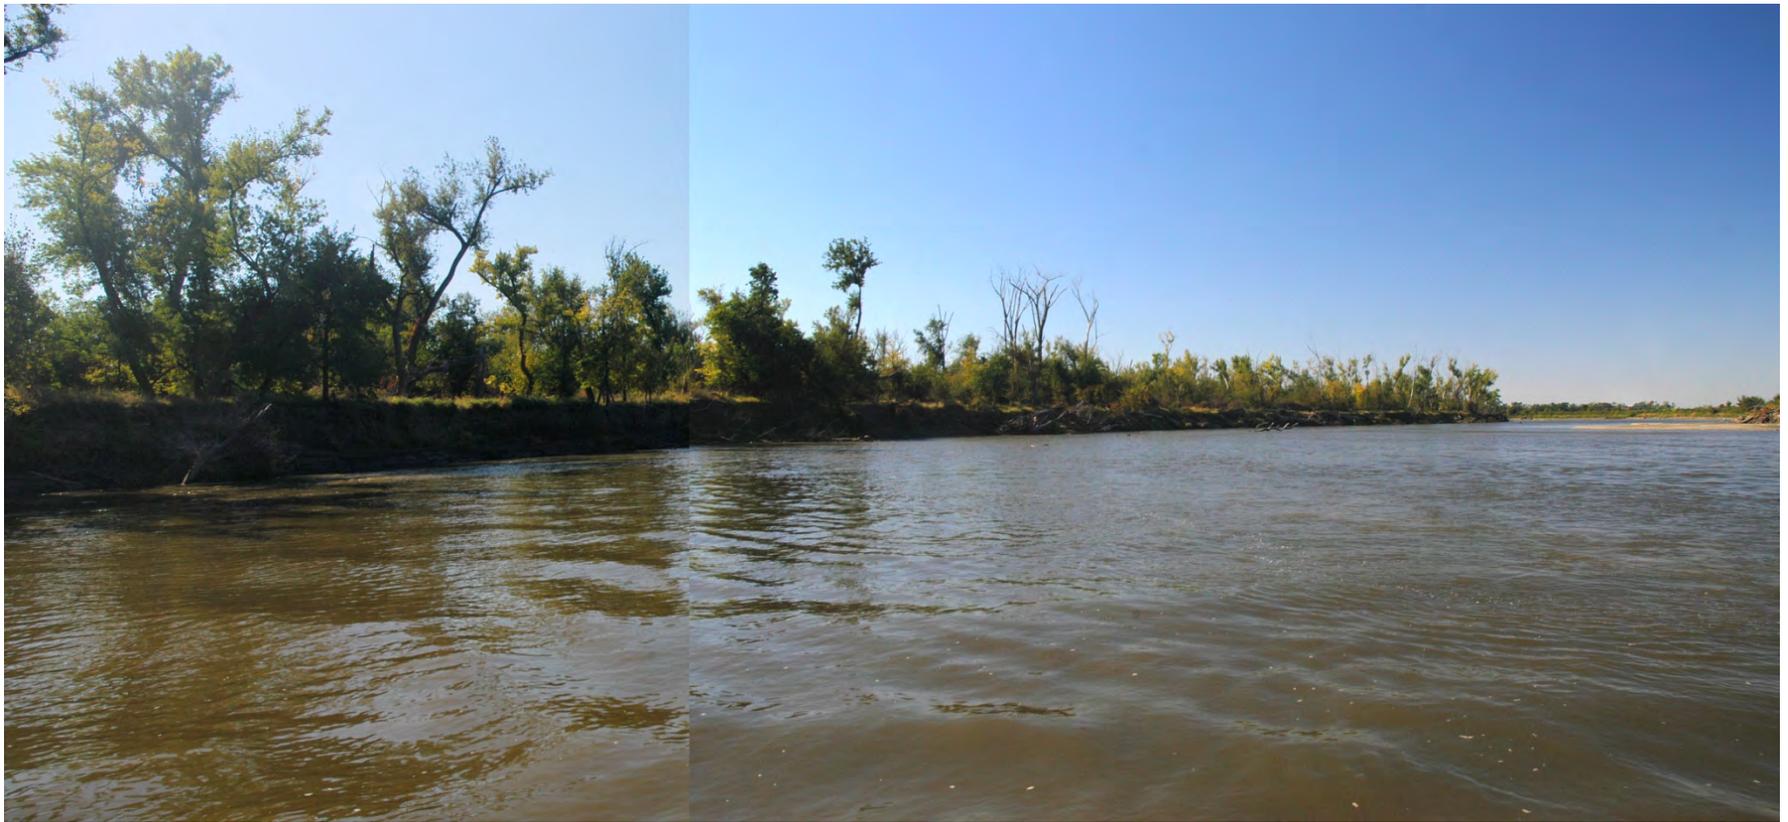
Figure 24. Panoramic view looking downstream at Field Site 4 taken on October 6, 2010.

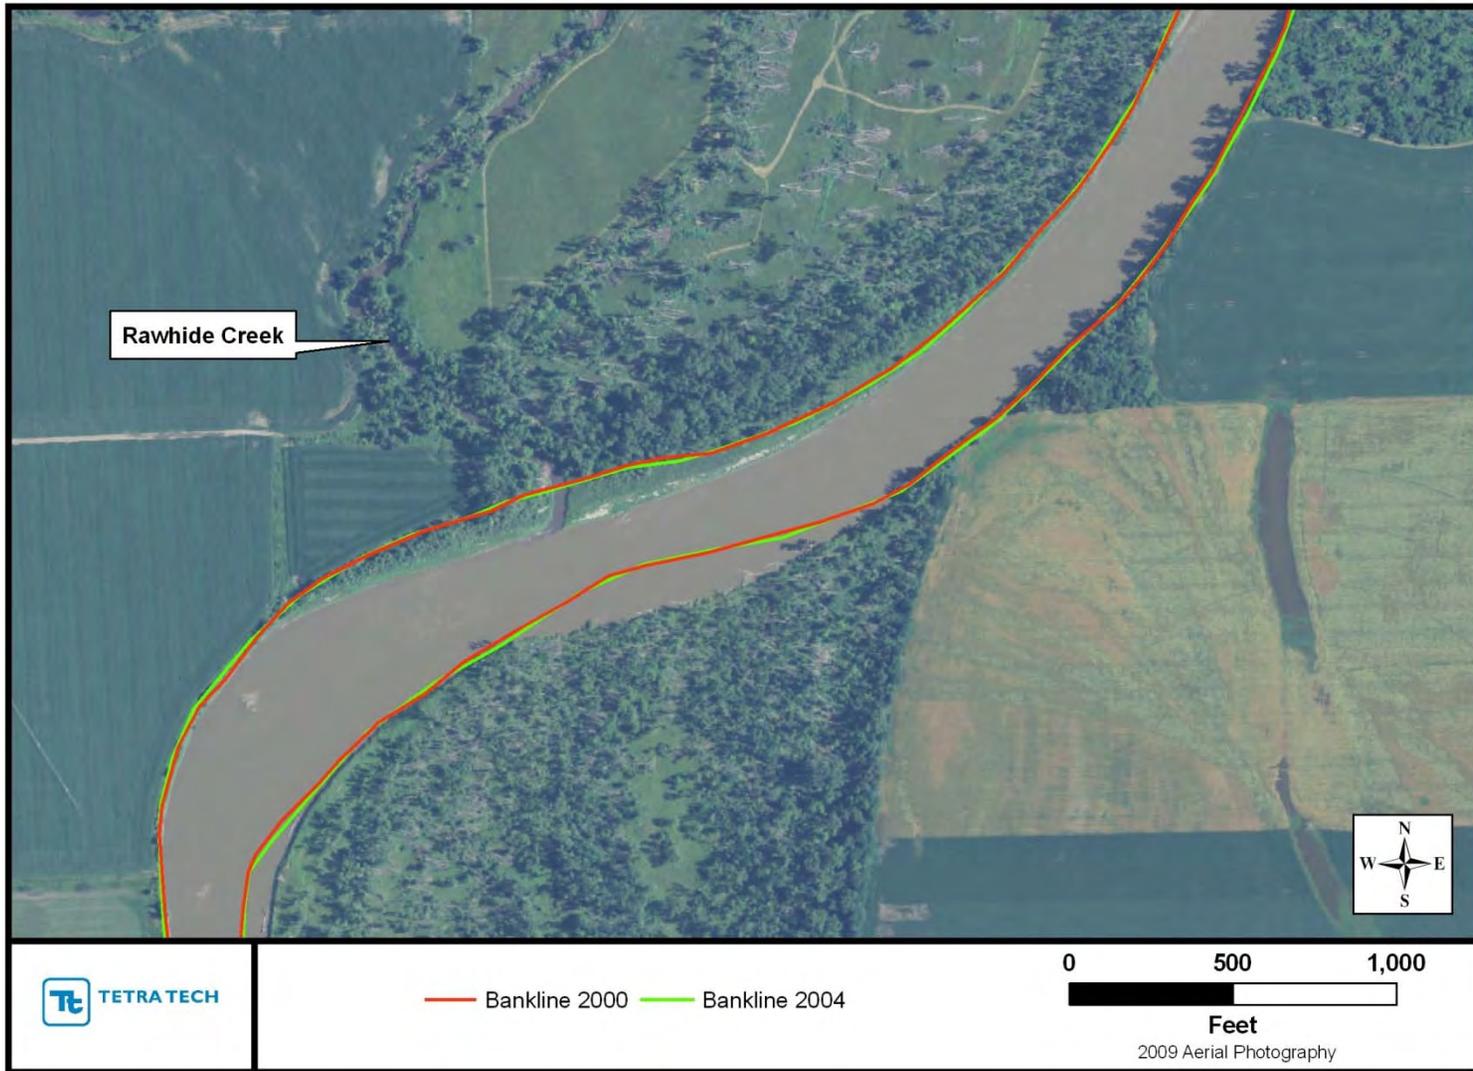
Figure 25. Aerial photograph of the downstream end of IPA Site 12 and Field Site 4 taken on September 22, 2009, when the discharge was ~1,040 cfs.

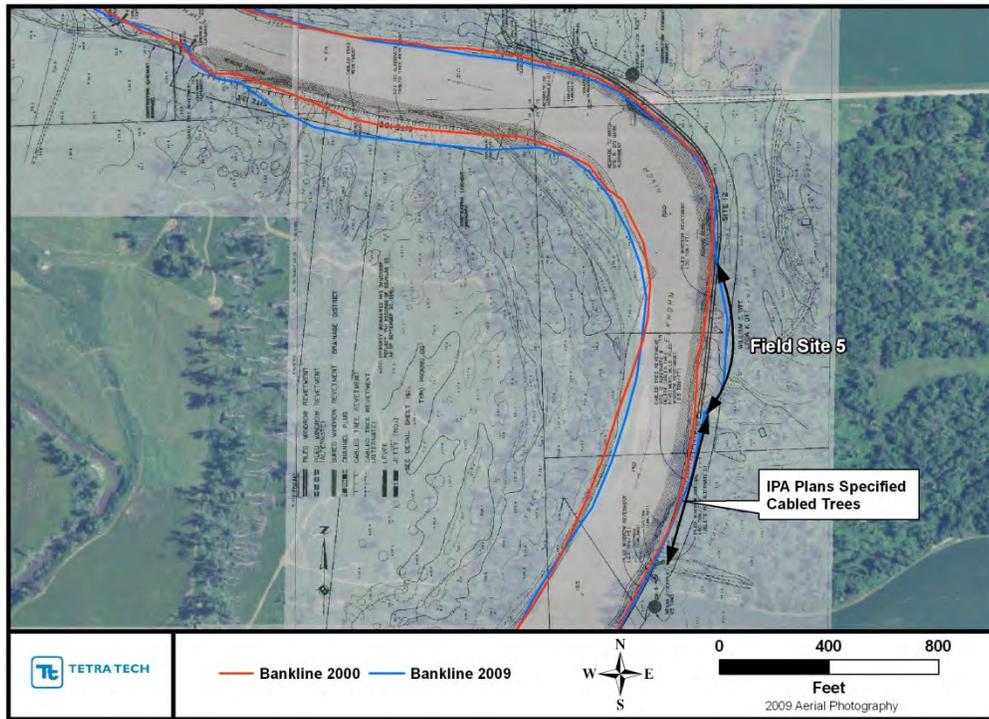
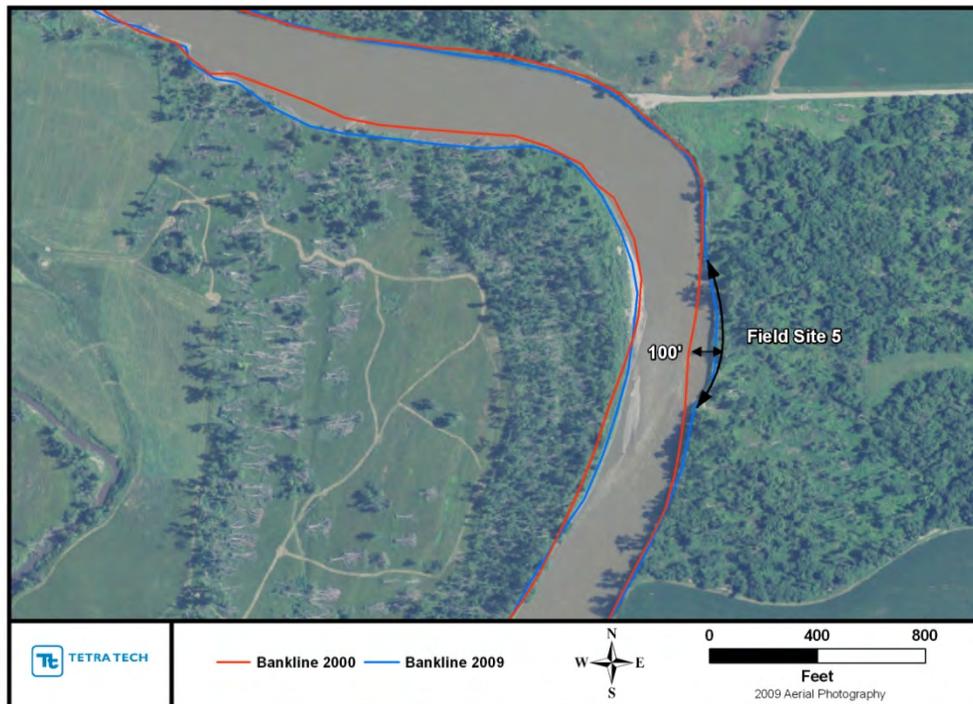
Field Site 5 is located on the left bank near the middle of IPA Site 12 where the bankline has retreated laterally by up to 100 feet over a length of approximately 600 feet since October 2004 (**Figures 26a and 26b**). Some rock is still present at the base of the bank, and concrete rubble has apparently been added to the site since the original construction (**Figure 27**). The IPA plans called for piled windrow revetment from approximately the downstream end of Field Site 5 through the bend upstream from the site. The construction plans also called for cabled-tree revetment for about 550 feet immediately downstream of Field Site 5, but windrow revetment was placed in lieu of the cabled trees (Table 1, Note 8). The portions of the site up- and

Figure 26a. Construction plans for the middle portion of IPA Site 12 overlaid on the September 2009 aerial photograph. Also shown are the October 2000, October 2004 and September 2009 banklines showing the ~100-foot bank migration at Field Site 5.

Figure 26b. September 22, 2009 aerial photograph (Discharge ~1,040 cfs) of Field Site 5 showing the October 2000 and October 2004 banklines.

downstream from Field Site 5 appear to be in good condition, but Field Site 5 is unstable and eroding, with significant gaps in the existing rock/concrete rubble protection. The overbank area along this site consists of moderately thick woods. If continued lateral erosion into the wooded area is considered to be a problem, it may be possible to check the erosion with additional windrow revetment, applied at a rate of 2.5 to 3.0 tons/foot. Before such additional rock is installed, however, it would probably be prudent to study this area in more detail, including evaluation of the construction notes, to gain a better understanding of why the indicated bank erosion has occurred to insure that the recommended fix is, in fact, appropriate.

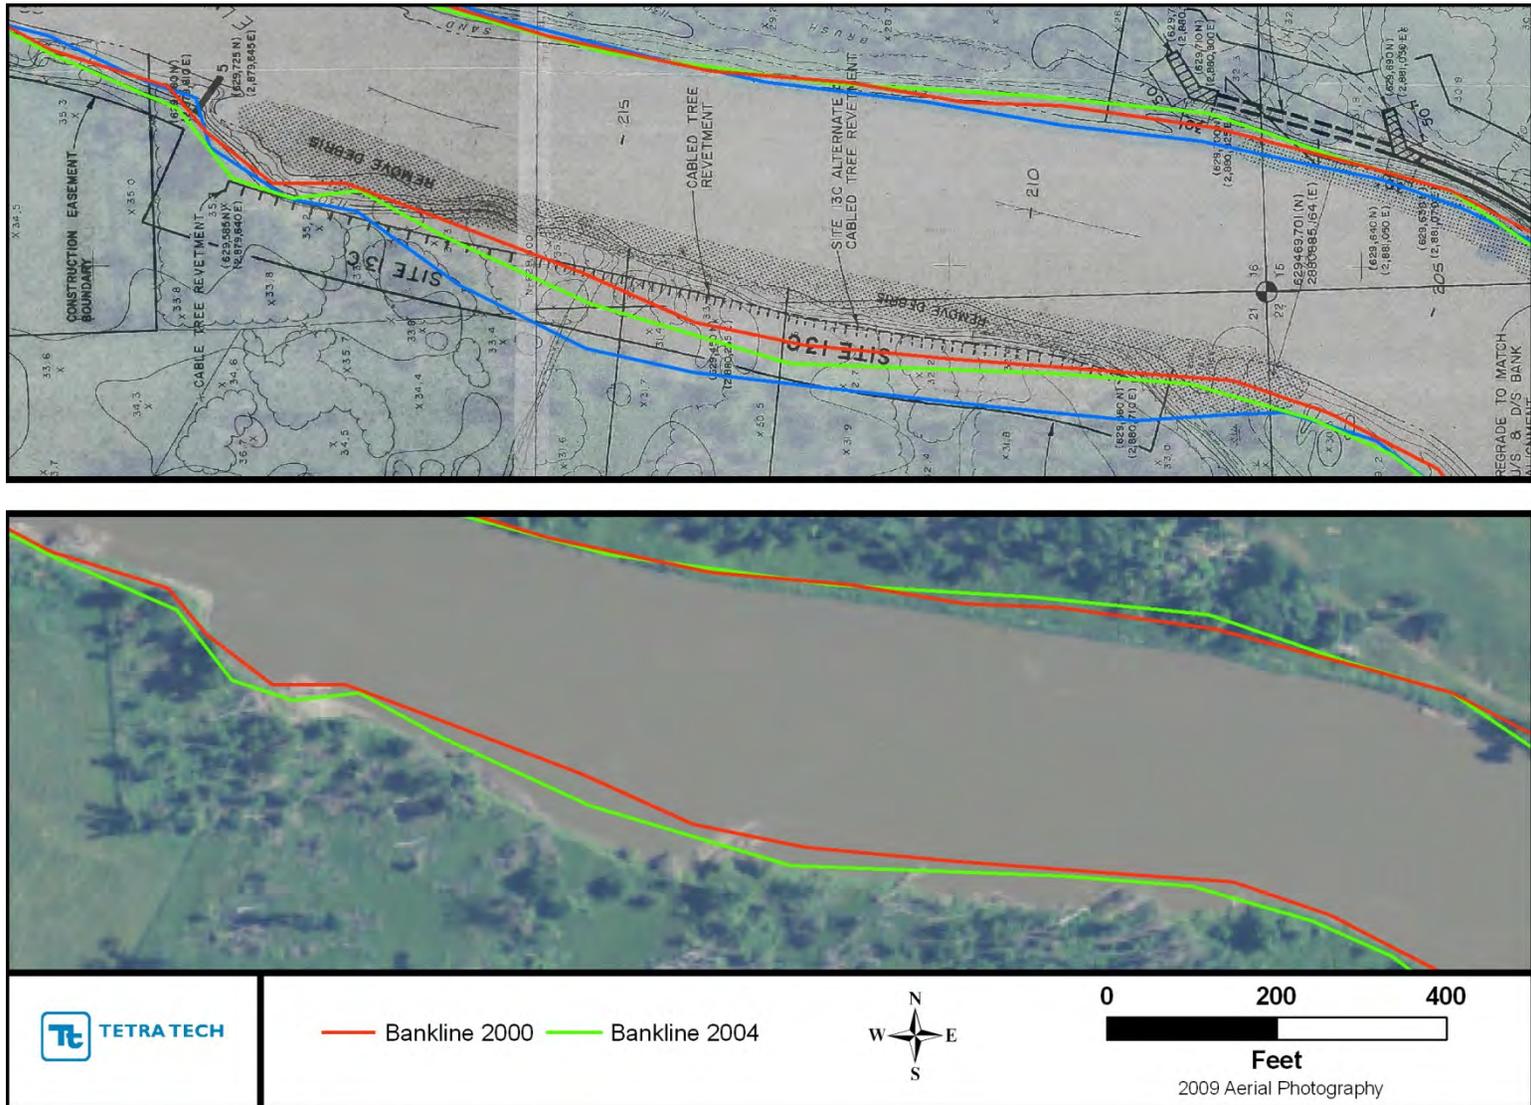
Figure 28a. Construction plans for the cabled-tree revetment at IPA Site 13C (Field Site 6) overlaid on the September 2009 aerial photograph. Also shown are the October 2000, October 2004 and September 2009 banklines.

Figure 28b. September 22, 2009 aerial photograph (Discharge ~1,040 cfs) of IPA Site 13B and Field Site 6 showing the October 2000 and October 2004 banklines.

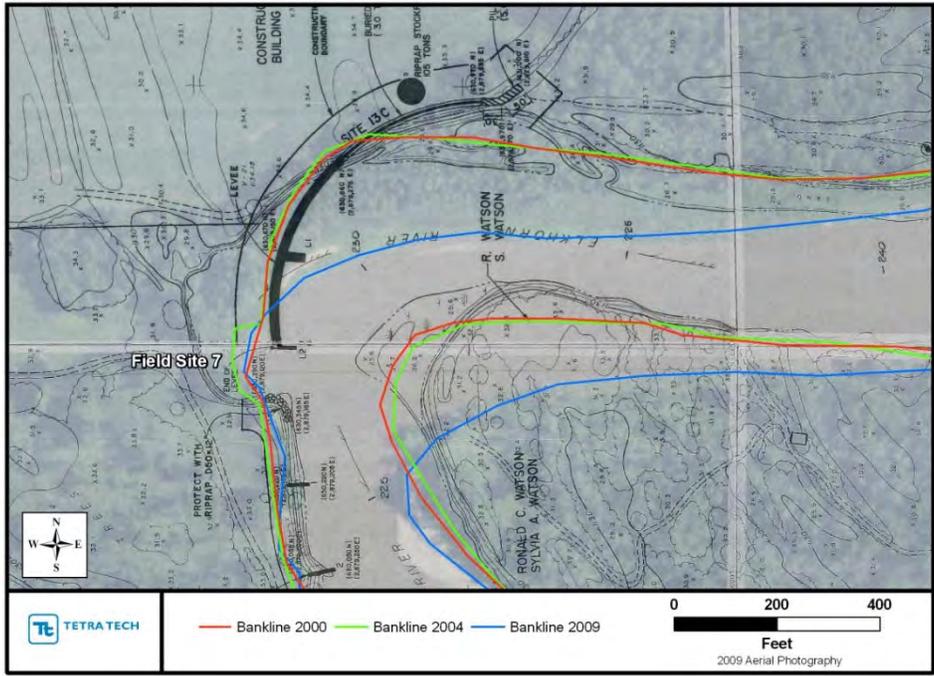
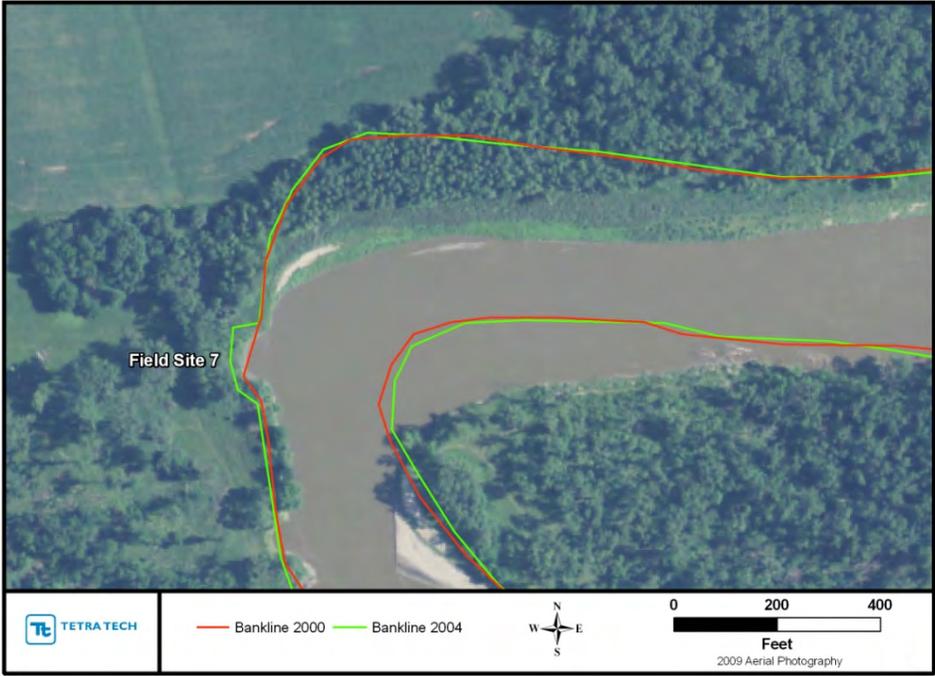
Field Site 7 is a riprap point at the downstream end of the levee that was constructed in the late 1990s where the rock has been stripped off the underlying filter fabric (**Figures 32a, 32b and 33**). Although the erosion hazard does not appear to be severe at this location, the site can be repaired by replacing the rock with riprap of an appropriate size. It is recommended that a granular filter be placed under the rock rather than the filter fabric that was previously used to limit the likelihood that the rock will simply slide off the underlying filter.

Figure 32a. Construction plans for the rock jetties, levee and buried windrow revetment at IPA Site 13C and the recently constructed rock point at Field Site 7 that was damaged during the 2010 high flow overlaid on the September 2009 aerial photograph. Also shown are the October 2000, October 2004 and September 2009 banklines.

Figure 32b. September 22, 2009 aerial photograph (discharge ~1,040 cfs) of the upstream portion of IPA Site 13B and Field Site 7 shown in Figure 31a, including the October 2000 and October 2004 banklines.

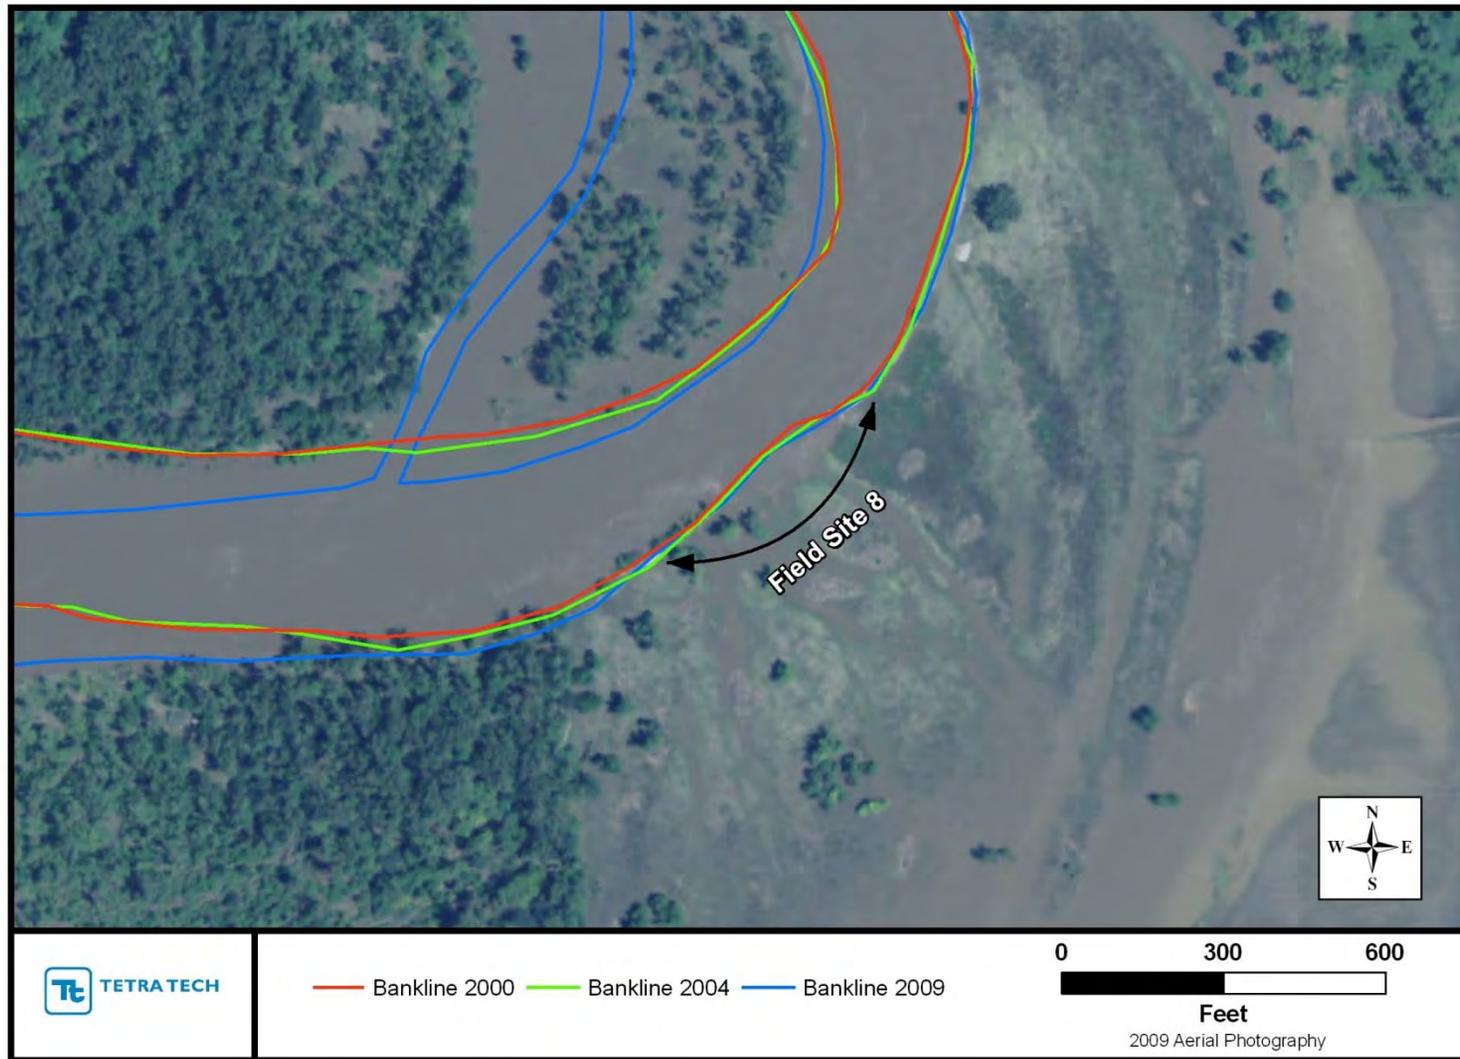
Field Site 8 is an approximately 300-foot long scallop that has developed in the left bank just downstream from a pre-existing rock spur located at the downstream end of the windrow revetment for Site 13B (**Figures 34 and 35**). The bankline at this location retreated into the overbank by nearly 80 feet downstream from the rock spur. The IPA construction plans called for cabled-tree revetment for approximately 1,000 feet downstream from the rock spur. The cabled-trees were not installed during the original construction, but windrow revetment was placed in this area in the late 1990s (**Figure 36**; Table 1, Note 16). With the exception of the scalloped area, the remainder of the bankline appears to be relatively stable at the present time.

Figure 34. Aerial photograph taken on June 16, 2010 (discharge ~37,250 cfs) of Field Site 8. Also shown are the banklines from the October 2000, October 2004 and September 2009 aerial photographs.

Recommended repairs at Field Site 8 include realigning the bankline to eliminate the scallop, and placement of appropriately sized rock riprap on the realigned bankline (**Figure 37**). The length of the realigned bankline would be about 350 feet, and the area that would need to be filled between the existing and new bankline is about 17,000 ft². Assuming a bank height of 12

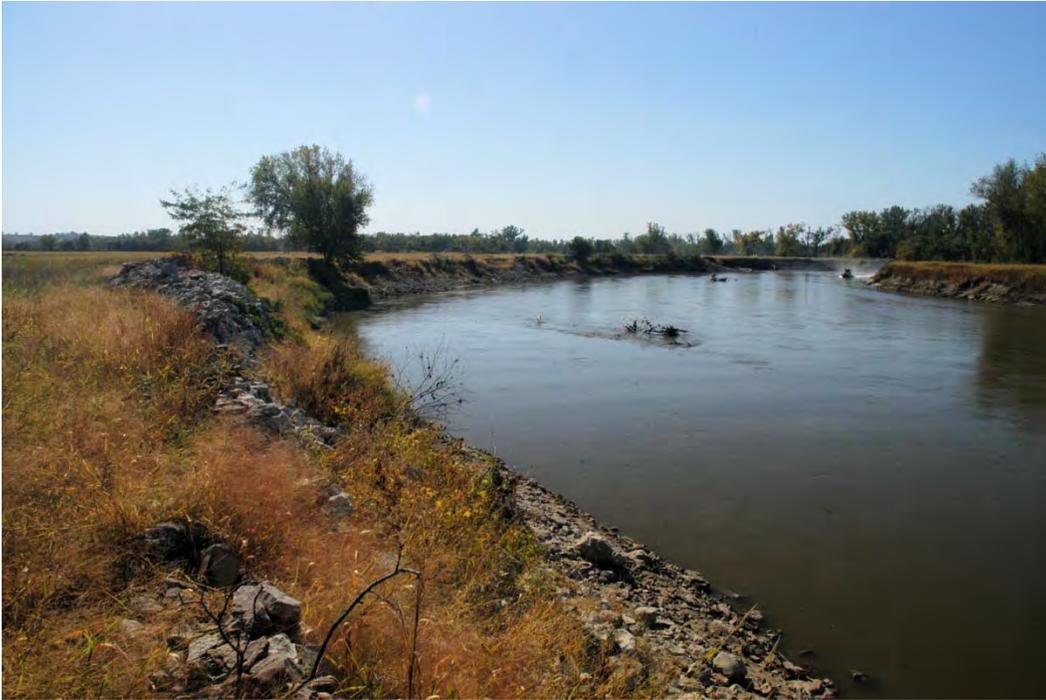
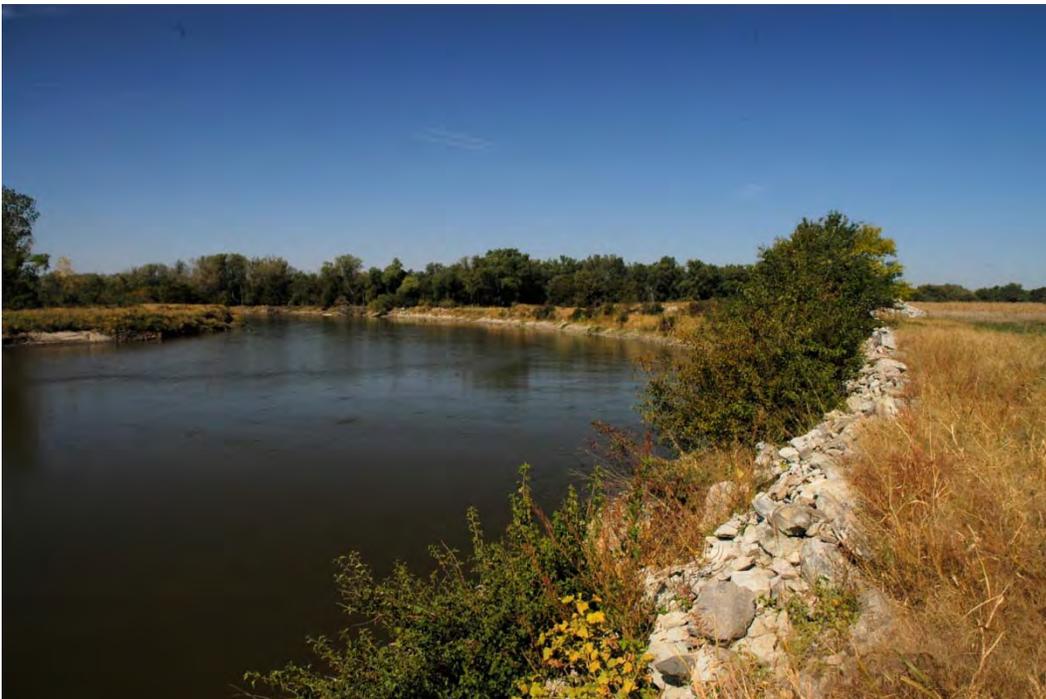
The upstream portion of Site 13B, where piled windrow revetment was installed at a rate of 3.0 tons/foot, appears to be relatively stable and functioning as intended. Most of the windrow rock has been launched, with 10 to 15 percent of the rock still in-place at the top of the bank along much of the site (**Figures 38 and 39**).

Figure 38. View looking downstream from near the downstream rock stockpile at IPA Site 13B.

Figure 39. View looking upstream from near the downstream rock stockpile at IPA Site 13B.
