To: Gerry Bowen
Papio-Missouri River Natural Resources District (PMRNRD)

Date: January 10, 2011

Subject: Preliminary Observations and Recommendations for Repairs to Elkhorn River IPA

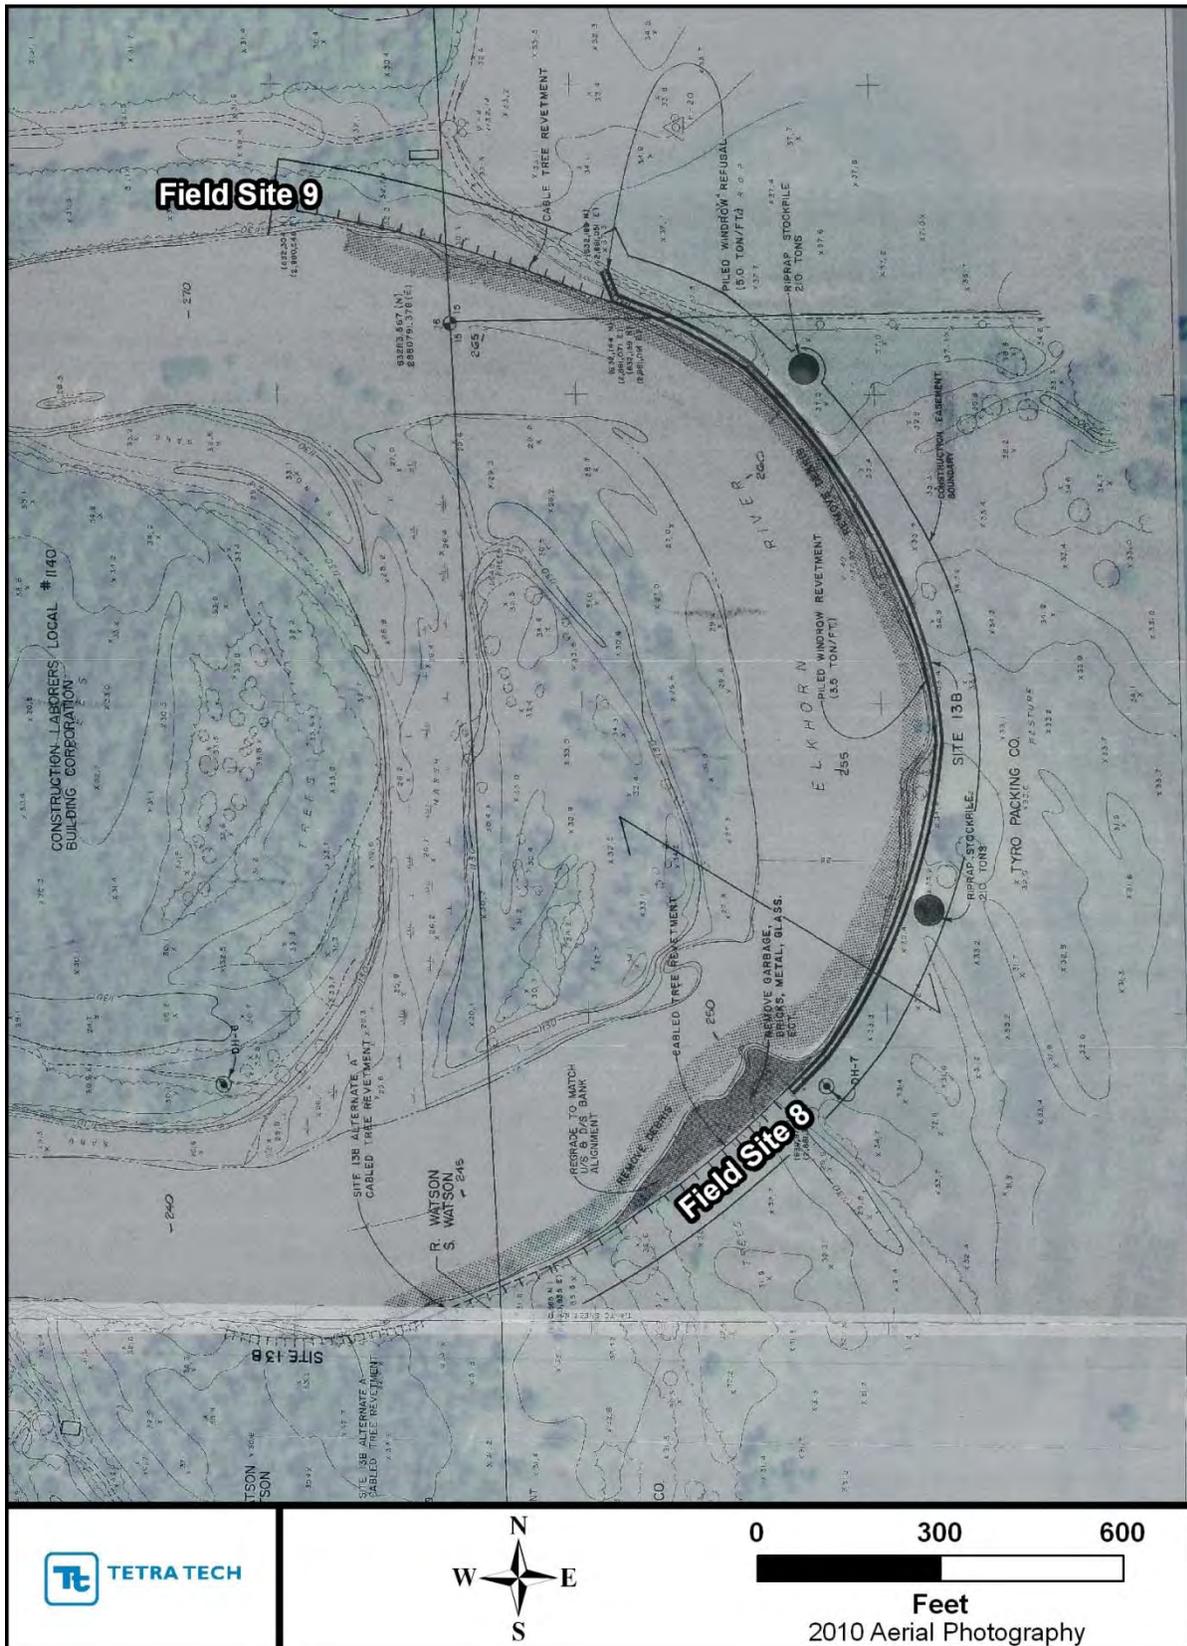
The IPA construction plans for Site 13B called for the piled windrow revetment to end about 300 feet downstream from the edge of the existing wooded area, with about 540 feet of cabled-tree revetment extending upstream from the end of the windrow (**Figure 40**). The cabled-trees were not installed; however, windrow revetment was placed in this part of the site at some point either during or after construction of the IPA (**Figure 41**). This portion of the site is also in good condition and is functioning as intended. A modest amount of bank erosion is now occurring in the approximately 300-foot reach just upstream from the existing rock (**Figures 41 and 42**). Woody debris is currently providing some protection for the site, but continued erosion is possible. A large woody debris jam has formed along the right bank just upstream from the site that appears to be constricting high flows against the left bank at Field Site 9 (**Figures 43 and 44**). A similar, but somewhat smaller, debris jam, was present about 400 feet downstream from the current location as late as 2004 that may have contributed to the erosion tendencies at the upstream end of IPA Site 13B (**Figure 45**). The bankline at Field Site 9 has migrated laterally into the wooded area by up to 50 feet in some places since October 2004.

Figure 40. Construction plans for IPA Site 13B overlaid onto the September 2009 aerial photograph. Note that windrow revetment has been installed at the upstream end where the plans call for cabled-tree revetment.

While Field Site 9 is not in a critically unstable condition at the moment, it should be monitored after future high flows, and the windrow revetment extended upstream at an application rate of 3.0 tons/foot, if necessary. Although the debris jam likely provides habitat value, removal of at least the part that projects into the main current would also relieve some of the erosional pressure on the left bank.

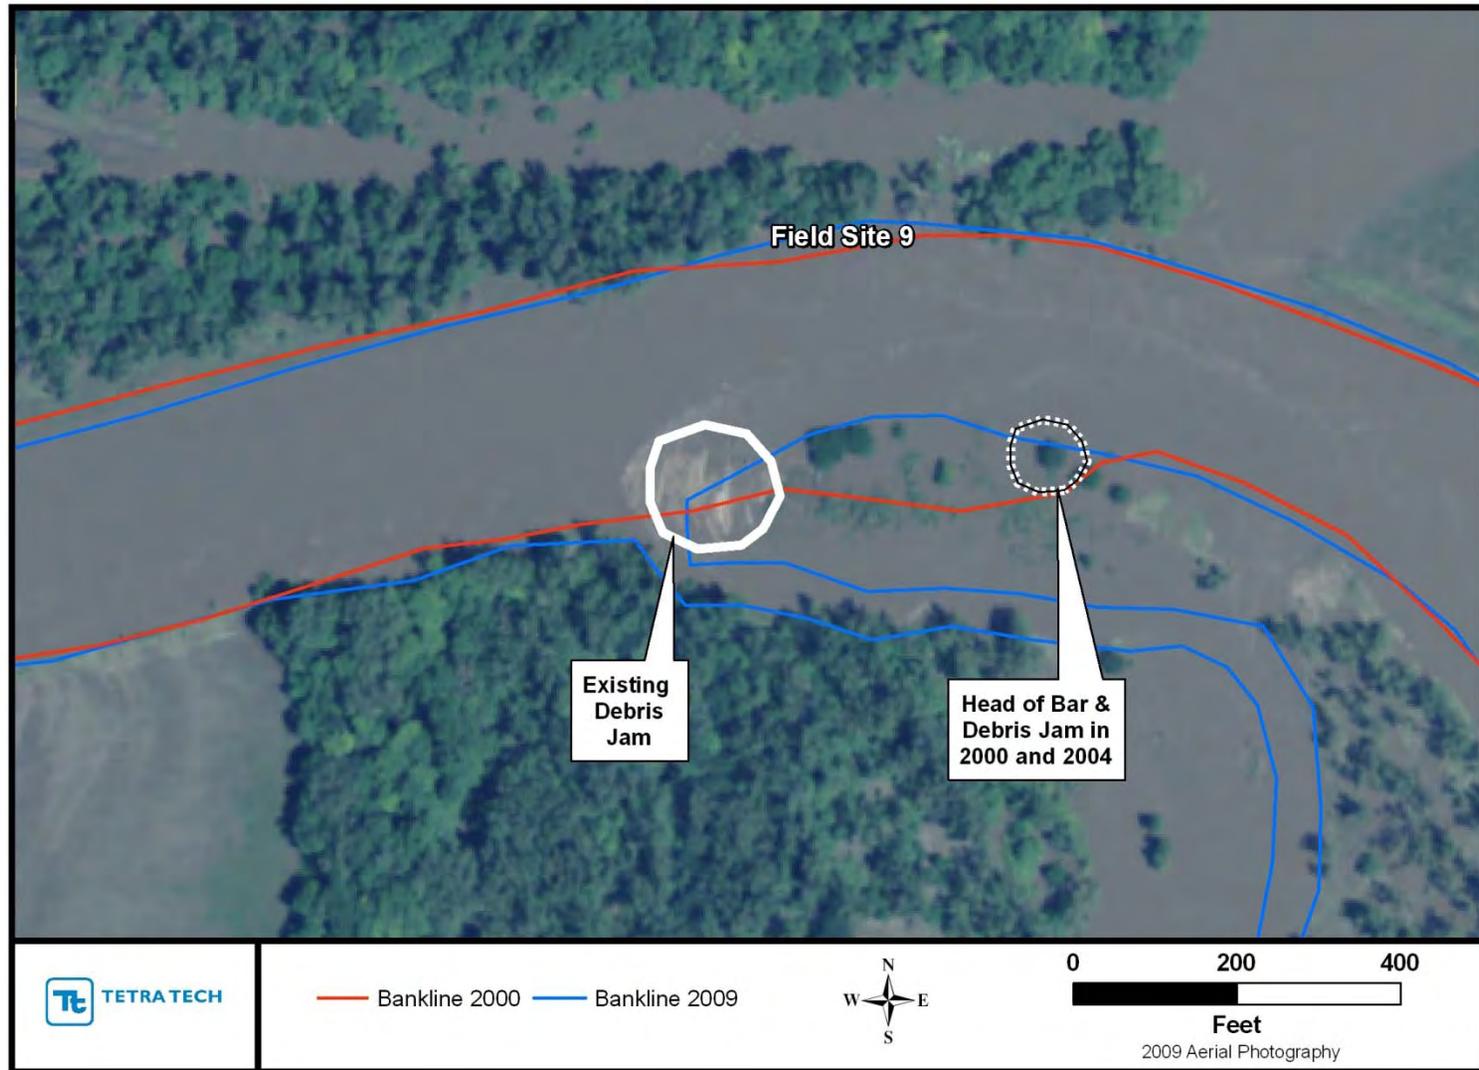
Figure 43. June 16, 2010 aerial photograph (Q~37,250 cfs) in the vicinity of Field Site 9 and the right bank debris jam located just upstream. The approximate location of the head of the point bar and debris jam shown in the October 2000 and October 2004 aerial photos, and the banklines from the October 2004 and September 2009, are also shown.

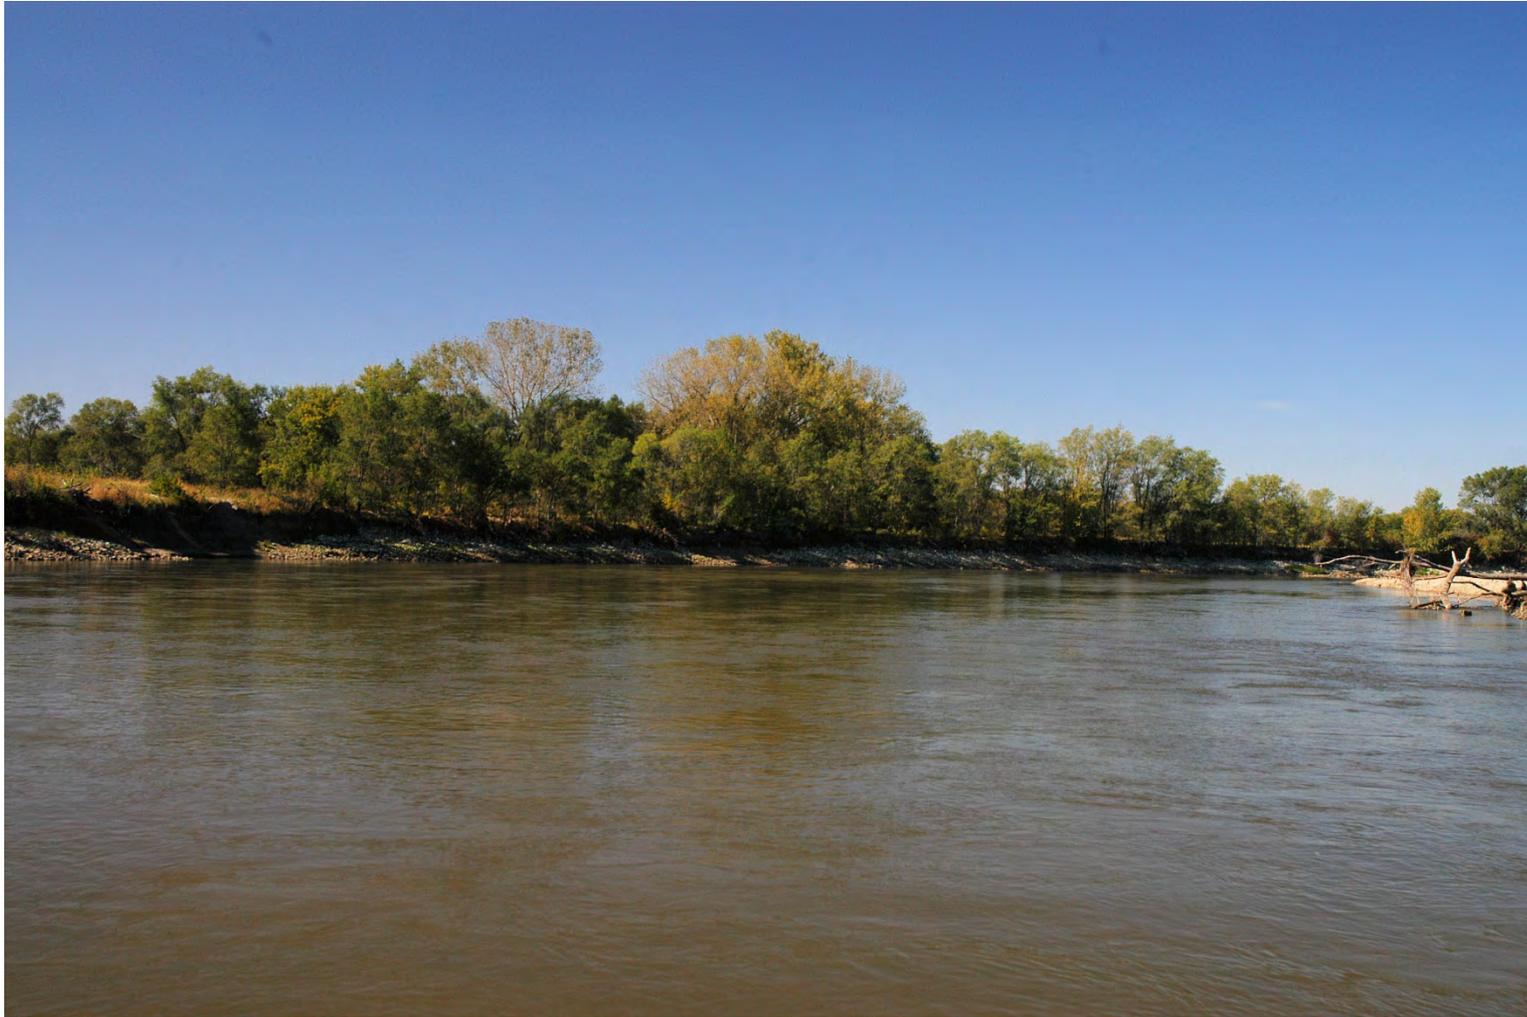
Figure 47. View looking upstream of the middle portion of the buried windrow revetment at IPA Site 13A.

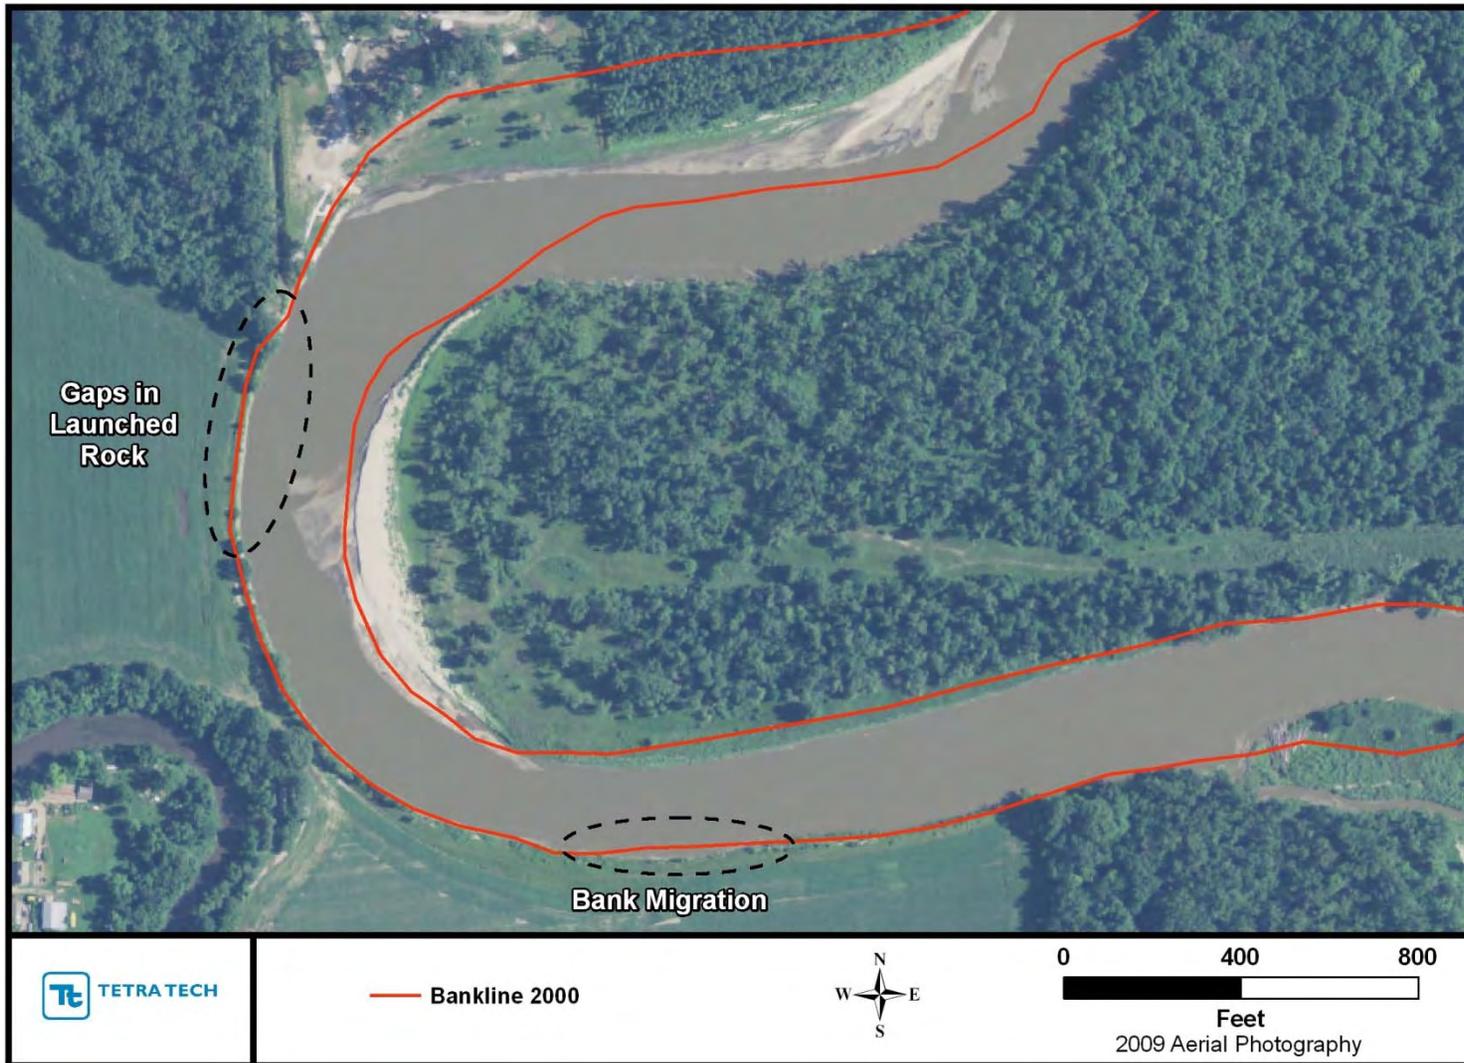
IPA Site 13A consisted of approximately 3,000 feet of buried windrow revetment, with an additional ~500 feet of piled windrow revetment at the downstream end (**Figure 46**). An application rate for the rock of 3.5 tons/foot was specified for the entire site. A portion of the upstream end of the site tied into the Elkhorn Crossing Recreation Area. A berm was constructed in the early-1990s along the portion of the site shown in yellow in Figure 1 to prevent overbank flows from cutting across the meander bend (Table 1). Most of the site downstream from the recreation area appears to be in good condition, with the bulk of the windrow rock launched along the toe and mid-height portion of the banks (**Figure 47**). With the exception of an approximately 400-foot long area near the downstream end of IPA Site 13A, where the bankline appears to have migrated by up to 25 feet, the bankline along the entire site downstream from the Recreation Area has remained in about the same place since completion of the IPA (**Figure 48**). There are, however, gaps in the launched rock at several locations over an approximately 1,000-foot reach immediately downstream from the Recreation Area (Field Site 10, **Figures 49 and 50**). These gaps can be repaired by placing appropriately-sized rock along the toe and intermediate-height portion of the banks. Where appropriate, additional piled windrow rock can be placed along the top of the banks at a rate of 2 to 2.5 tons/foot to prevent further damage if the upper part of the bank continues to erode.

Figure 48. September 2009 aerial photograph of IPA Site 13A (Field Site 10). Also shown is the bankline in the October 2000 aerial photograph.

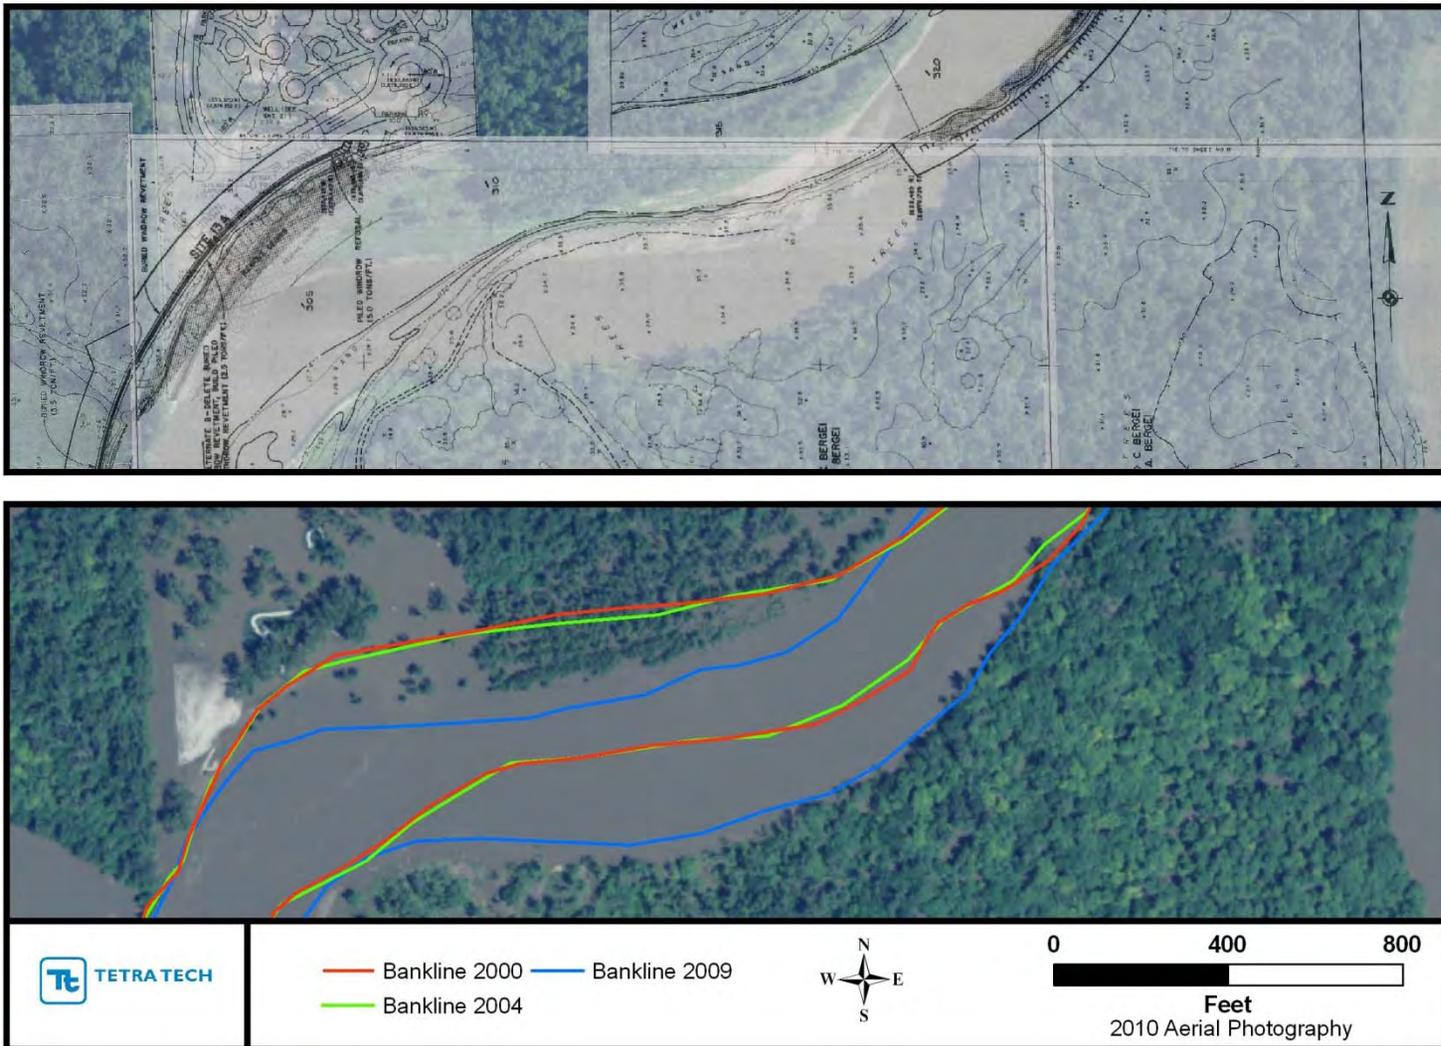
The average channel width through the bend at IPA Sites 13A and 14 is about 300 feet, and the radius of curvature of the bend at IPA Site 13A is about 670 feet; thus, R_c/W is approximately 2.2, the approximate maximum sharpness (or minimum R_c/W) at which the bend should develop without cutting off. Prior to construction of the IPA, this bend followed the typical evolutionary sequence indicated by Brice and Blodgett (1978) and Shen and Schumm (1981) (**Figure 55**). The bank protection provided by the IPA effectively stopped continued downstream migration, and the bend is now compressing through downstream migration (i.e., erosion of the left bank) of the upstream bend at IPA Site 14. The left bank opposite the Recreation Area eroded southward at an average annual rate of about 9.3 feet/year between late-1984 and October 2000, and migration effectively stopped during the relatively dry period between 2000 and 2004. The annual erosion rate increased substantially to about 46 feet/year between October 2004 and September 2009, and the bank eroded by an additional approximately 75 feet between

Figure 51a. Construction plans for the upstream portion of IPA Site 13A and downstream portion of IPA Site 14 overlaid onto the September 2009 aerial photograph. Also shown are the banklines from the October 2000 and October 2004 aerial photograph.

Figure 51b. Same image as Figure 51a with construction plans removed.

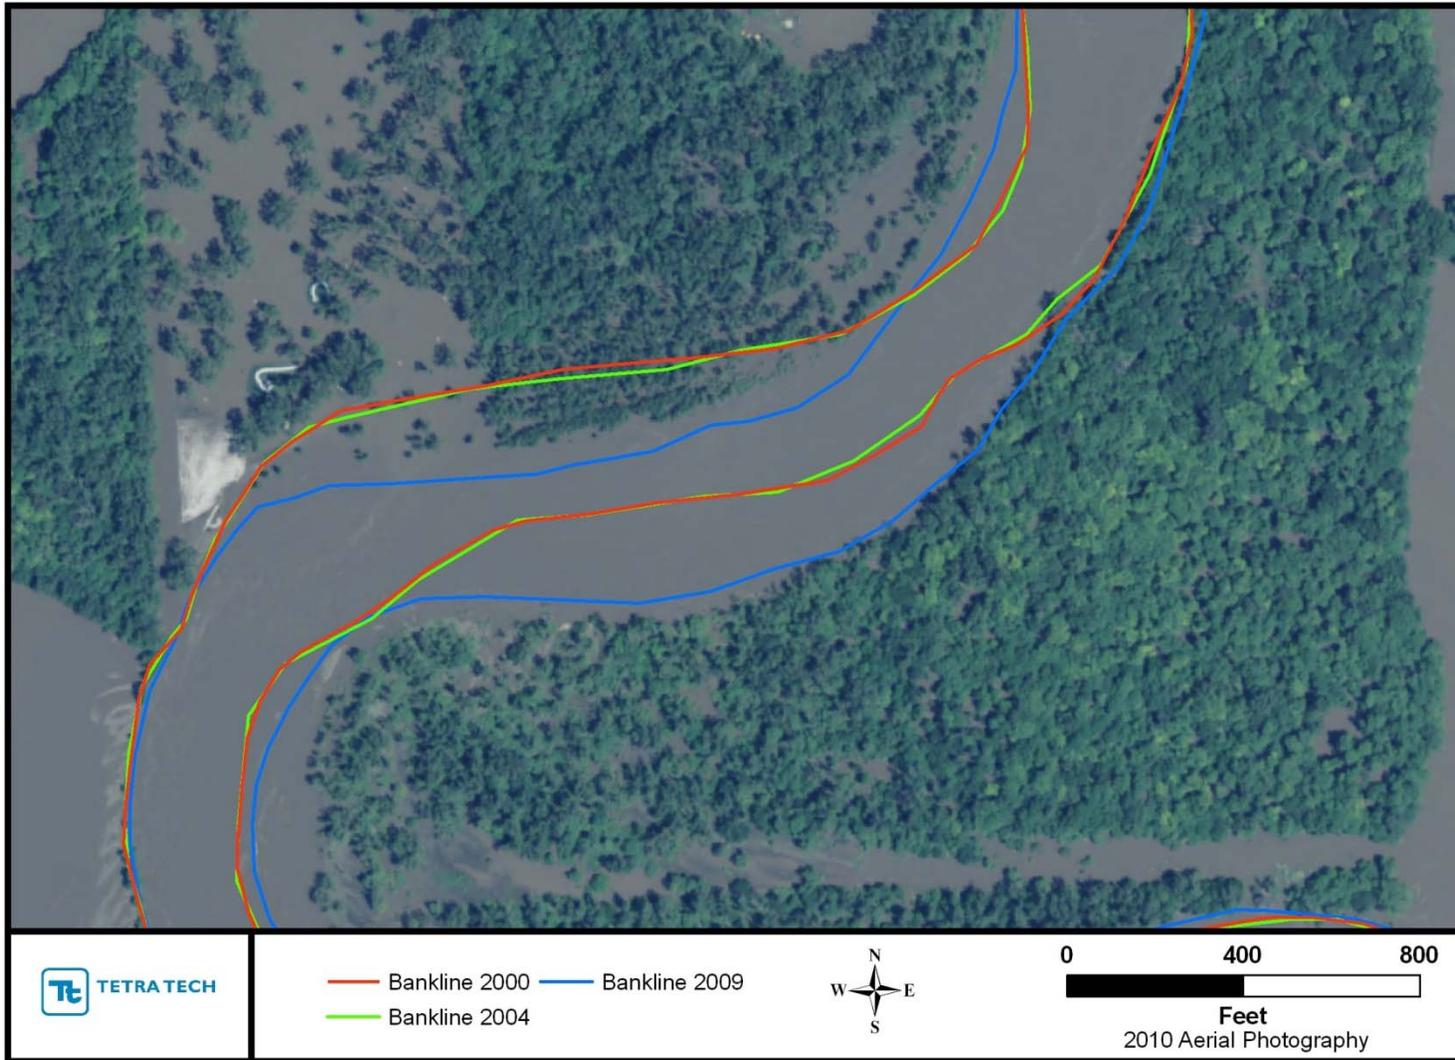
Figure 52. June 16, 2010 aerial photograph Field Site 11, between IPA Sites 13A and 14 showing the additional 55 to 60 feet of lateral migration after September 2009.

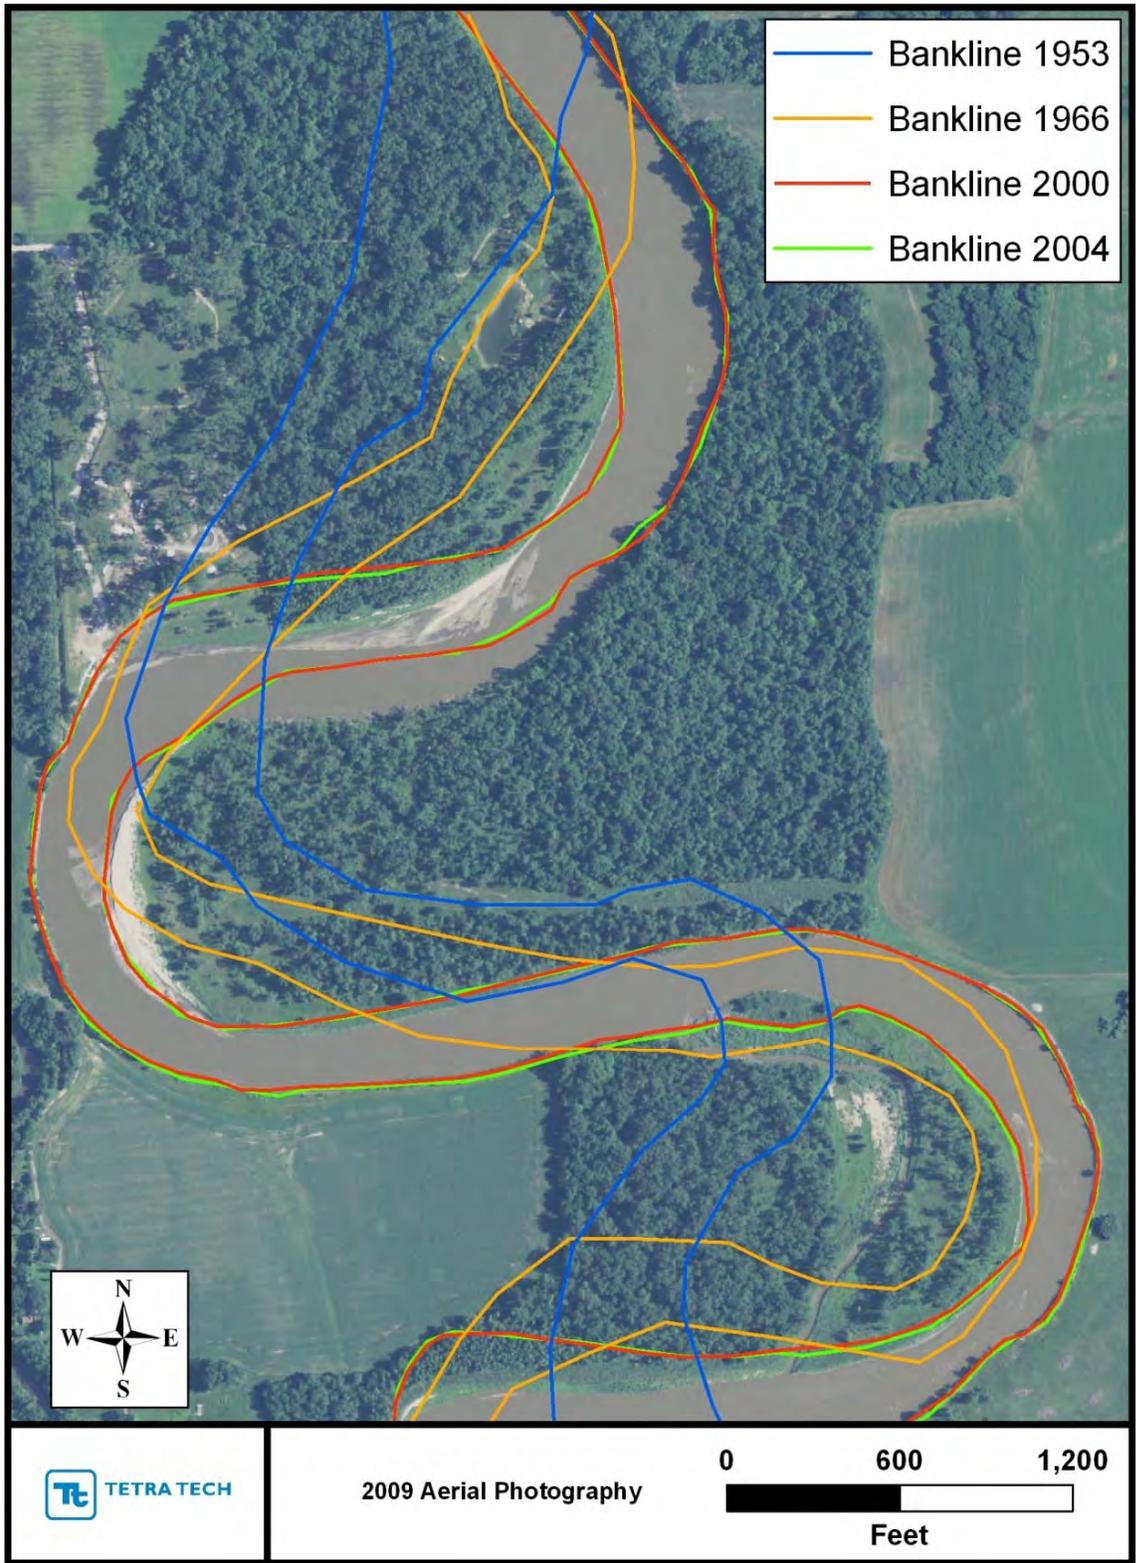
Figure 55. September 2009 aerial photograph showing the bankline locations in June 1953, April 1966, October 2000, and October 2004.

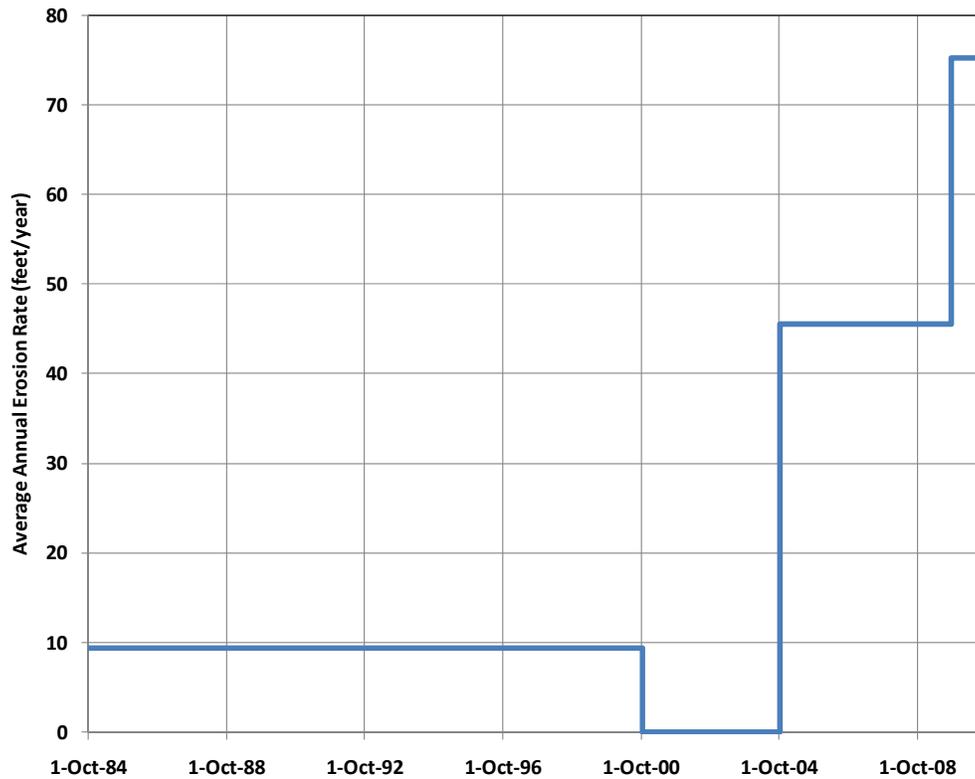
September 2009 and mid-June 2010 (**Figure 56**). [It should be noted that most of the erosion between the 2009 and 2010 aerial photos most likely occurred during the rising limb, peak and early part of the falling limb of the 2010 hydrograph (Figure 6). Data are not available to determine how much additional erosion occurred during the later part of the 2010 high-flow hydrograph.] Future erosion rates in this bend may slow, based on the findings of Hickin (1975) and others, because the bend at IPA Site 13A is approaching its maximum sharpness. Considering the topography and amount of trees and other vegetation in the wooded area through which the cut-off would occur, it seems unlikely that the bend would abruptly cut off, but this must be considered as a possibility.

Figure 56. Average annual erosion rates in the bend at the downstream end of IPA Site 14 between late-1984, when the aerial photographs used to develop the mapping were taken and mid-June 2010.

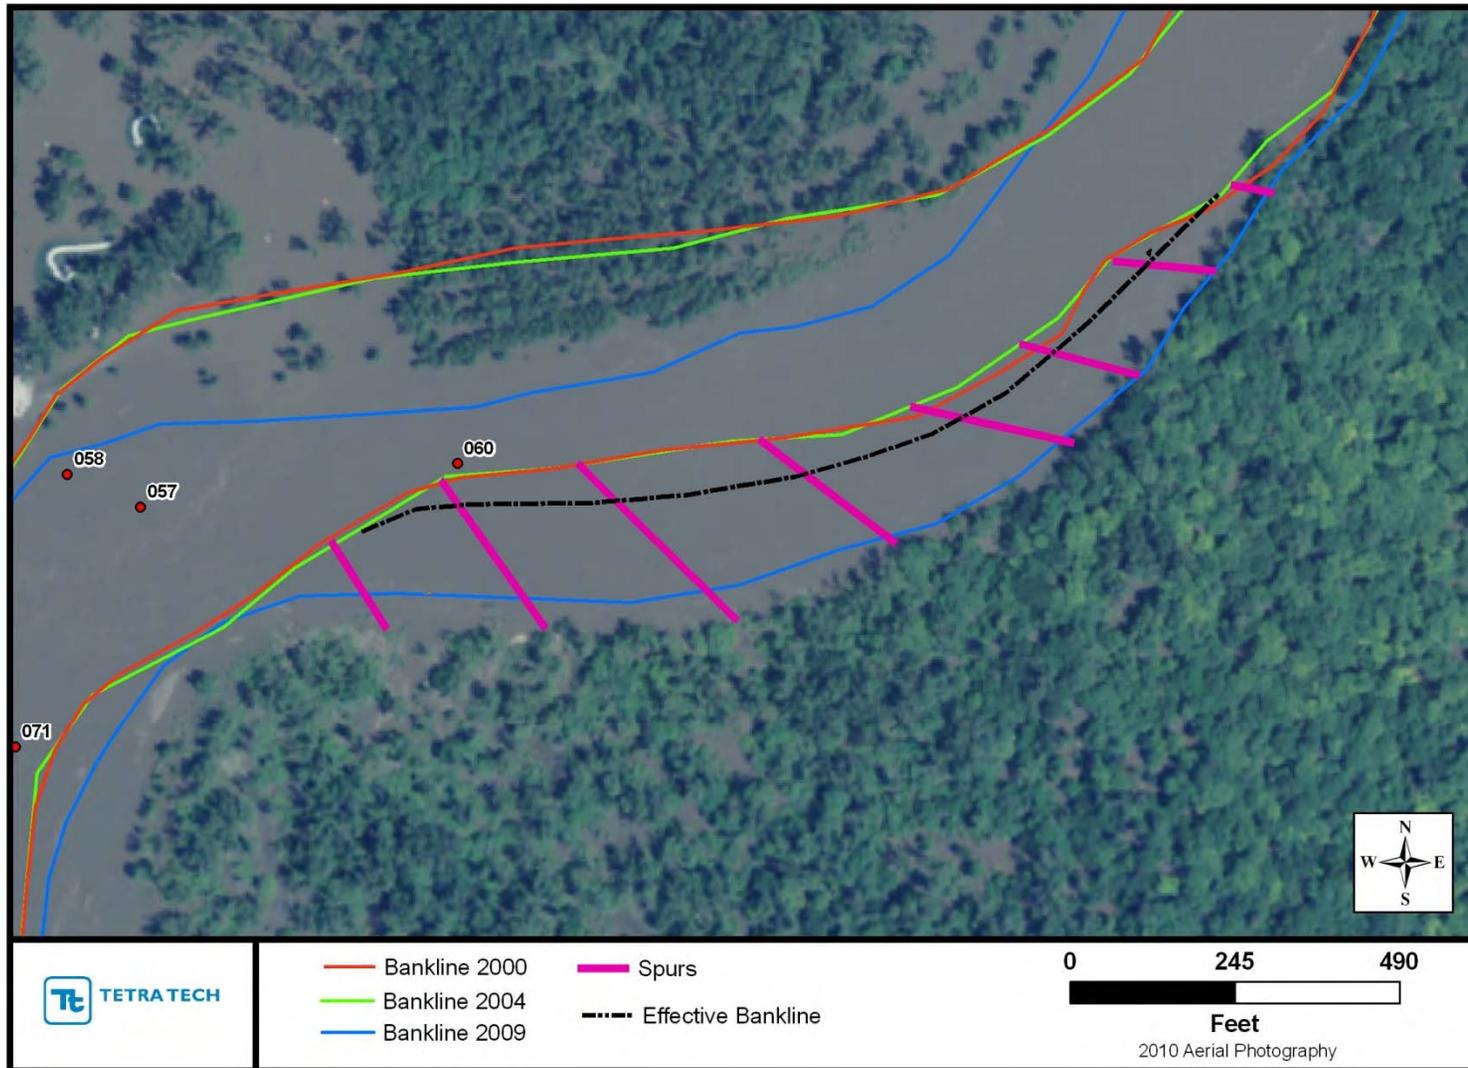
During the field visit, Director Tesar indicated that the rock that is visible in Figure 57 that was placed in 2009 has slumped 2 to 3 feet down into the channel, and he is concerned that the installation may eventually fail. Sufficient data are not available confirm this observation, but it appears to be reasonable based on the existing elevation at the top of the bank compared to the top of the rock. If the observation is correct, it may be necessary to repair the installation to insure continued stability, and these repairs could be done in conjunction with relocating the boat ramp.

Figure 57. Preliminary layout of spur dike field that would restore the river alignment in the vicinity of the Elkhorn Crossing Recreation Area to eliminate the sandbar at the boat ramp.

The sandbar at the boat ramp obviously creates a problem for use of the ramp, and PMRNRD has expressed a desire to modify the site in a manner that will remove and prevent future formation of the sandbar. Since this sandbar is formed by accretion on the inside of the bend that is associated with migration of the opposite bank, the only effective way to cause the river to remove the sandbar and insure that it does not re-form is to shift the left bank opposite the site back to its approximate position prior to formation of the sandbar. This could be achieved by constructing a series of rock jetties or bendway weirs in the eroded area along the left bank, with the ends of the structures at approximately the 2004 bankline (**Figure 57**), but the cost would be very high (cumulative length of the spurs would be ~1,700 feet, not considering the necessary tie-back to prevent flanking). It is questionable whether the necessary environmental permits could be obtained for such a project. Two other alternatives could be considered for dealing with the sedimentation issues at the boat ramp, both of which would require stabilization of the existing bankline at IPA Site 14 to insure their continued viability:

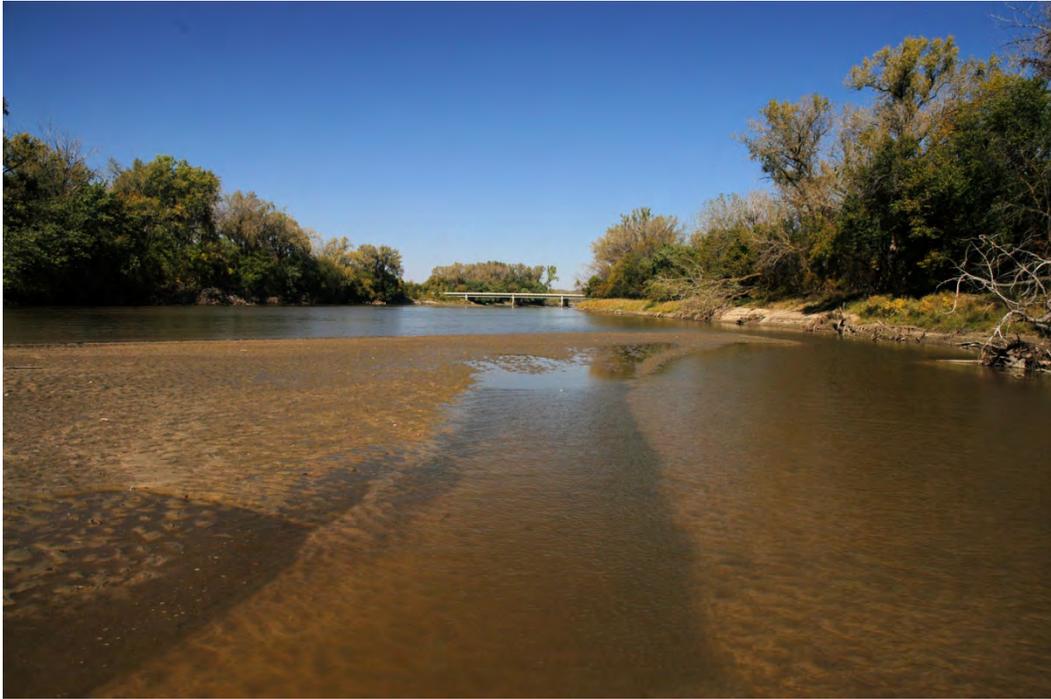
During the field discussions, Director Tesar indicated that there is concern that the river is widening in the approximately one-half-mile reach downstream from the Highway 36 Bridge. Some erosion of the right bank for several hundred yards downstream from the bridge was observed during the site visit, but the left bank appears to be relatively stable (**Figures 60 and 61**). Comparison of the banklines in the 2000, 2004, 2009 and 2010 aerial photos indicates that there has been little, if any widening in this reach over at least the past decade, except along the left bank for about 550 feet downstream from the bridge (**Figure 62**). It also appears that the left bankline has retreated by up to 30 feet over a distance of about 400 feet beginning about 650 feet downstream from the bridge, and the right bankline may have retreated by up to 30 feet over a distance of about 800 feet, beginning about 1,400 feet downstream from the bridge. These relatively small distances are likely within the resolution of the photographs; thus, there is considerable uncertainty as to whether this amount of lateral erosion actually occurred. In any case, the average width of the channel in the approximately 0.7-mile reach extending from the end of the left-bank widening in the first 550 feet downstream from the bridge was 320 feet in October 2000, and the average width in this part of the reach is the same in the September 2009 aerial photo. Based on the 1996 construction plans, the span length of the Highway 36 Bridge between the abutments is also about 320 feet.

Figure 60. View looking upstream through the Highway 36 Bridge.

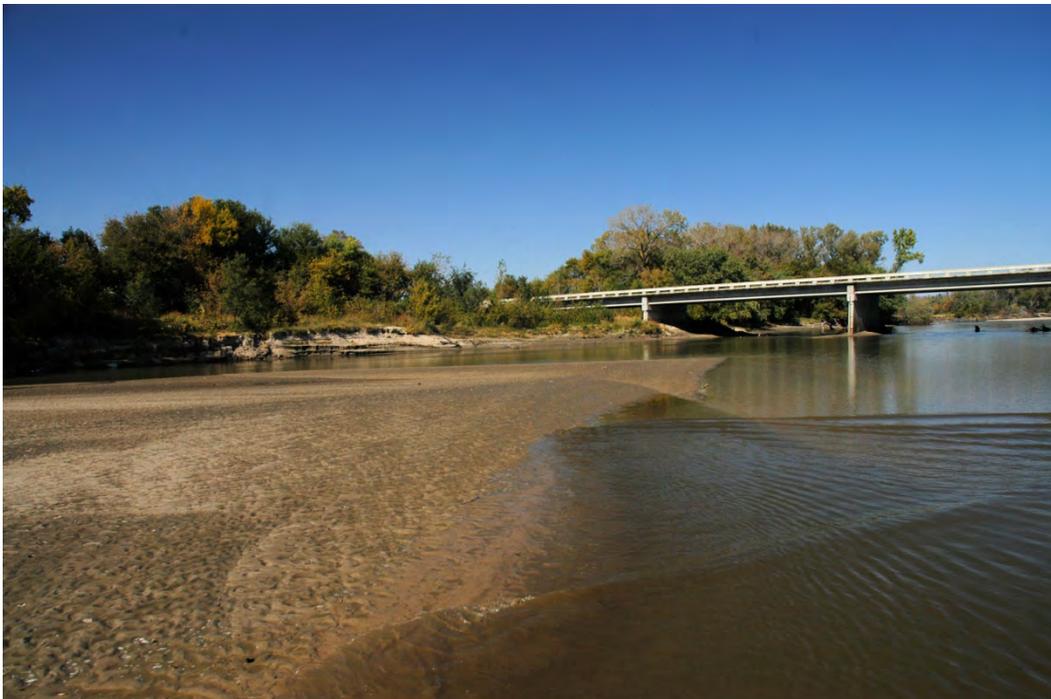
Figure 61. View looking upstream through the right end of the Highway 36 Bridge.

11	14	2000		\$ 180	\$ 562,000	High	Windrow revetment on left bank and relocate Elkhorn Crossing Boat Ramp	Figures 50 and 59
12	N/A	400		\$ 180	\$ 108,000	Low-Medium	Windrow revetment	Figure 61
13	15	2250	3	\$ 287	\$ 645,000	High	Realign bank line and back fill to eliminate scallop, windrow revetment	Figure 65
Total					\$ 2,901,500.0

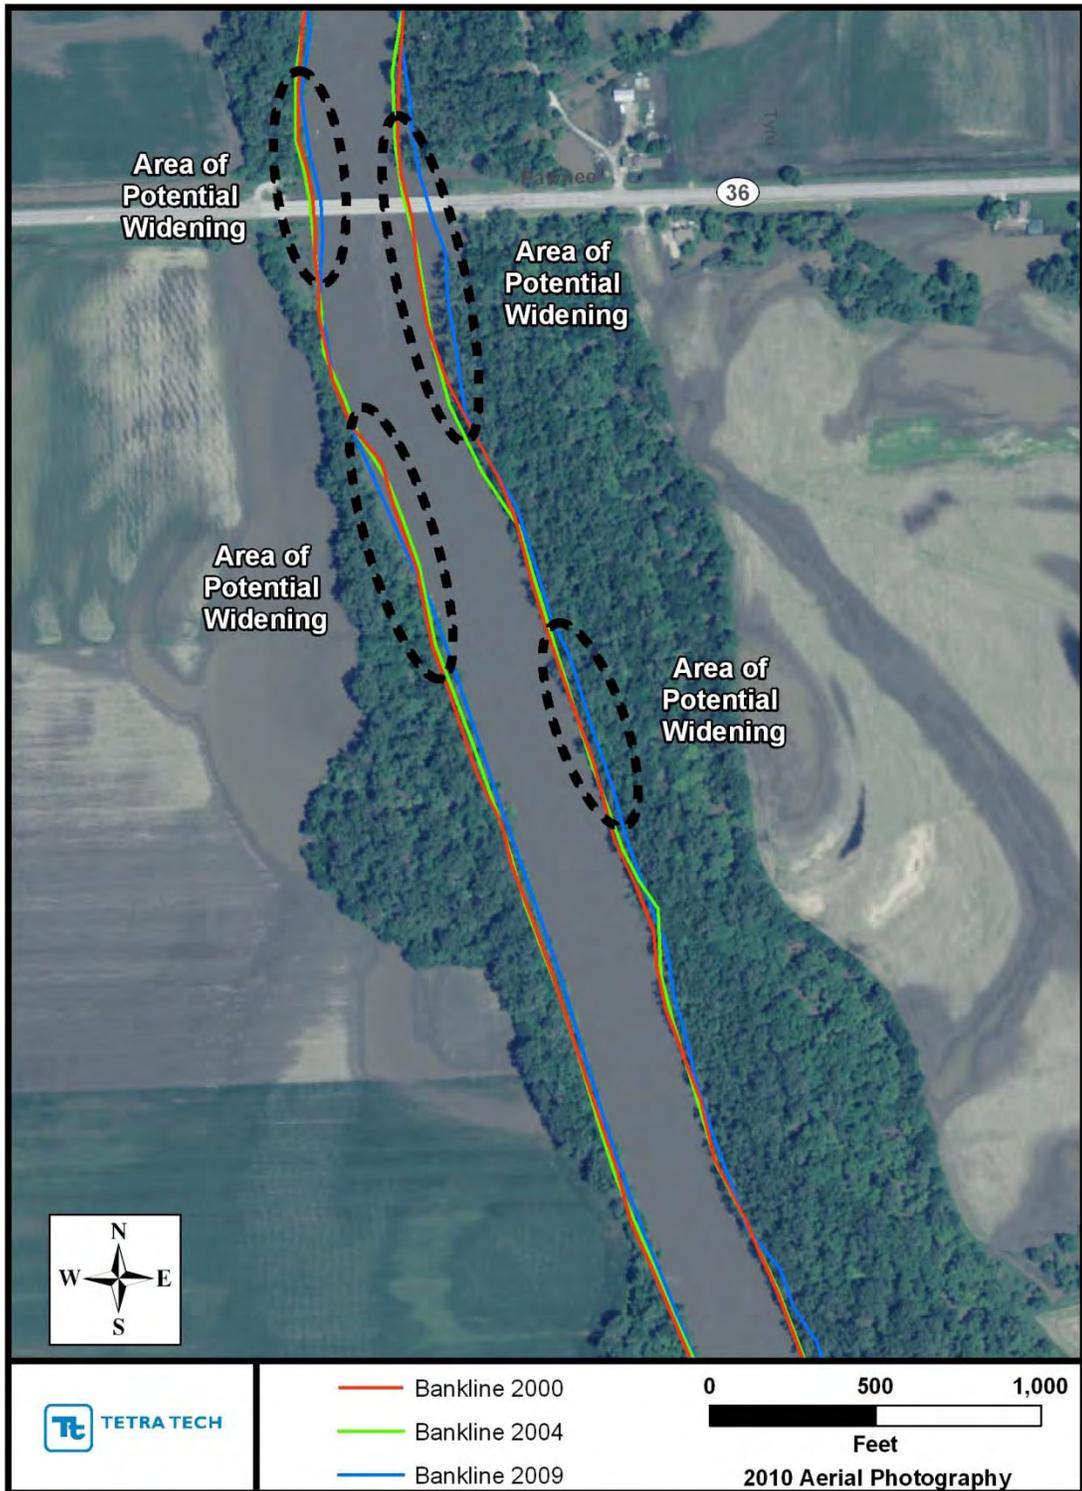
Based on the above information, it does not appear that this reach of the river is systematically widening. It is interesting to note, however, that the line of riparian trees in the right overbank that provide a measure of bank stability is relatively thin for about 750 feet downstream from the bridge. If the observed erosion in this area is creating a hazard to the adjacent property, the erosion could be checked with windrow revetment similar to the installations for the IPA, or the rock could be placed directly on the bank. If the windrow option is chosen, it would probably be necessary to remove the existing trees. It is possible that the bank could be built outward by the necessary amount to allow placement of the riprap on a minimum 2.5H:1V slope without constricting the river sufficiently to affect the upstream water-surface profile at high flows. Whether this is, in fact, the case would require detailed hydraulic modeling.

Figure 62. 2010 aerial photograph of the reach downstream from the Highway36 Bridge, showing the banklines from the 2000, 2004, and 2009 aerial photos (Field Site 12).

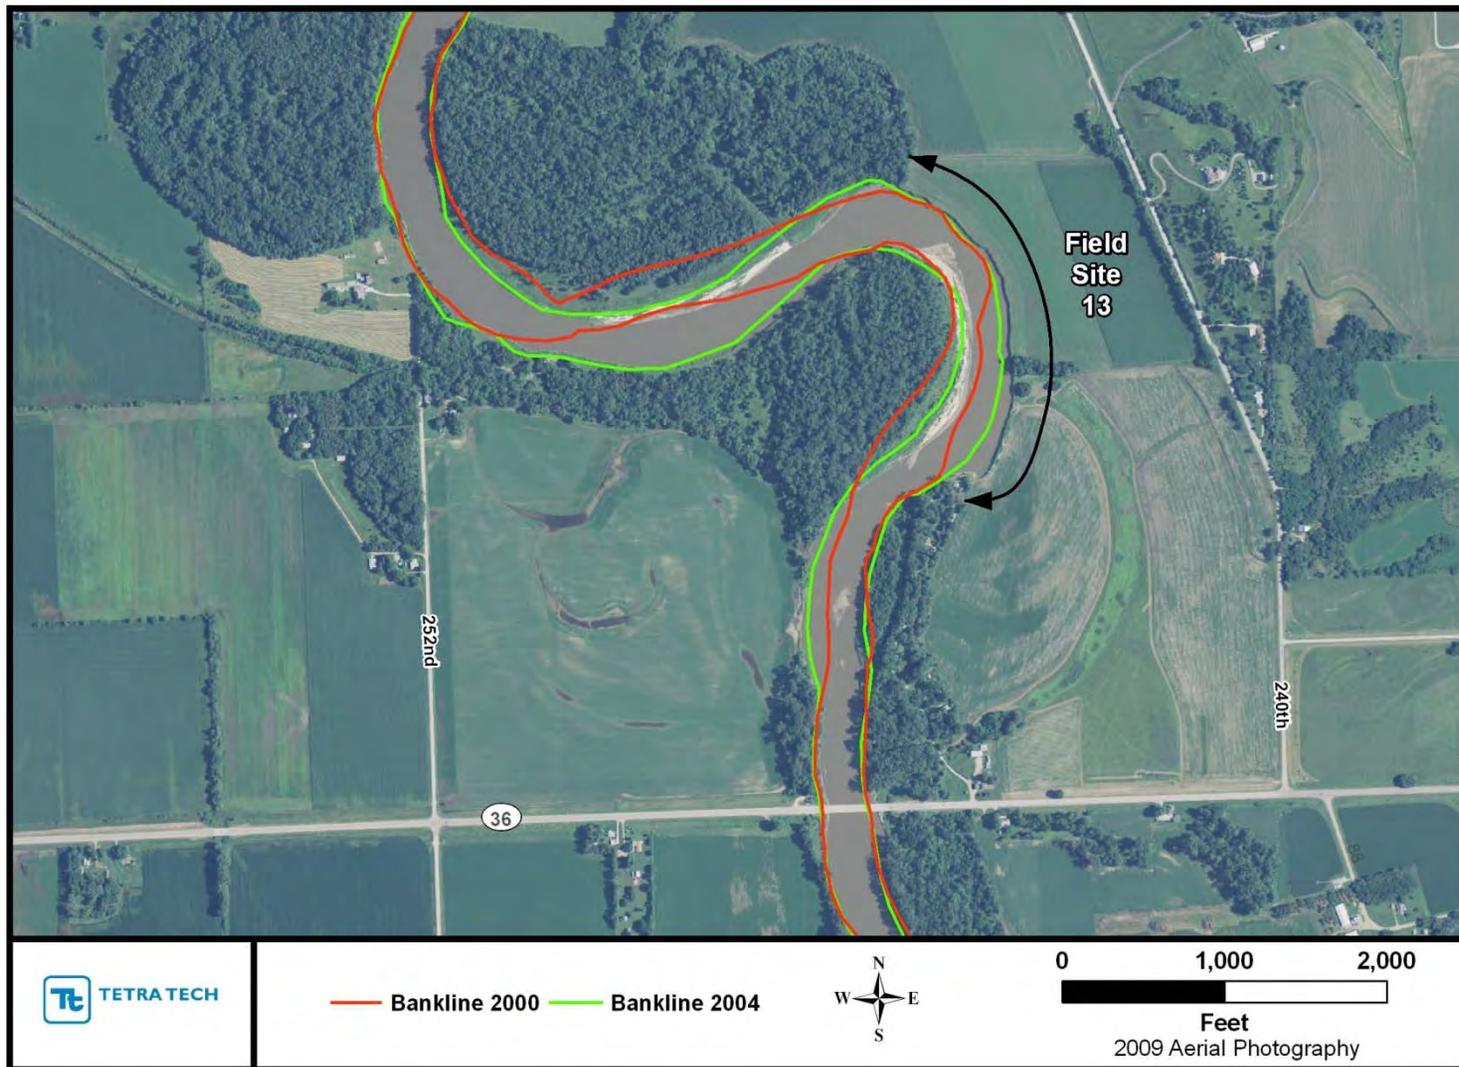
This site, which is located outside the boundaries of the IPA, consists of the bend located about one-half-mile upstream from Highway 36 that has migrated to the east by about 300 feet to the east since October 2000 (**Figure 63**). During the site visit, Director Tesar indicated that there is concern that this bend will continue to migrate, causing the river to flank into the left (east) overbank, potentially abandoning the Highway 36 Bridge. This site was considered in the evaluation to assess whether future changes at the site could potentially affect the stability of the downstream river within the IPA boundaries.

An abandoned meander channel is clearly visible in both the 2009 and 2010 aerial photographs that extends from just upstream from the apex of this bend downstream to just above Highway 36 where it reconnects to the river (**Figures 63 and 64**). Bank protection in the form of rock and concrete rubble has been placed on the bank to protect the properties in the left overbank at the upstream end of the wooded area at the downstream end of the bend (**Figure 65**). The protection has effectively prevented additional erosion of the bankline at this location, but the bankline just upstream has continued to erode. At the present time, there is a relatively sharp hook in the bankline where it transitions from the eroding zone to the protected zone. Although the erodible portion of the bank does not appear to have migrated significantly during the portion of the 2010 high flow before June 16, when the aerial photo was taken, it likely will continue to

Figure 63. 2009 aerial photograph of the eroding bend at Field Site 13, showing the banklines in 2000 and 2004.
