To: Gerry Bowen
Papio-Missouri River Natural Resources District (PMRNRD)

Date: January 10, 2011

Subject: Preliminary Observations and Recommendations for Repairs to Elkhorn River IPA

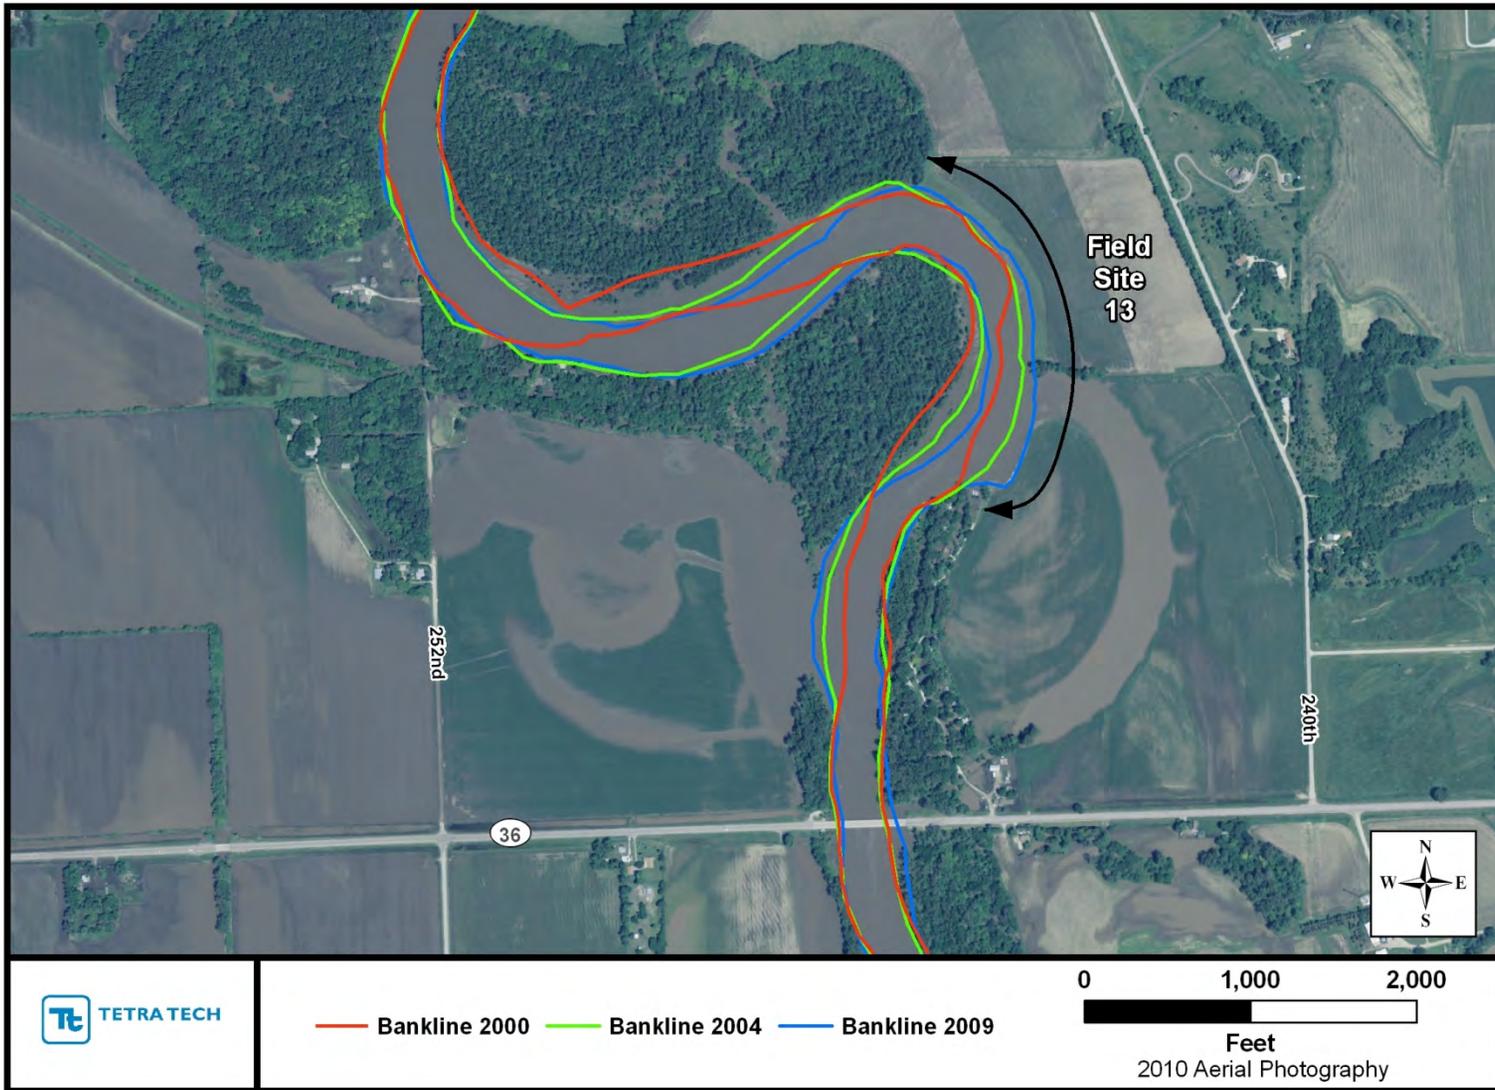
An abandoned meander channel is clearly visible in both the 2009 and 2010 aerial photographs that extends from just upstream from the apex of this bend downstream to just above Highway 36 where it reconnects to the river (**Figures 63 and 64**). Bank protection in the form of rock and concrete rubble has been placed on the bank to protect the properties in the left overbank at the upstream end of the wooded area at the downstream end of the bend (**Figure 65**). The protection has effectively prevented additional erosion of the bankline at this location, but the bankline just upstream has continued to erode. At the present time, there is a relatively sharp hook in the bankline where it transitions from the eroding zone to the protected zone. Although the erodible portion of the bank does not appear to have migrated significantly during the portion of the 2010 high flow before June 16, when the aerial photo was taken, it likely will continue to

Figure 64. 2010 aerial photograph of the eroding bend at Field Site 13, showing the banklines in 2000, 2004 and 2009.

erode during future high flows. Considering the relative stability and existing bank protection along the downstream wooded area, it is unlikely that the bend will avulse to the east and impact Highway 36 or the bridge crossing. Considering the geometry of the bend, the most likely scenario is that, as the bend continues to develop, the radius of curvature will decrease sufficiently to encourage the bend to cut off on the inside, effectively straightening the river upstream from the bend. Continued development of the bend will, however, cause additional erosion in the adjacent field, and could endanger the homes that are located in the wooded area (many, or perhaps most, of which were damaged by flooding during the 2010 high flows).
