MEMORANDUM

SUBJECT: California Bend Environmental Restoration Project – Access Road

Geotechnical Exploration Report

California Bend Slope Failure

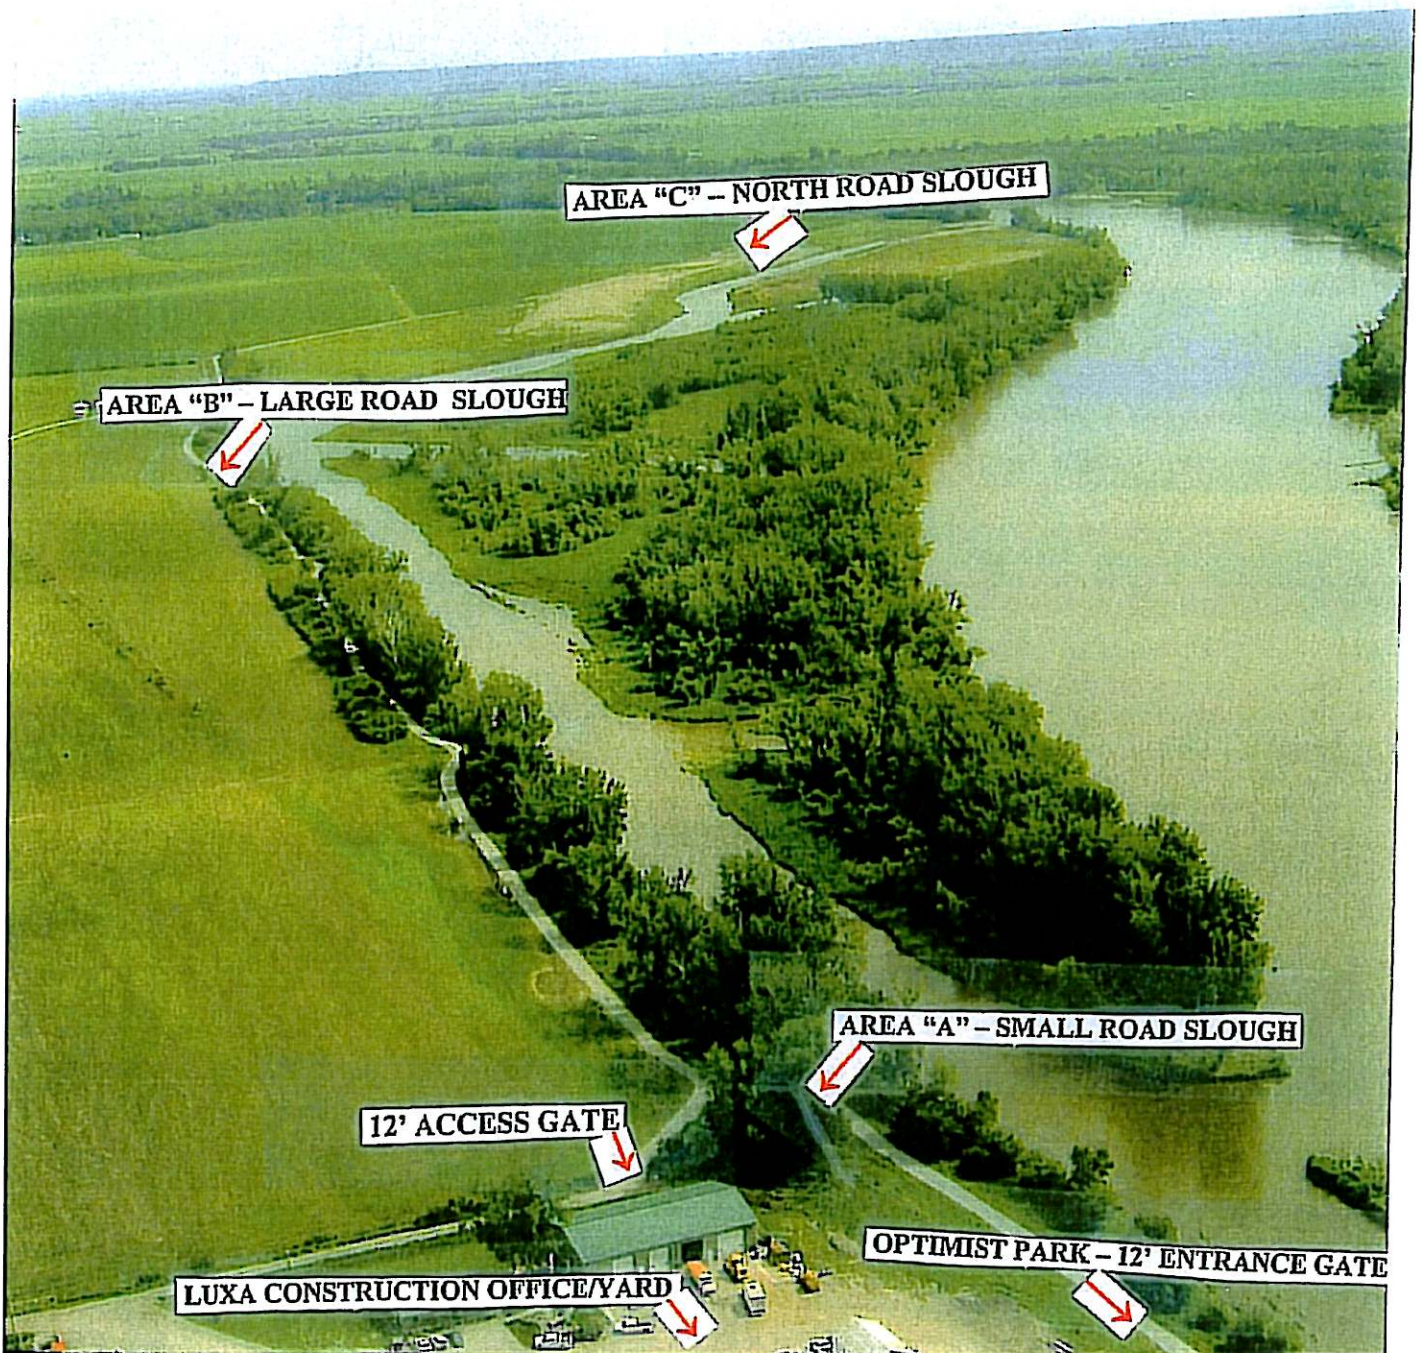
Exhibit D: California Bend – Road Washout Site Map.

In May of 2007, a rain event occurred over-and-above the site that resulted in overland flooding and a quick, yet short lived, rise of the Missouri River. This excessive rain caused several serious erosion concerns along the access road through the site (Exhibits D, E and F). Some sloughing in this area is non consequential to the District, but the threat to the only access road to the upstream end of the project is the major concern.

It is Management's plan to leave slope as is and monitor it for changes along with minor grading to allow good access and smooth the area with District equipment (Option 2). If the slope fails again in the future it is likely to occur along the same vertical slip-plane and not likely impact the adjacent landowner initially. Repair designs and construction bids could then be sought to address the situation more permanently.
