Whitted Creek Stream Rehabilitation Project

The Papio-Missouri River Natural Resources District

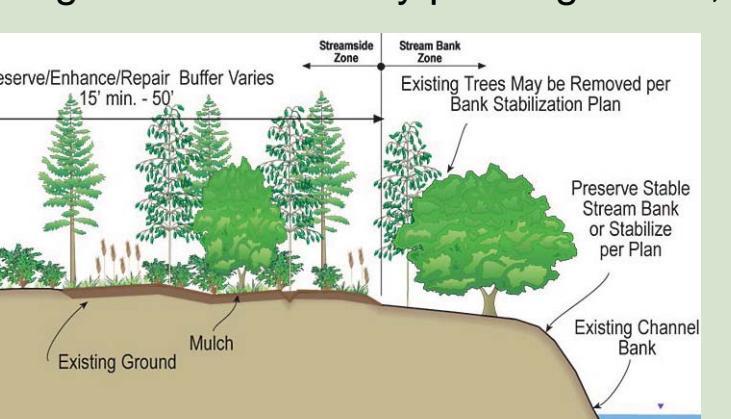
Jonceptual Plan of Restored Ribarian Buffe

vegetation along the banks of rivers and streams that filter polluted runoff and provide a transition zone between water and human land use. They are complex ecosystems that provide habitat and improve the stream communities they shelter. Greater than 11 acres of riparian buffer will be improved along Whitted Creek by planting over 5,000 native trees and

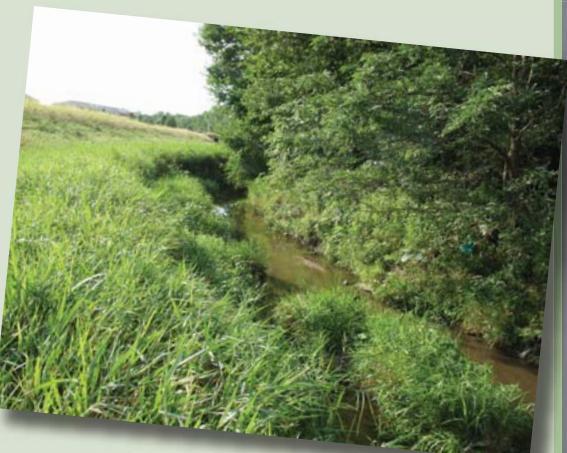
Mature riparian buffer on right bank, nowed levee on left bank

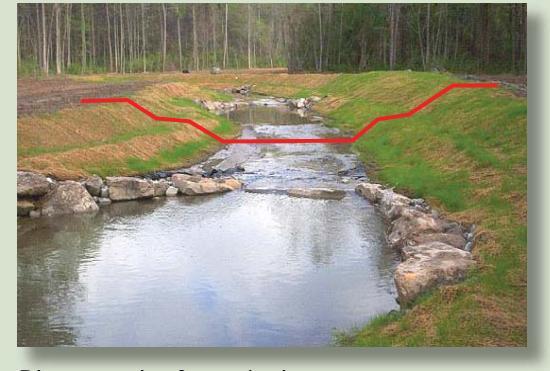
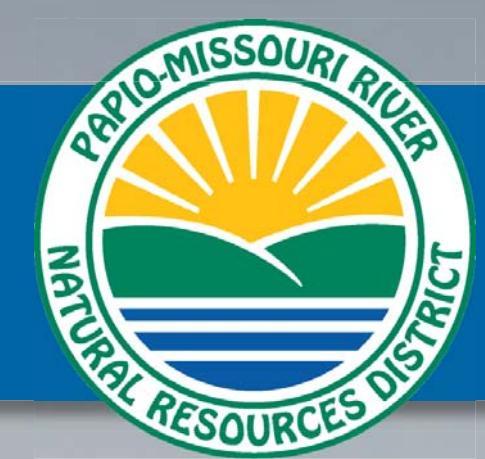
Specially designed structures are used in this project to maintain the stability of the channel. One type of structure, the cross vane (seen at right) is used extensively. These structures are made of large rocks that are strategically placed in the stream. The structures divert stream flows away from the stream banks to the center of the channel, creating scour pools and oxygenating the water, elements that are critical for aquatic habitat.

Photograph of a typical cross vane structure

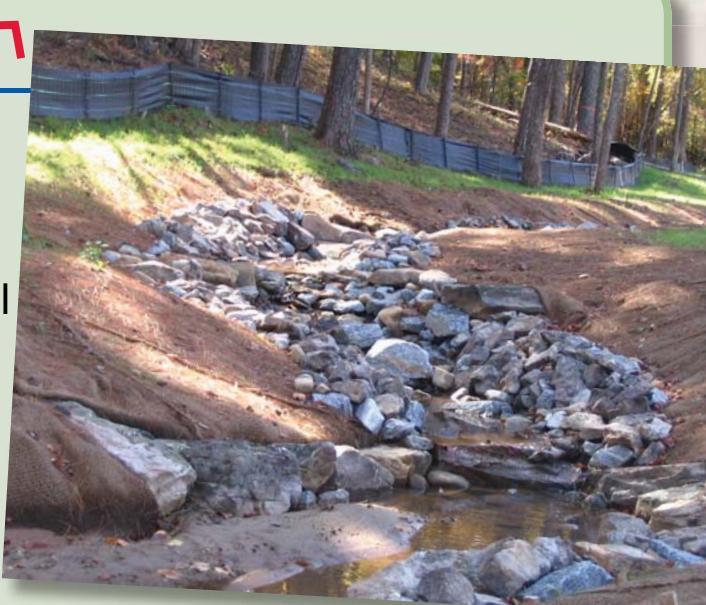
Step-Pool Transition

Step-pools provide a natural way to transition the stream bed through a relatively large change in elevation. Step-pools in streams serve several purposes: dissipating the energy of high-velocity water, protecting the banks and bed from this high-energy erosive flow, and

providing fish passage across the changes in bed elevation through

several small "steps" instead of one big jump. The restored tributary contains a step-pool transition from Whitted Creek to Papillion Creek

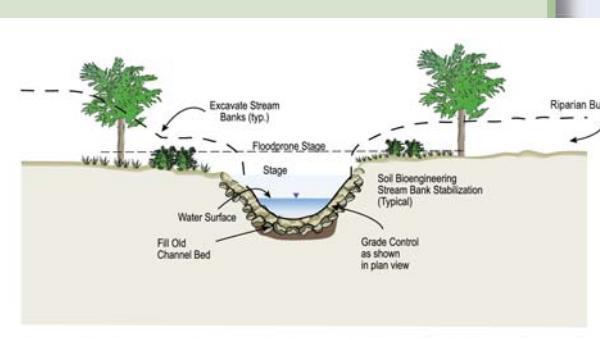
high sinuosity and highly connected floodplain.

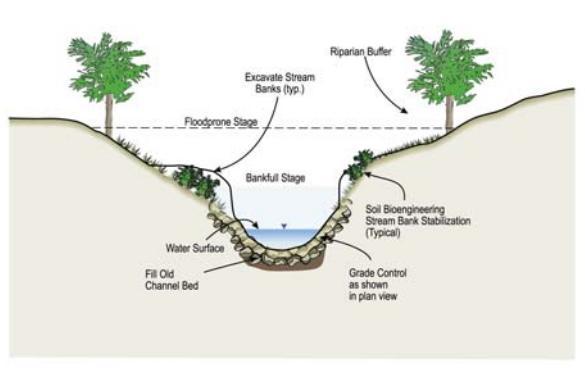
Confined stream channel characterized by rapids and steeper gradients
